LEVEL 2 HISTORIC BUILDING RECORD

THE BYRE

To support Listed Building consent for proposed alternations/works to be implemented at The Byre, Llawhaden, Narberth. SA67 8HN.

15 June 2023

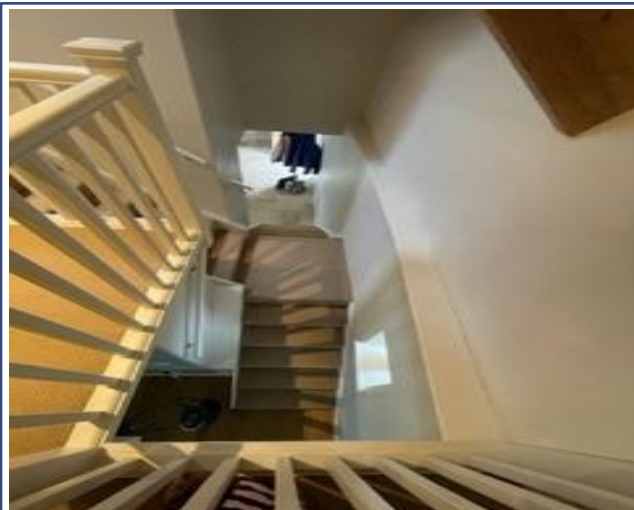
- The wall on the front (south elevation) is half plaster board and half original wall. The lower half is painted plaster board and the top half is the original wall painted in clay paint with a wooden sill running across the “half landing”. This is shown in the photograph in Figure 171.

Figure 171: The Byre Jack and Jill staircase looking at the south and east elevation walls.

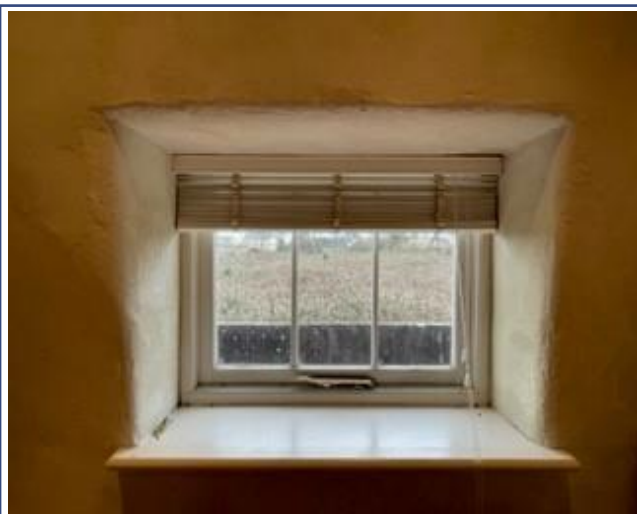
- One single glazed glass wooden window on the side (west elevation) with a wooden windowsill. The description is as described for the exterior of the building in paragraph 7.33.

Figure 175: The Byre Bedroom 2 window on the west elevation wall.

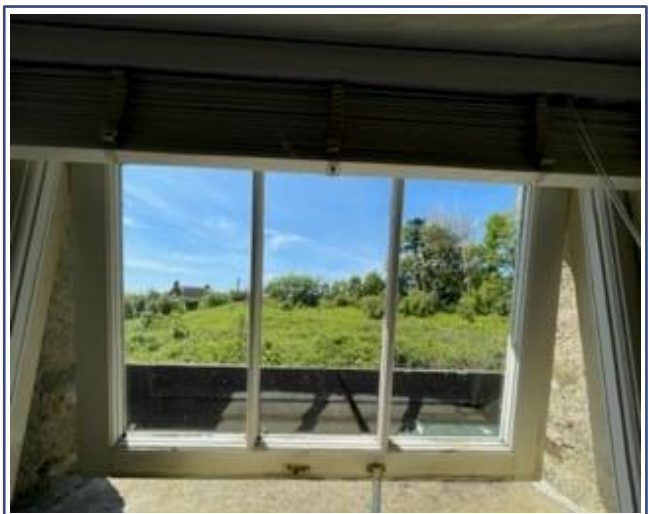
Figure 176: The Byre Bedroom 2 Window on the west elevation wall.

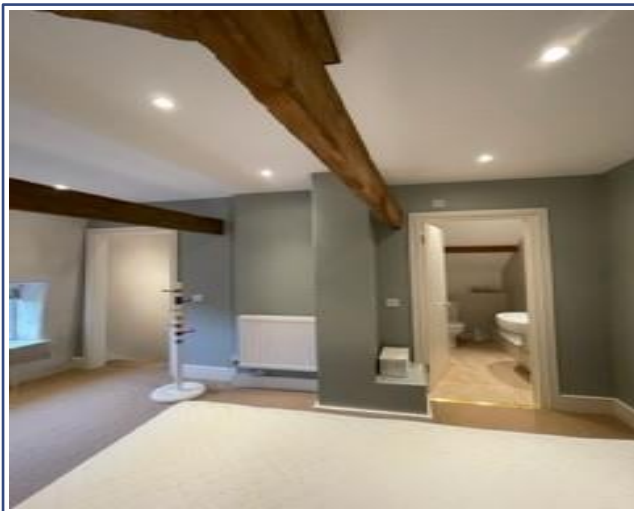
Figure 181: The Byre Bedroom 2 looking at the west and north elevation walls and door to the Ensuite Bathroom.

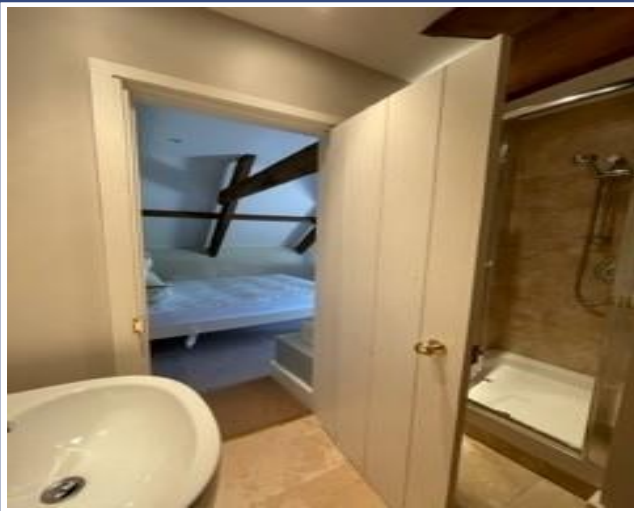
Figure 185: The Byre Bedroom 2 Ensuite Bathroom looking at the south elevation wall and "stable style" door.

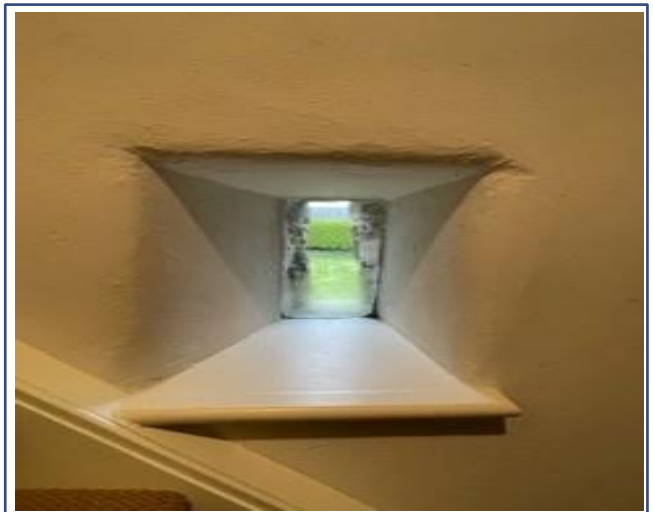
Figure 192: The Byre Bedroom 2 Staircase looking at the north elevation wall and the "slat" window.

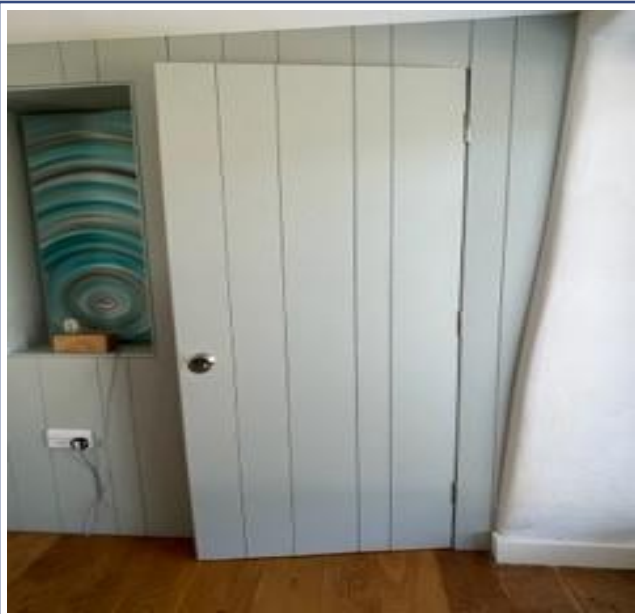
Figure 193: The Byre Internal Door looking at the west elevation wall leading from the Lounge to Bedroom 2.

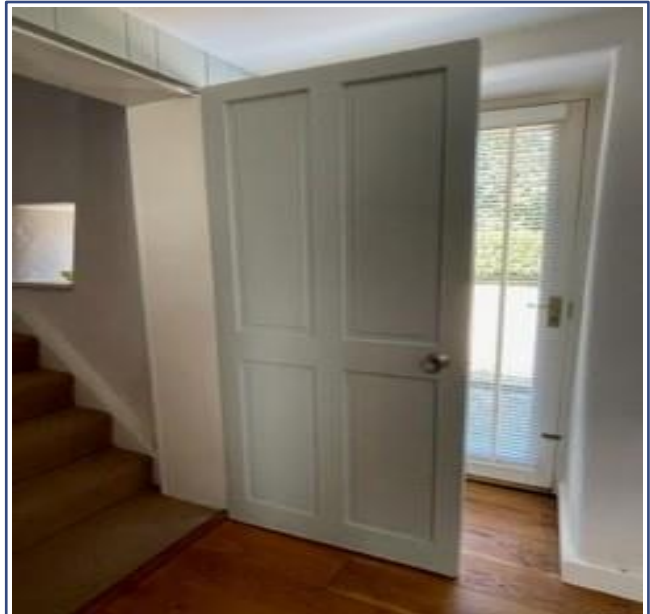
Figure 194: The Byre Internal Door looking at the north and west elevation walls leading from the Lounge to Bedroom 2.

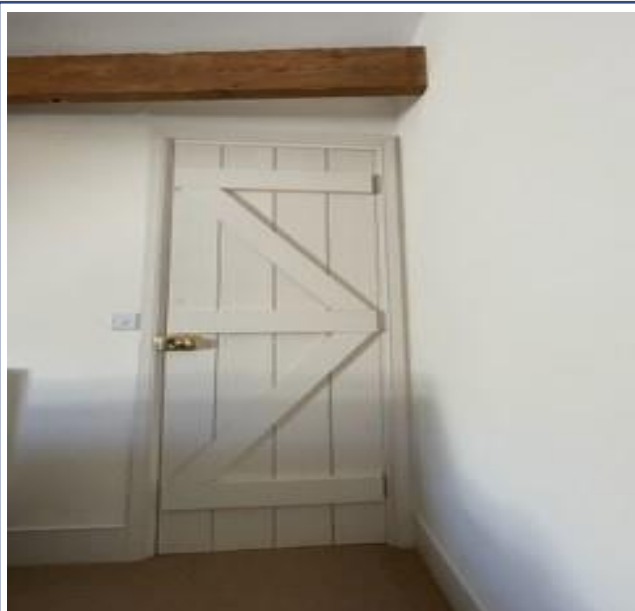
Figure 195: The Byre Internal Door looking at the east elevation wall leading from Lounge 2 to the Landing.

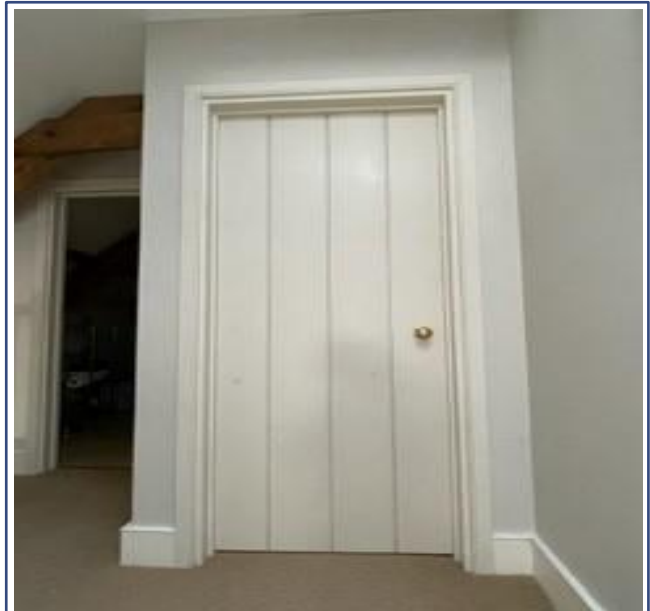
Figure 196: The Byre Internal door looking at the west elevation wall leading from the Landing to Lounge 2.
