Llechwedd, Lledrod, Ceredigion

Archaeological Buildings Record & Watching Brief Report

Planning #: A120791

12th January 2017

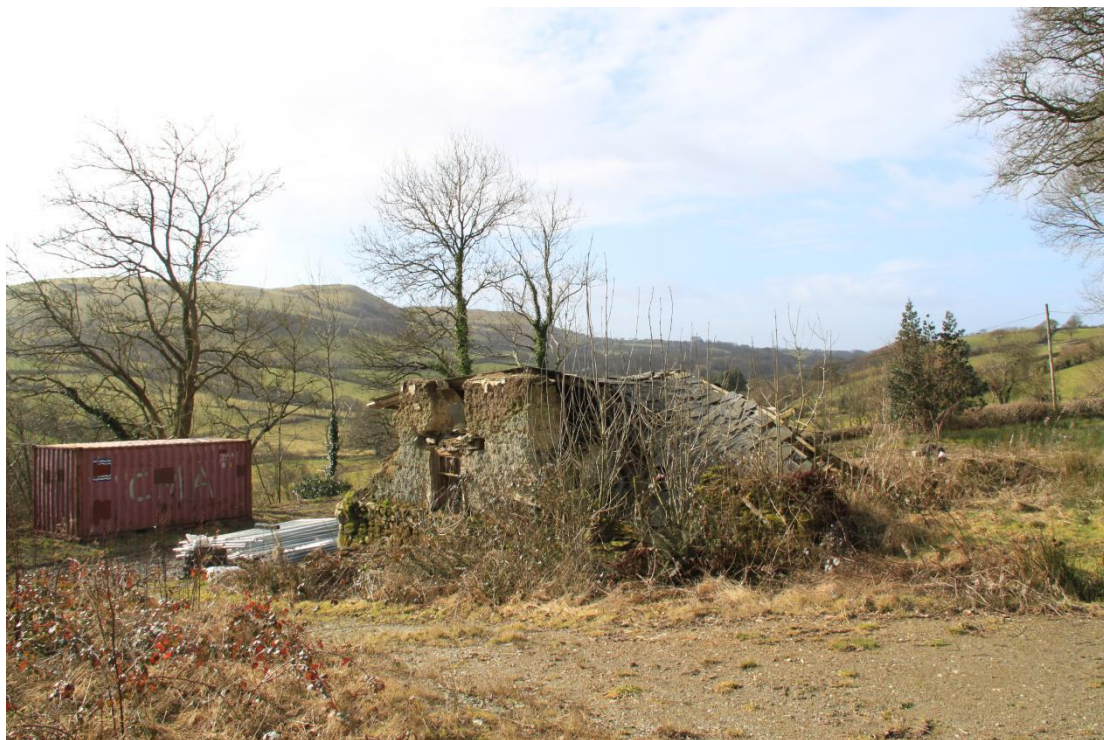
Plate 4 - AD004-BR-004 - View of farmhouse looking south-west.

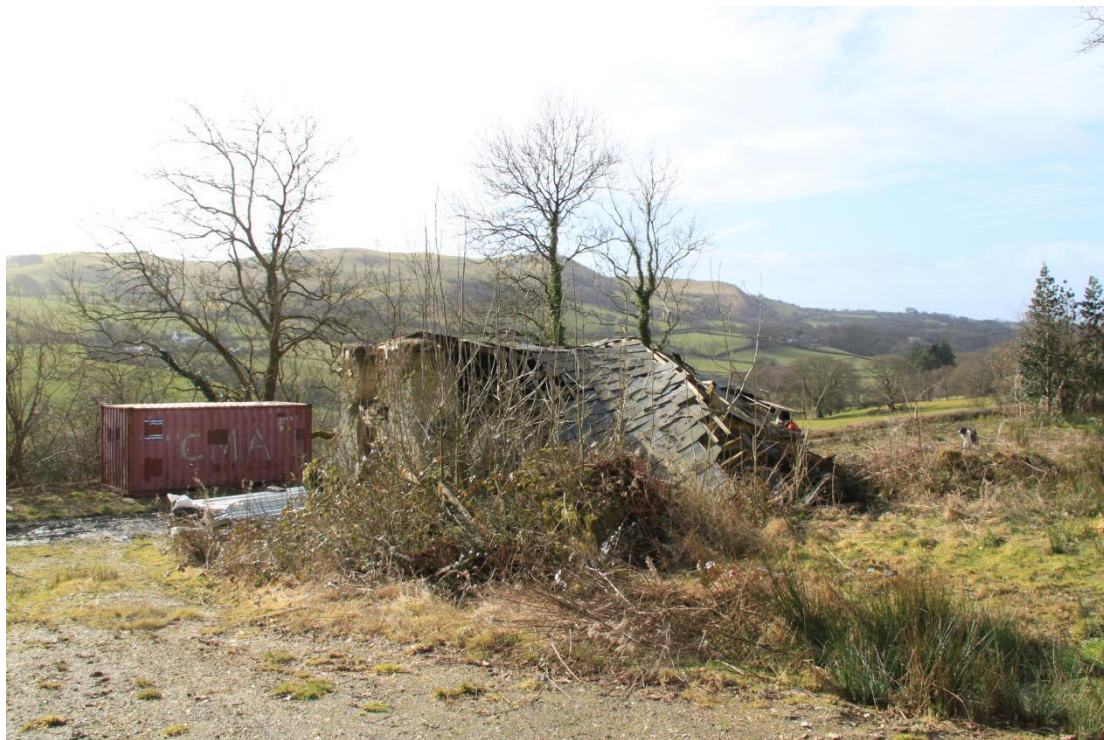
Plate 5 - AD004-BR-005 - View of farmhouse looking south-west.

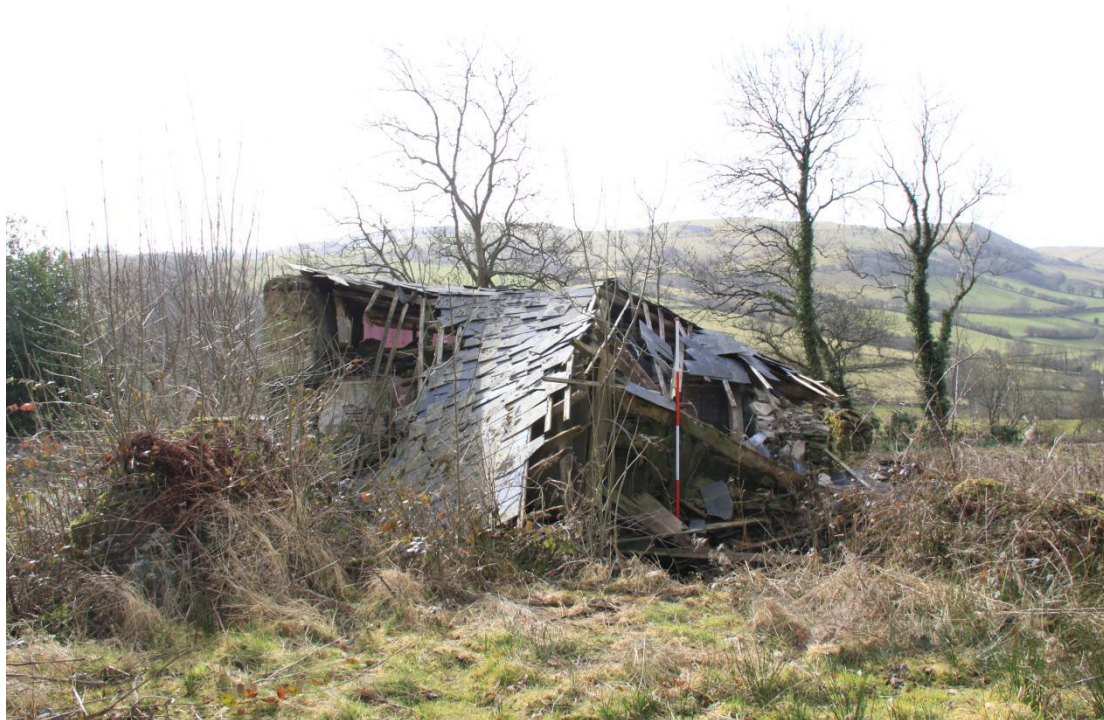
Plate 6 - AD004-BR-006 - View of farmhouse looking south - upslope end.

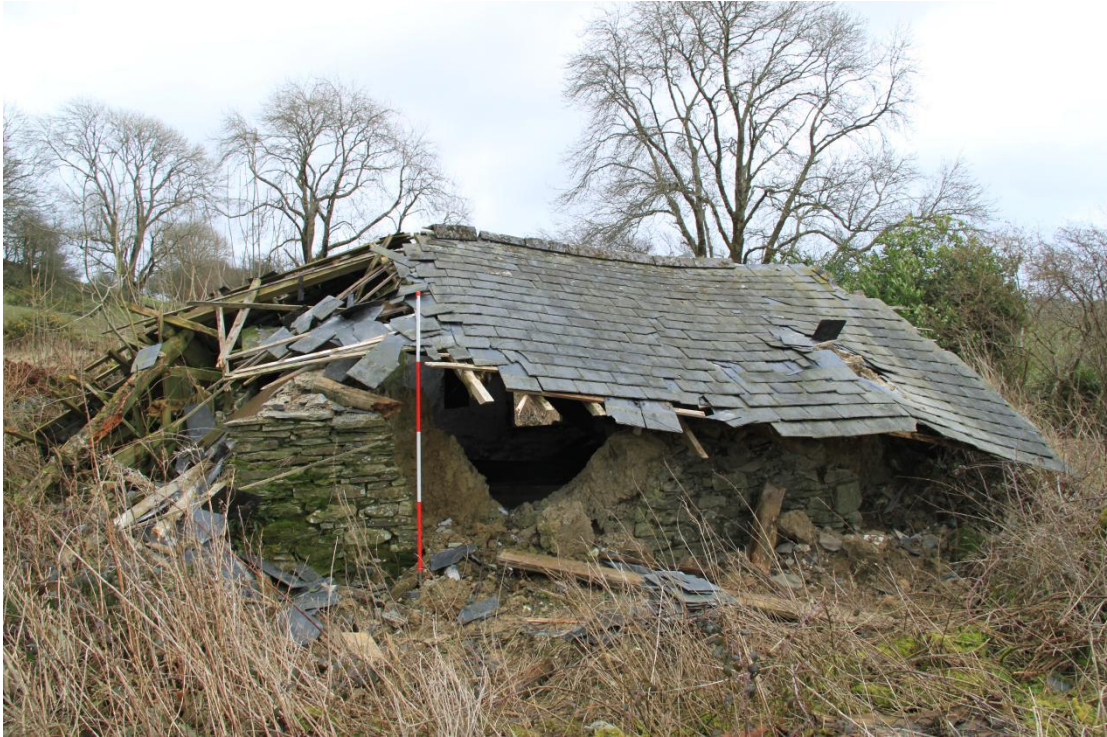
Plate 7 - AD004-BR-007 - View of east elevation remains.

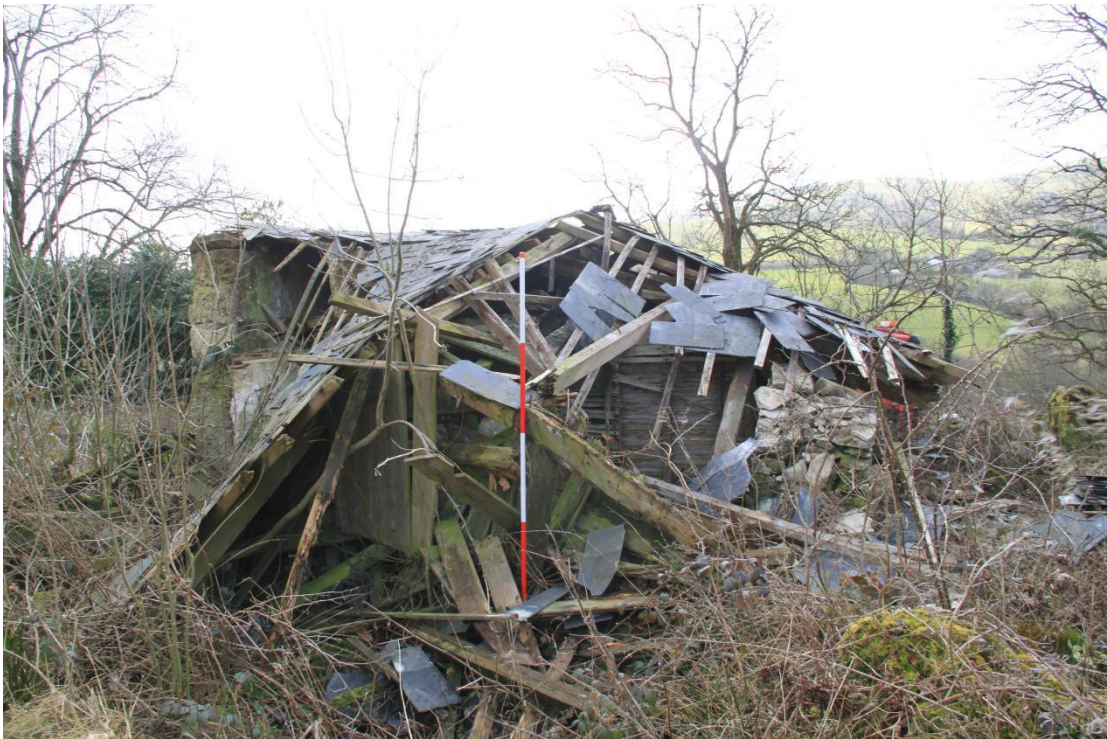
Plate 8 - AD004-BR-008 - View of farmhouse looking south.

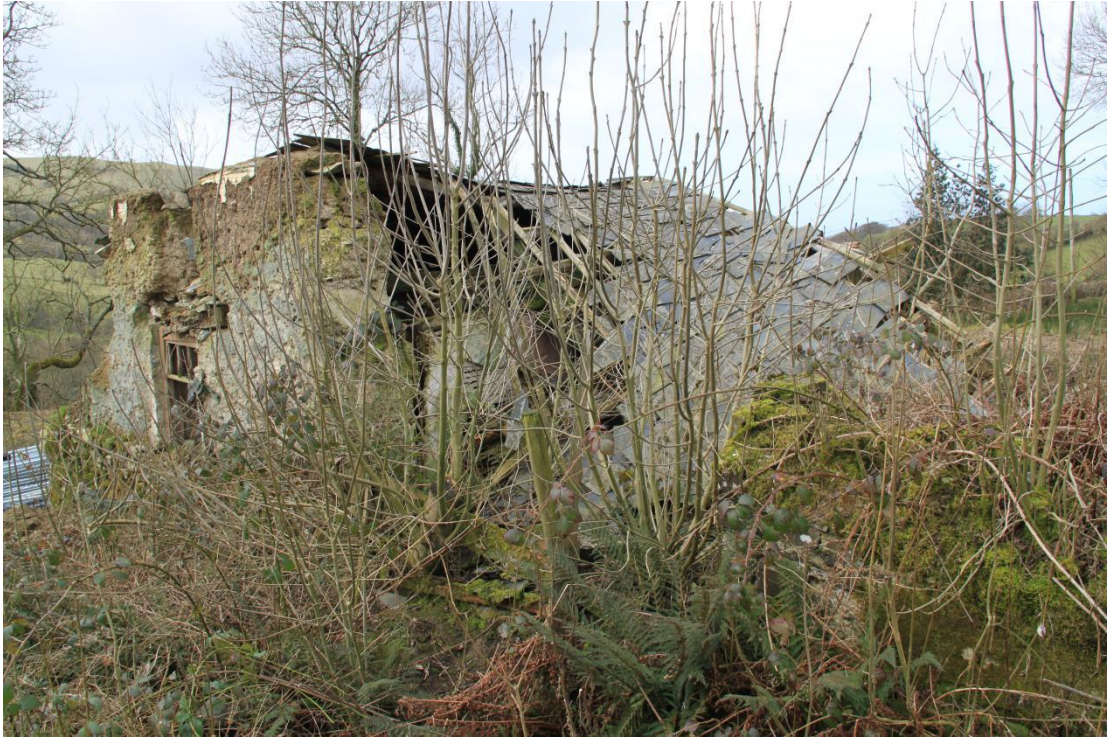
Plate 9 - AD004-BR-009 - View of farmhouse showing elements of upslope stone gable wall.

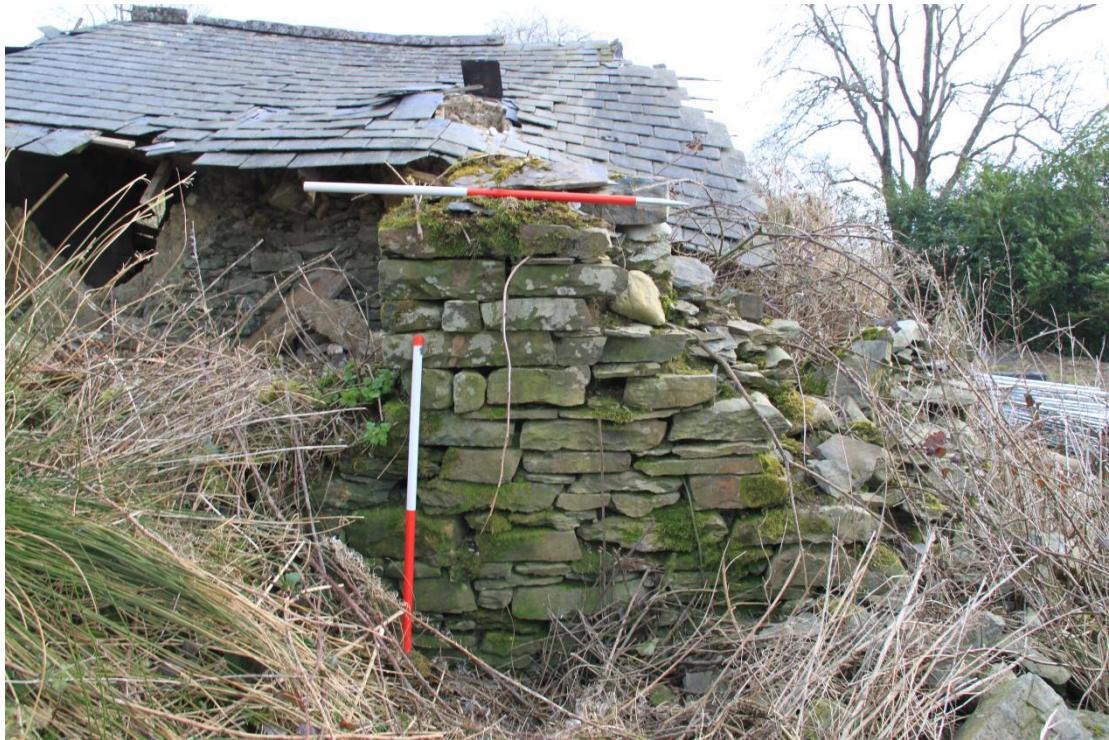
Plate 17 - AD004-BR-017 - West elevation of stone extension, showing window reveal.

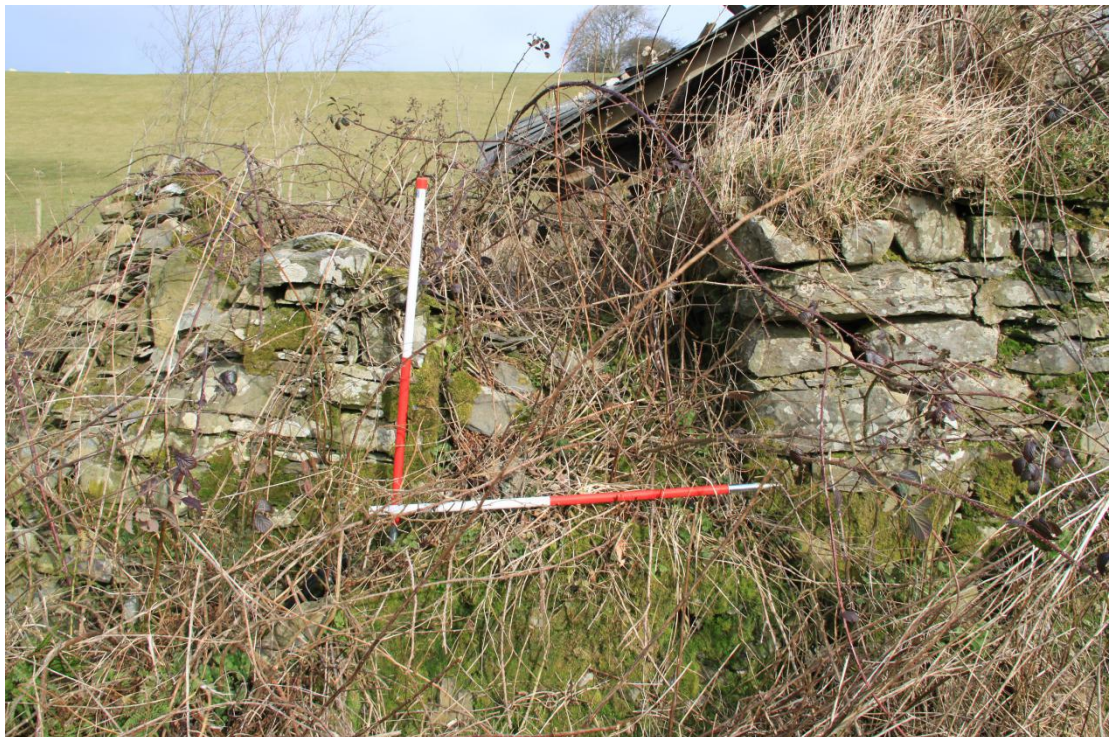
Plate 18 - AD004-BR-018 - View of south elevation of extension, showing doorway formed between new stone wall and existing platform.

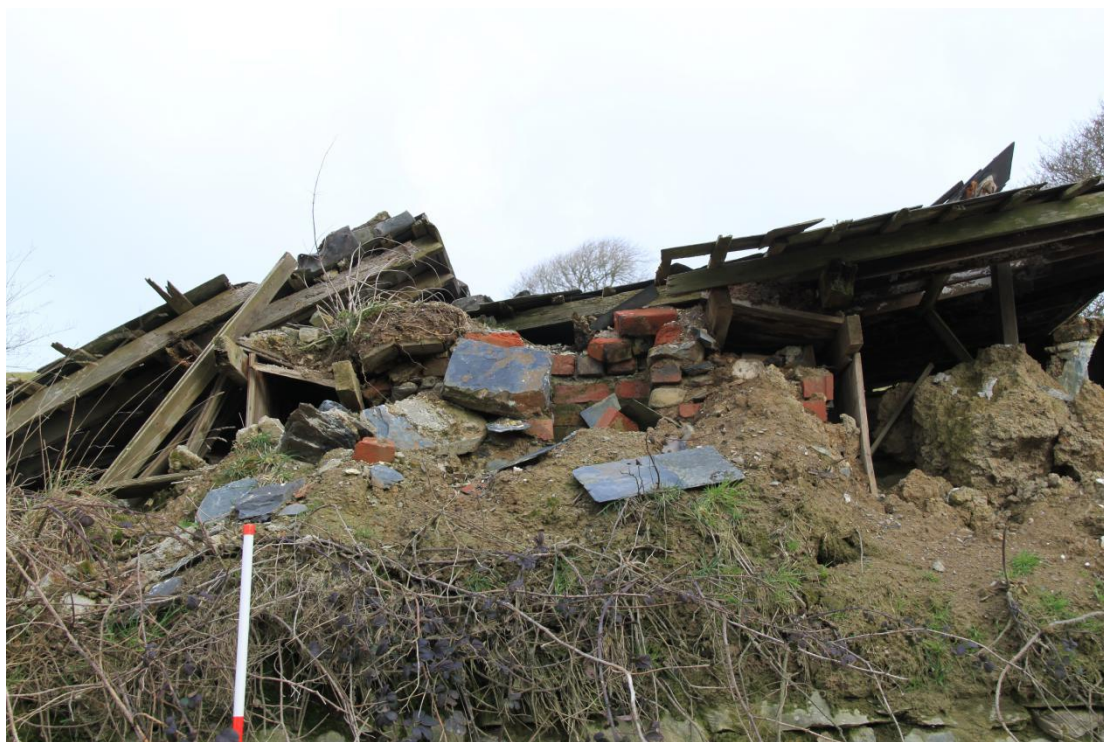
Plate 19 - AD004-BR-019 - South elevation, showing rear of brick fireplace.

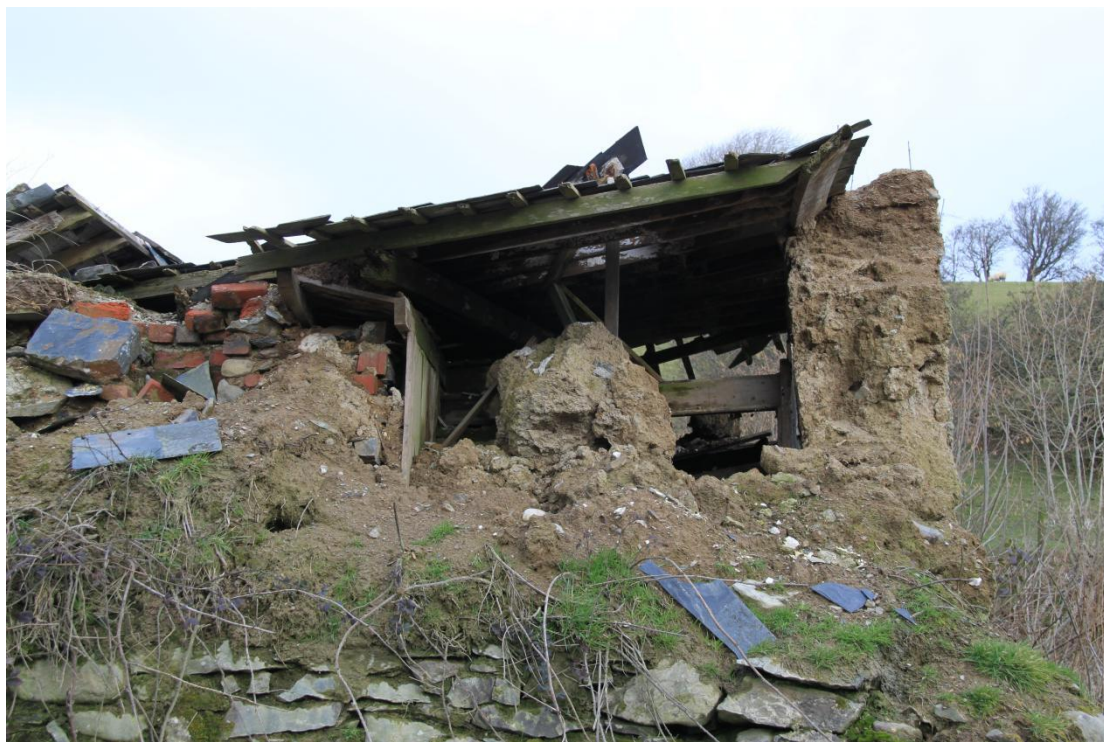
Plate 20 - AD004-BR-020 - South elevation, revealing rear of stair.

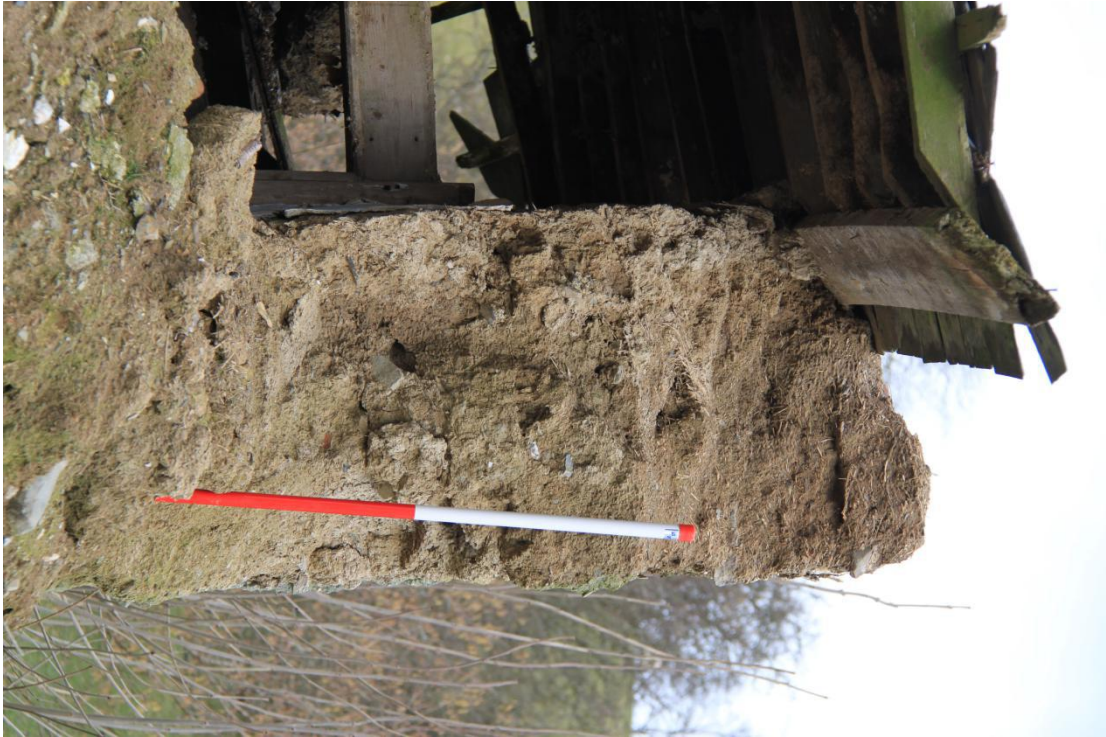
Plate 21 - AD004-BR-021 - Section of east lateral wall, showing difference in upper clom composition and lower.

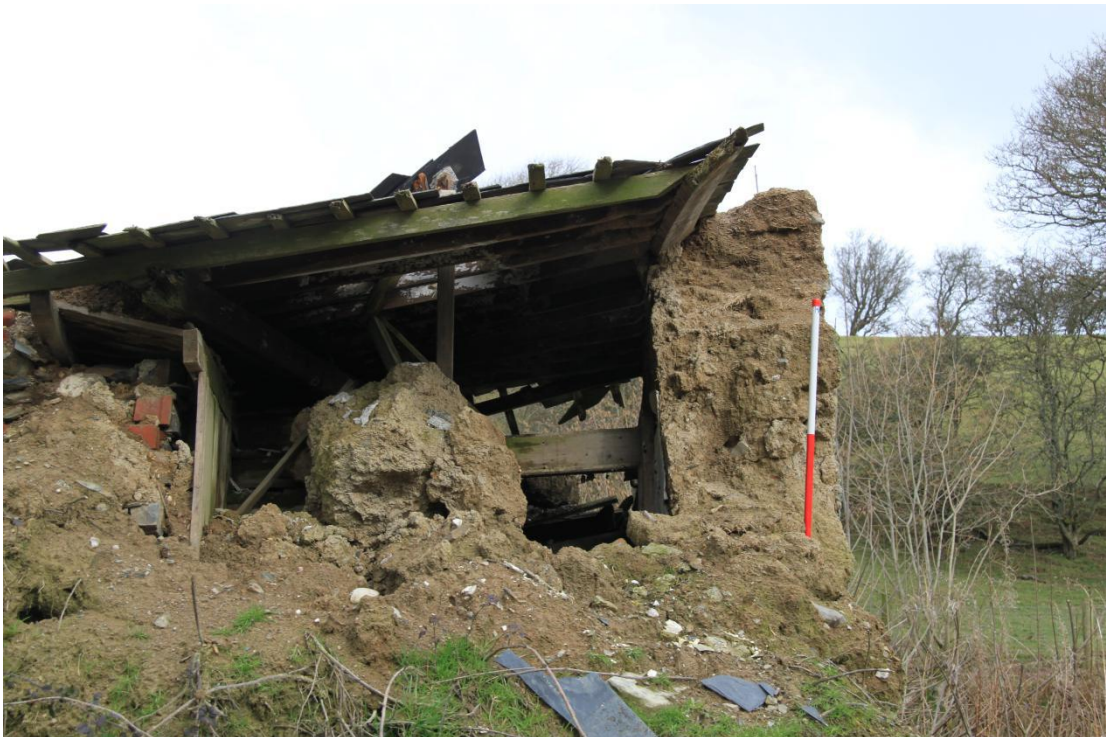
Plate 22 - AD004-BR-022 - Section of east lateral wall, showing difference in upper clom composition and lower.

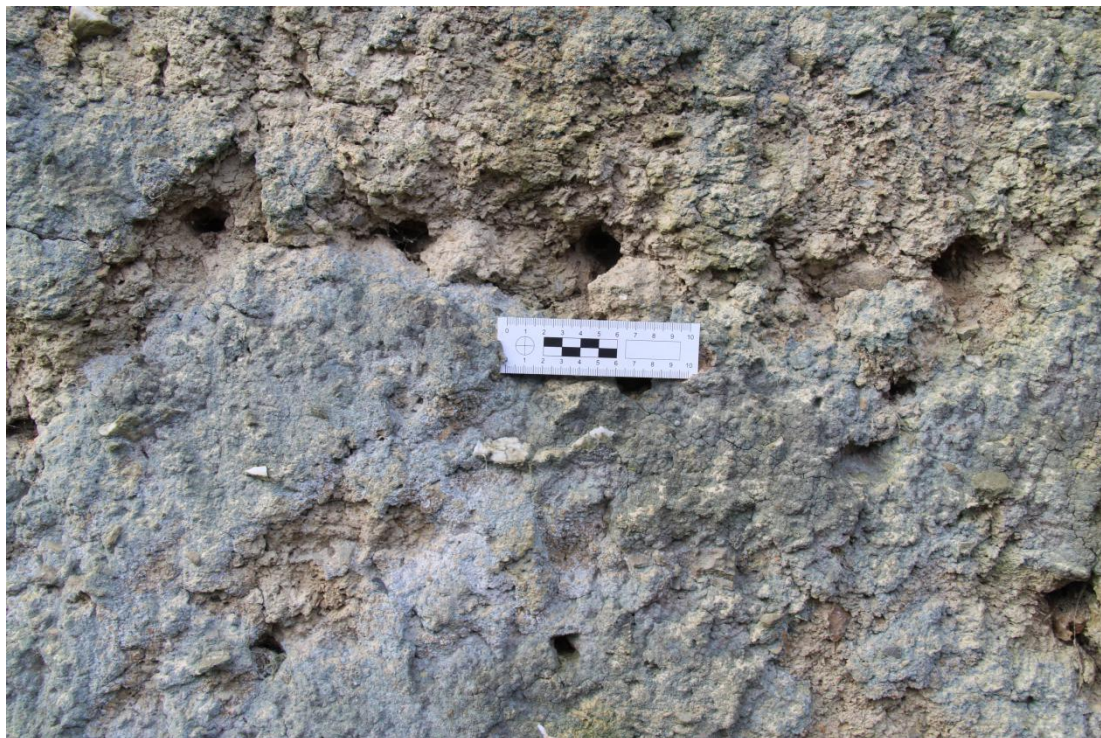
Plate 23 - AD004-BR-023 - Detail of 'pug holes' to support the adherence of render, east elevation.

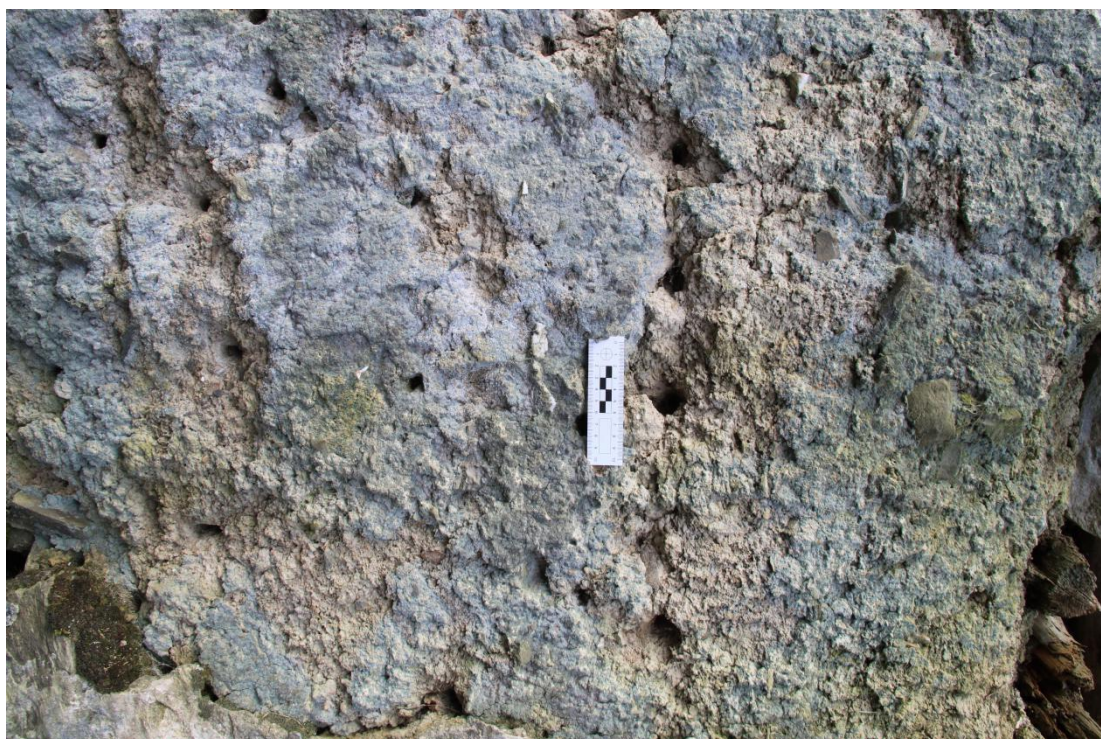
Plate 24 - AD004-BR-024 - Detail of 'pug holes' to support the adherence of render, east elevation.

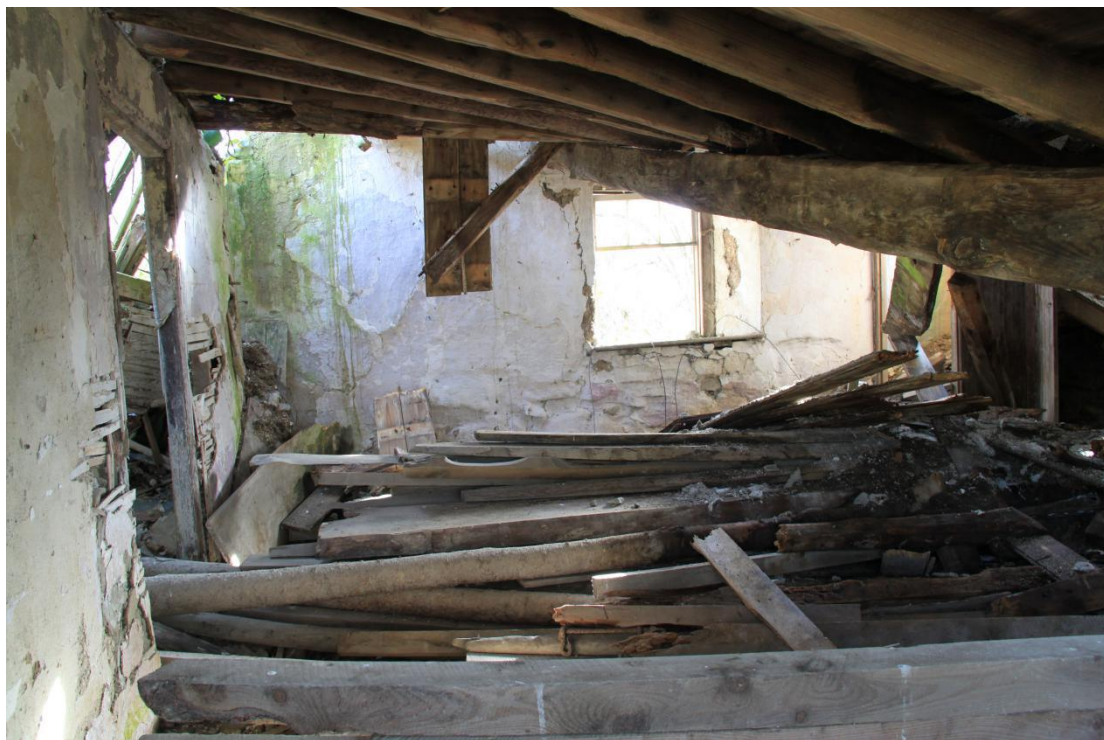
Plate 26 - AD004-BR-026 - Kitchen, viewed towards the east.

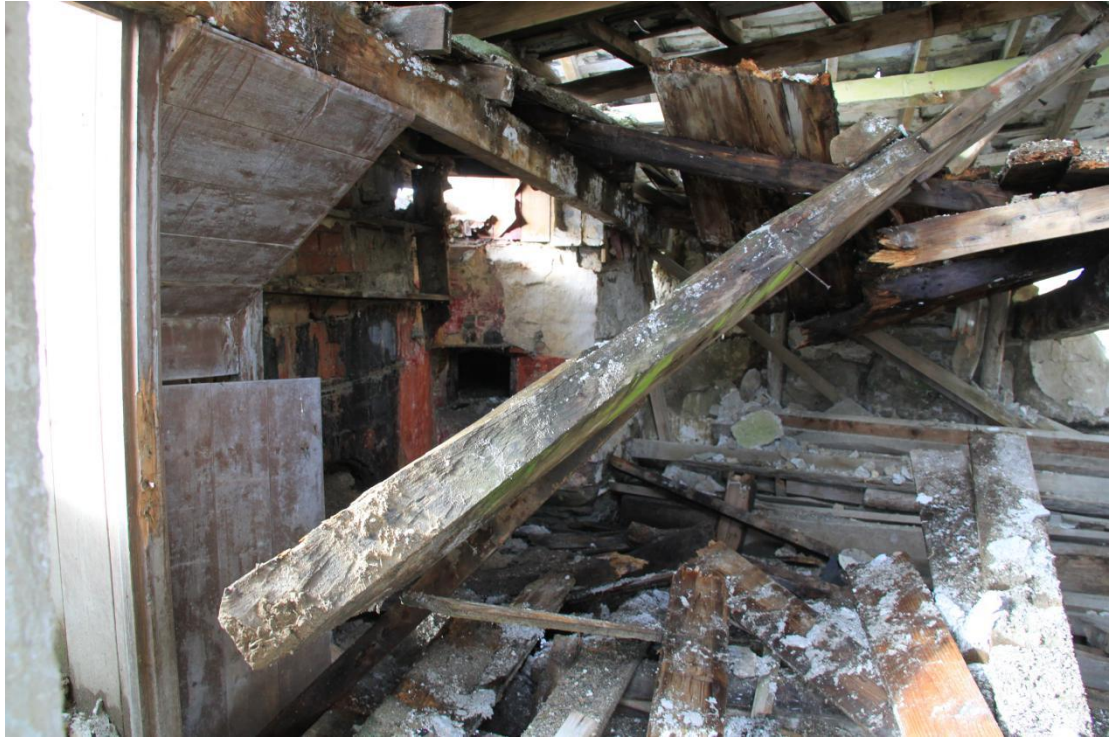
Plate 27 - AD004-BR-027 - Kitchen, viewed towards the west.

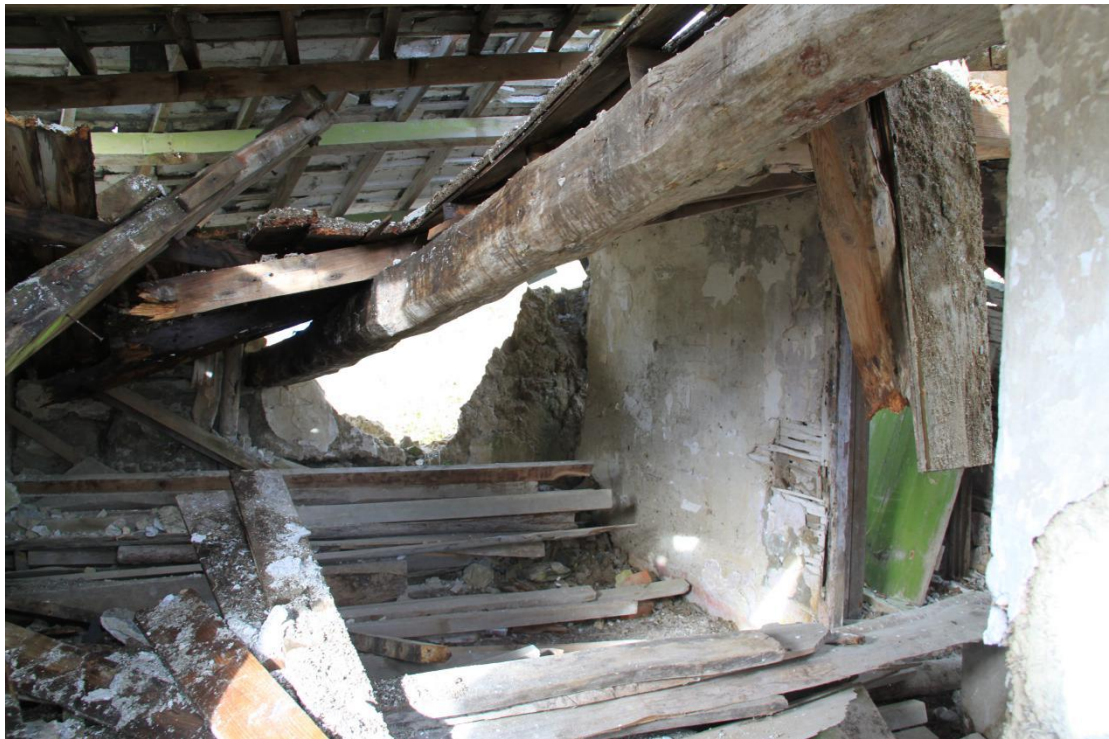
Plate 28 - AD004-BR-028 - Kitchen, viewed towards the west.

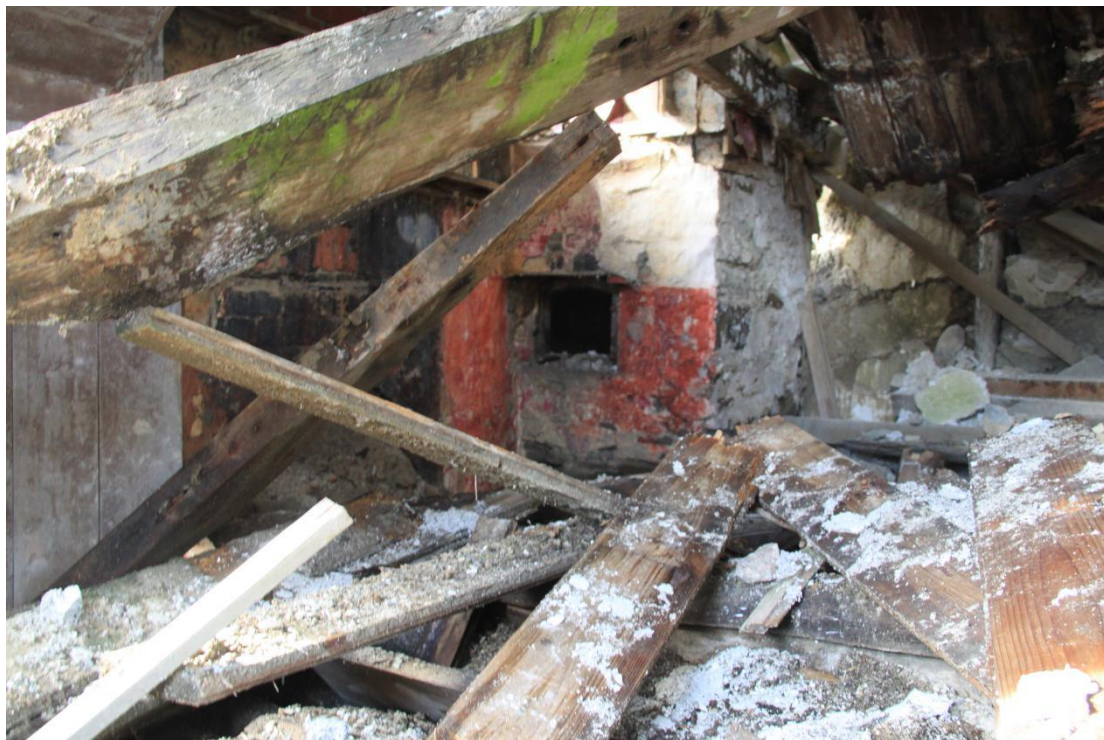
Plate 29 - AD004-BR-029 - Kitchen, viewed towards the south-west.

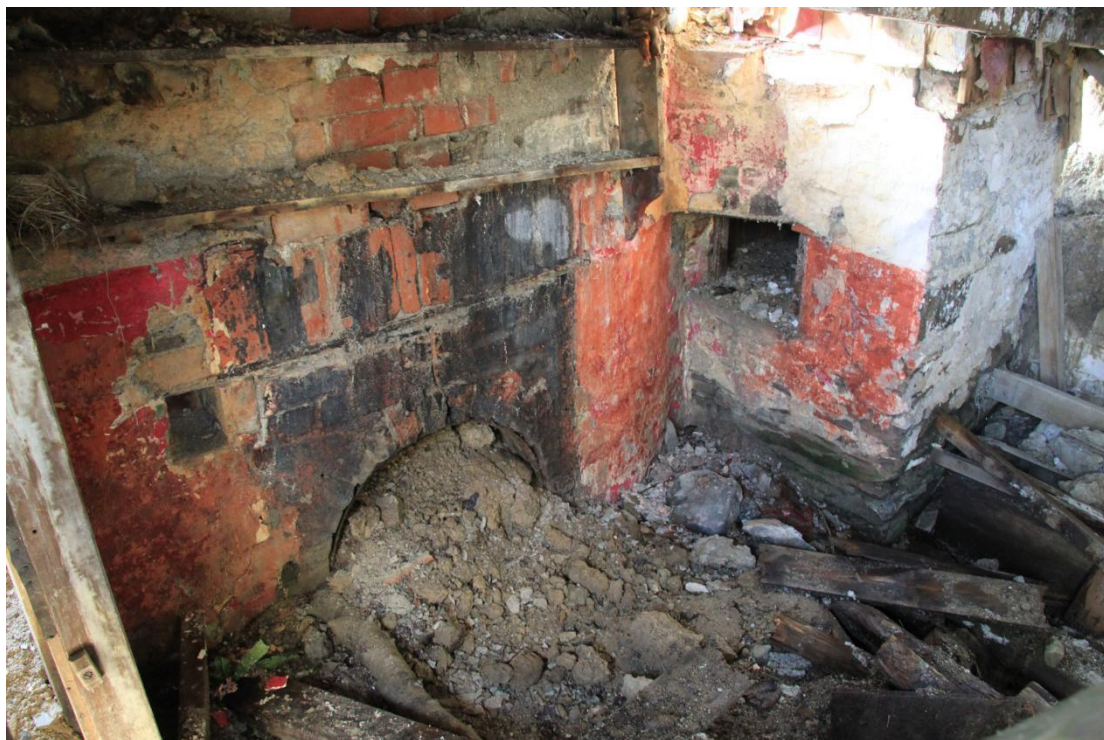
Plate 30 - AD004-BR-030 - Brick fireplace and bread oven.

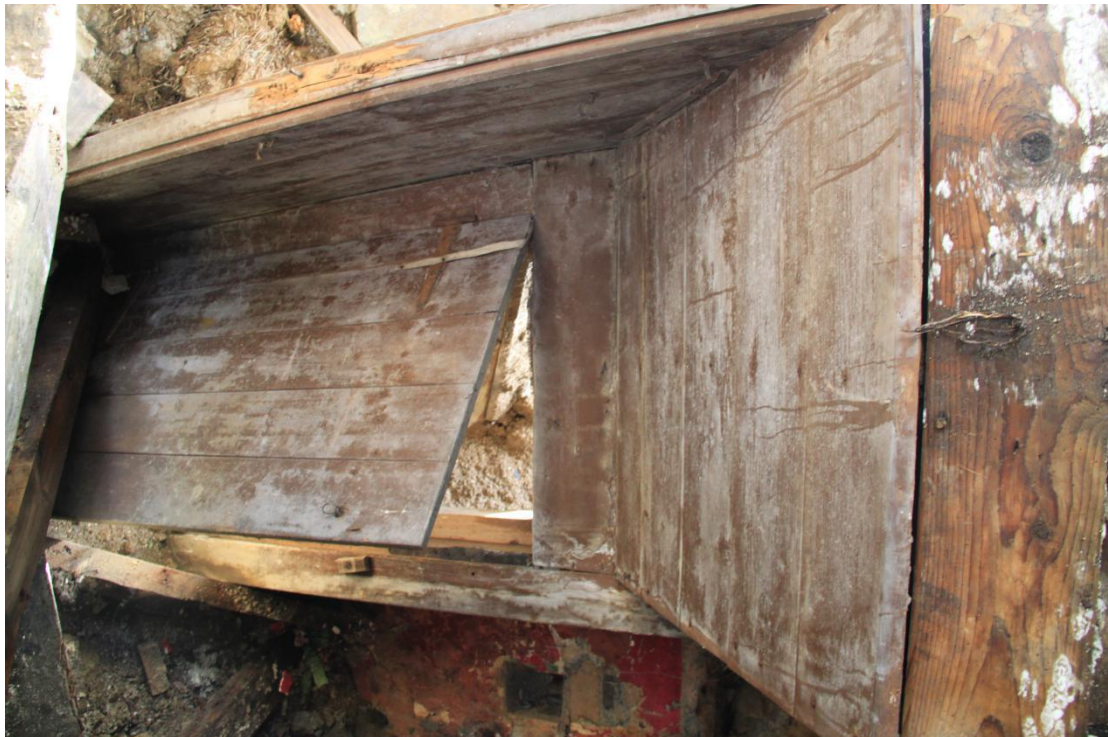
Plate 32 - AD004-BR-032 - Doorway to staircase.

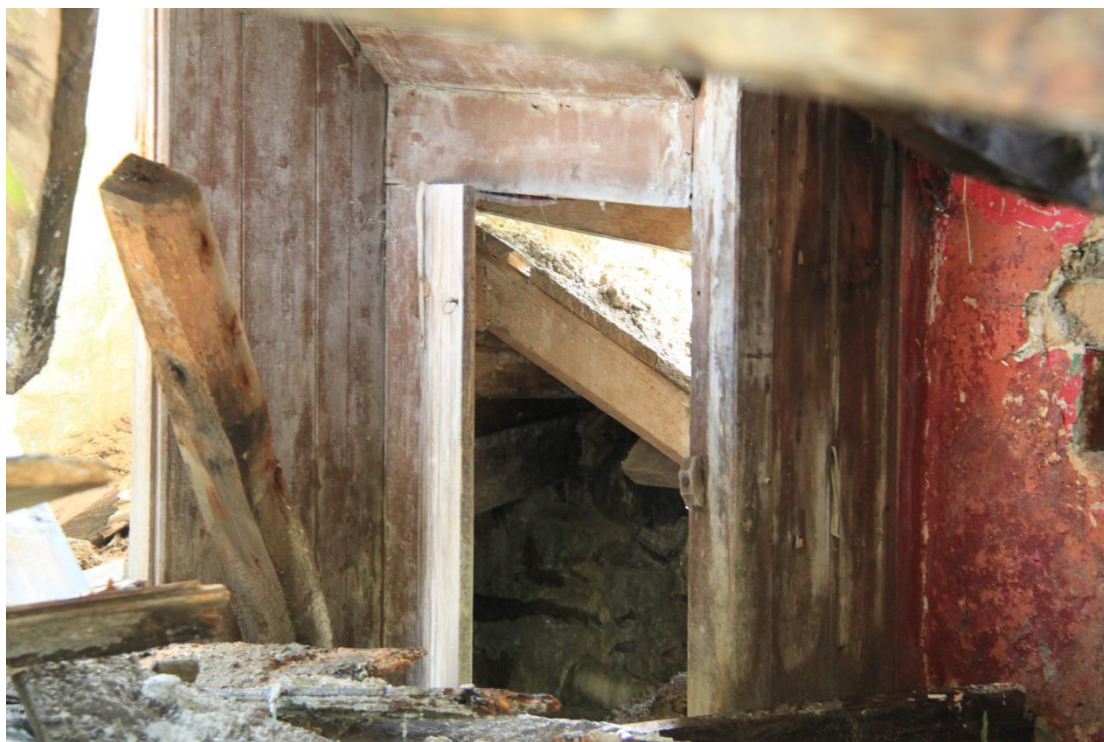
Plate 33 - AD004-BR-033 - Underside of stair, clad with bead-and-butt boards.

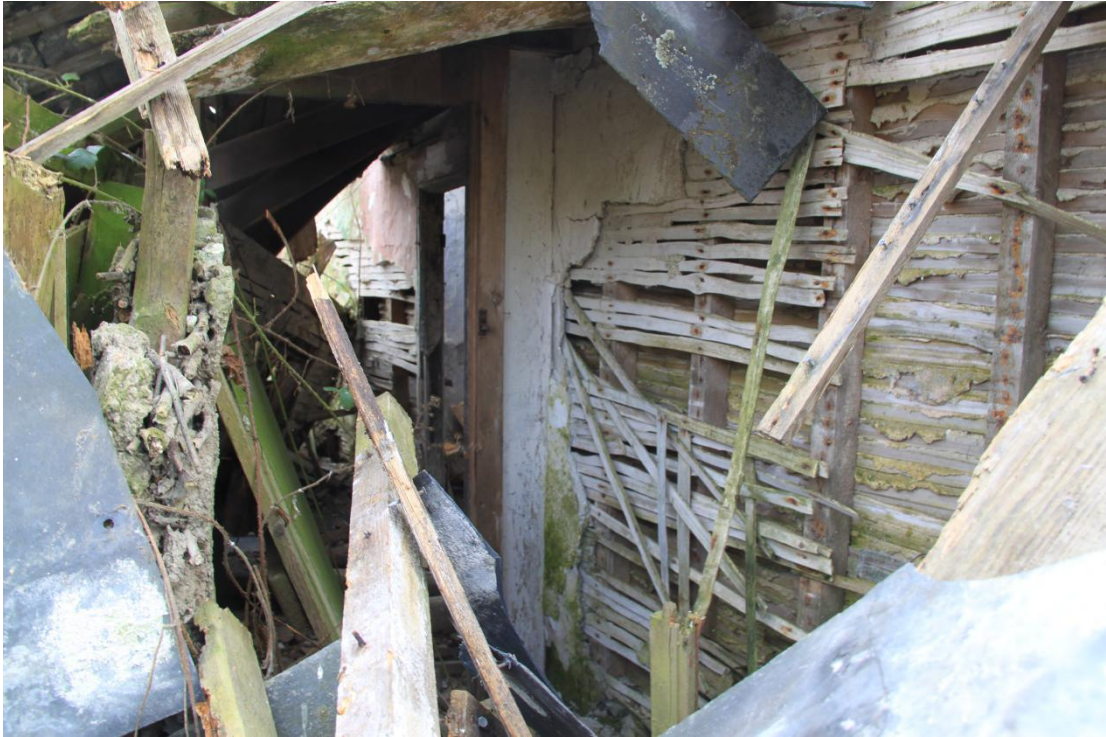
Plate 35 - AD004-BR-035 - Passage side of kitchen partition, in lathe and plaster.

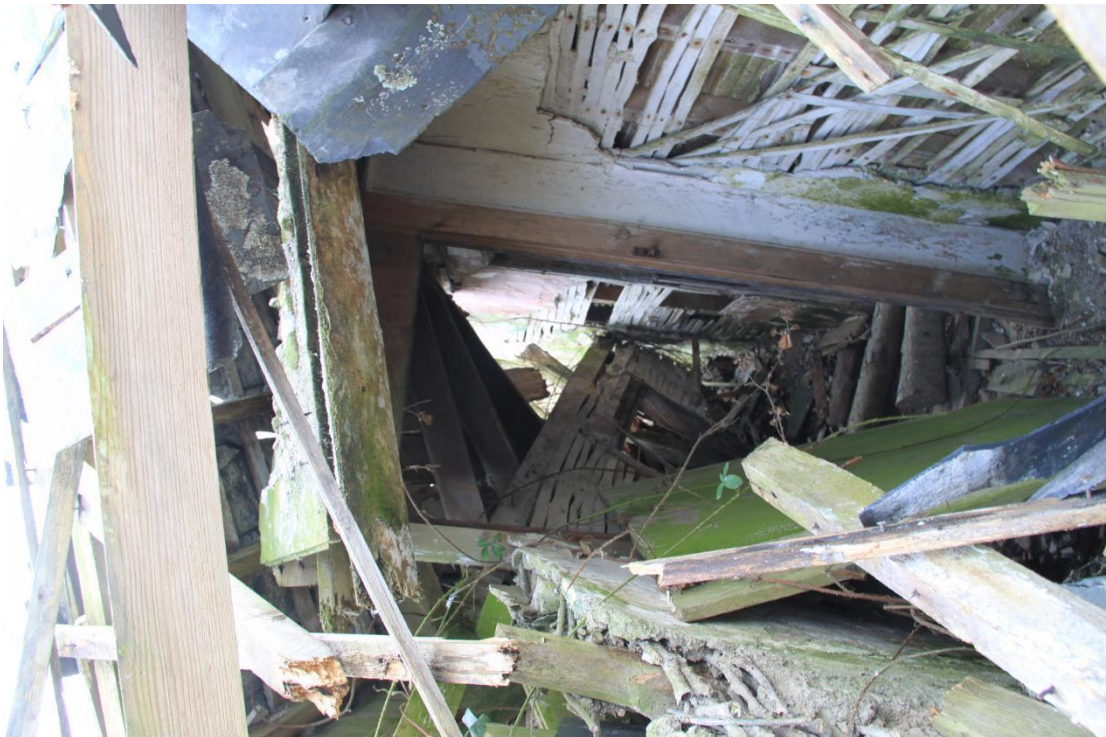
Plate 36 - AD004-BR-036 - Passage side of kitchen partition, in lathe and plaster, also showing parlour partition in woven hazel and clom.

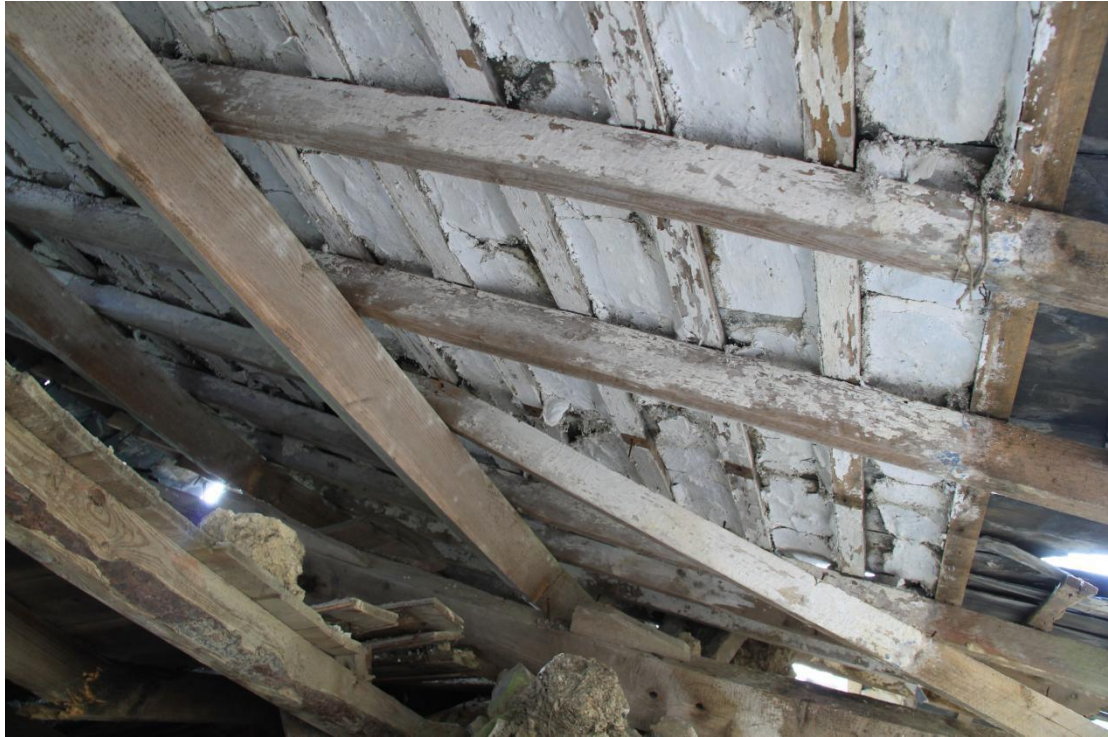
Plate 37 - AD004-BR-037 - Limed underside to slated roof.

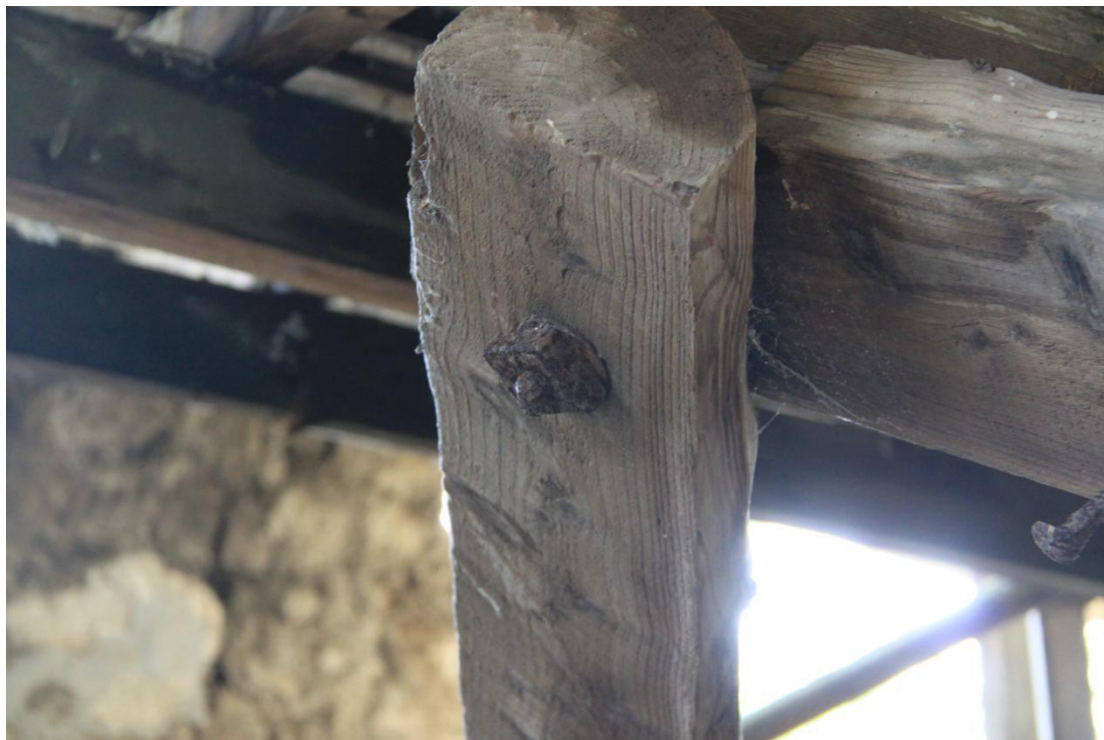
Plate 39 - AD004-BR-039 - Nut and bolt fixing to apex of principle rafters.

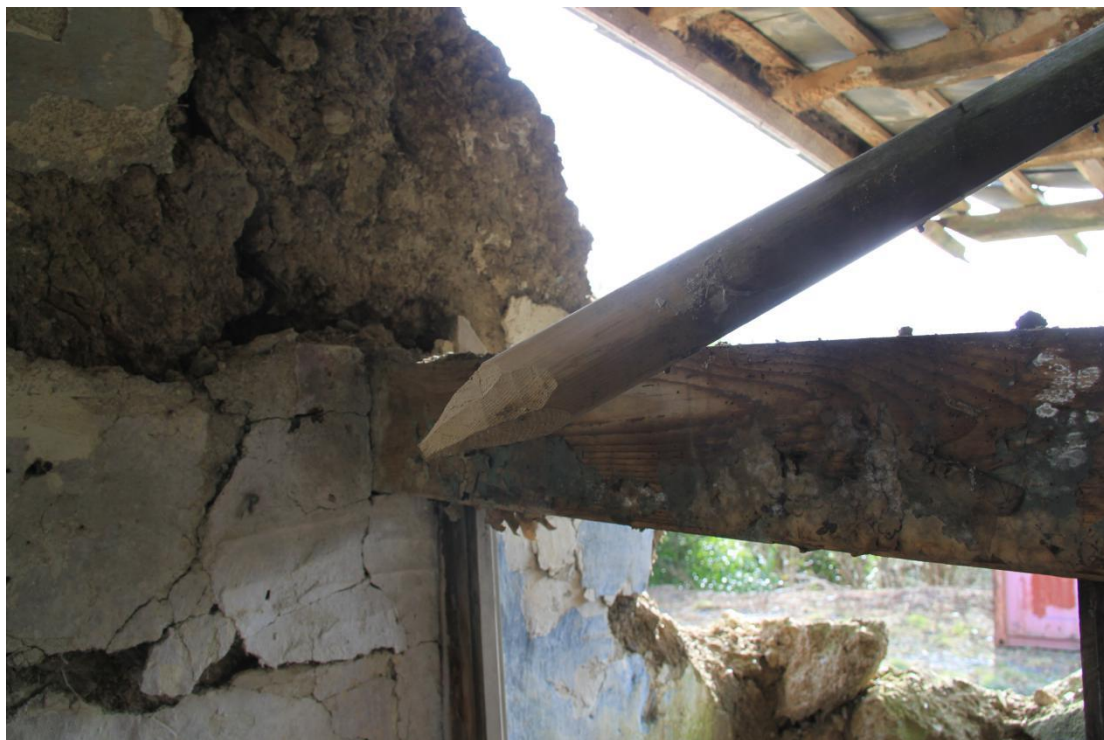
Plate 40 - AD004-BR-040 - Spiked end to later common rafter.

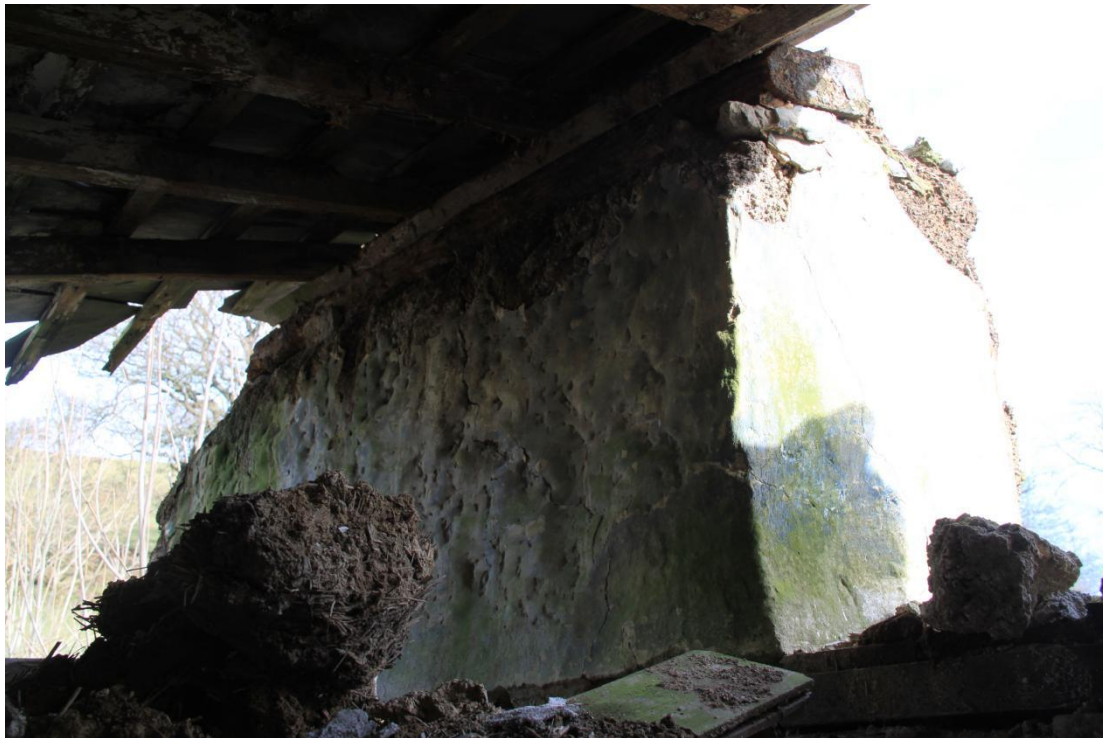
Plate 41 - AD004-BR-041 - Northern window reveal at first floor and internal wall. Showing wall plate.
