Llechwedd, Lledrod, Ceredigion

Archaeological Buildings Record & Watching Brief Report

Planning #: A120791

12th January 2017

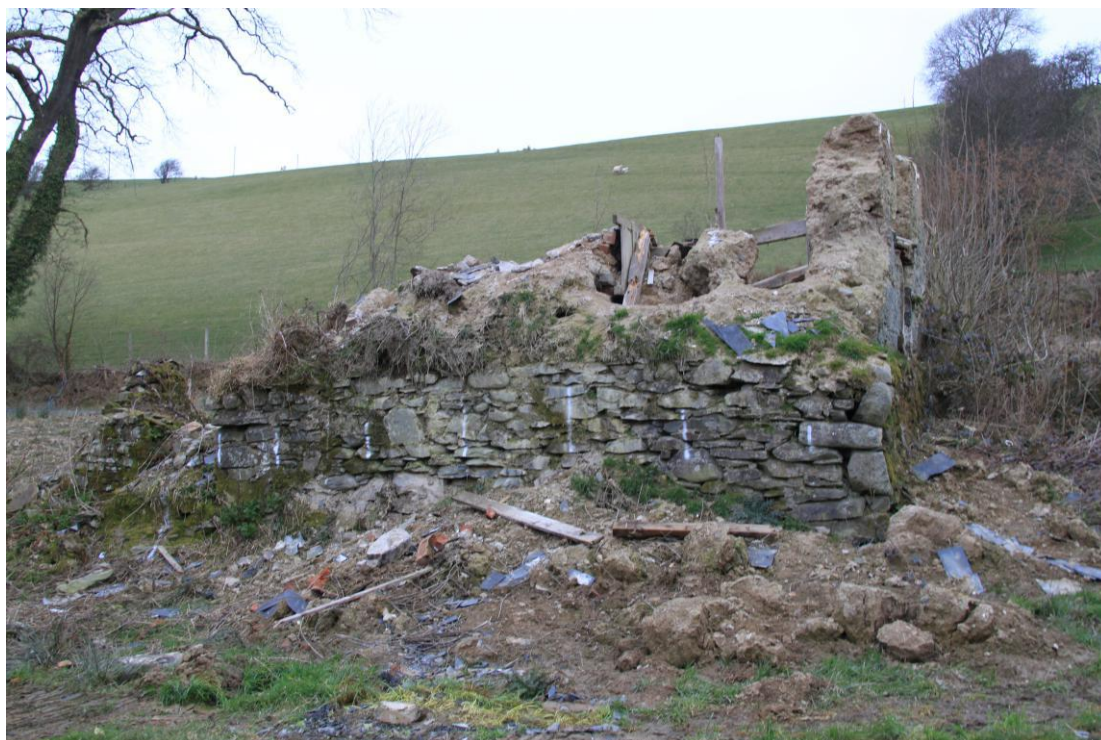
Plate 42 - AD004-D1-042 - Demolition of farmhouse, viewed towards north.

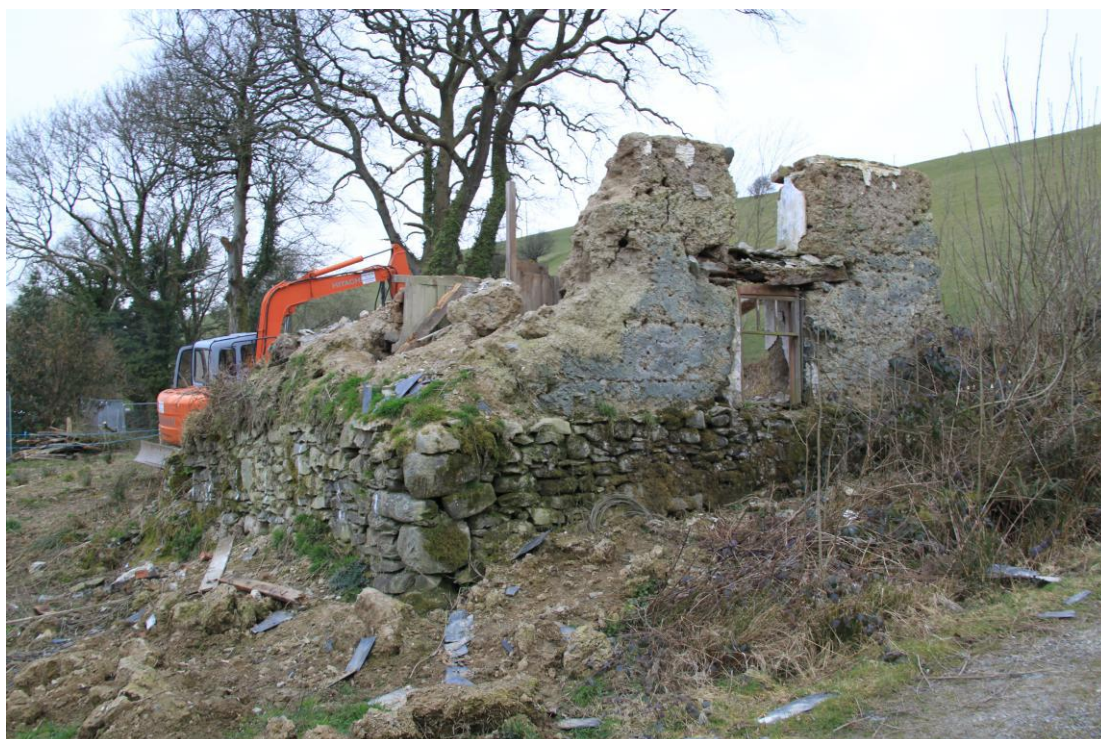
Plate 43 - AD004-D1-043 - Demolition of farmhouse, viewed towards north-west.

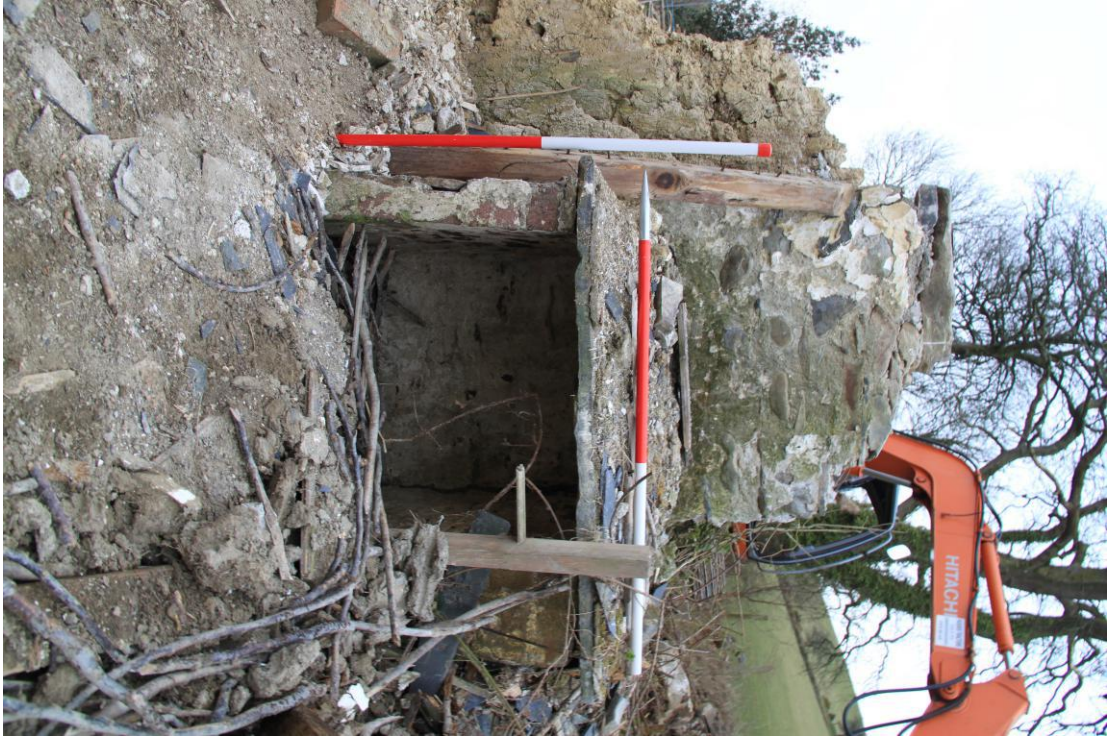
Plate 44 - AD004-D1-044 - Pantry prior to demolition.

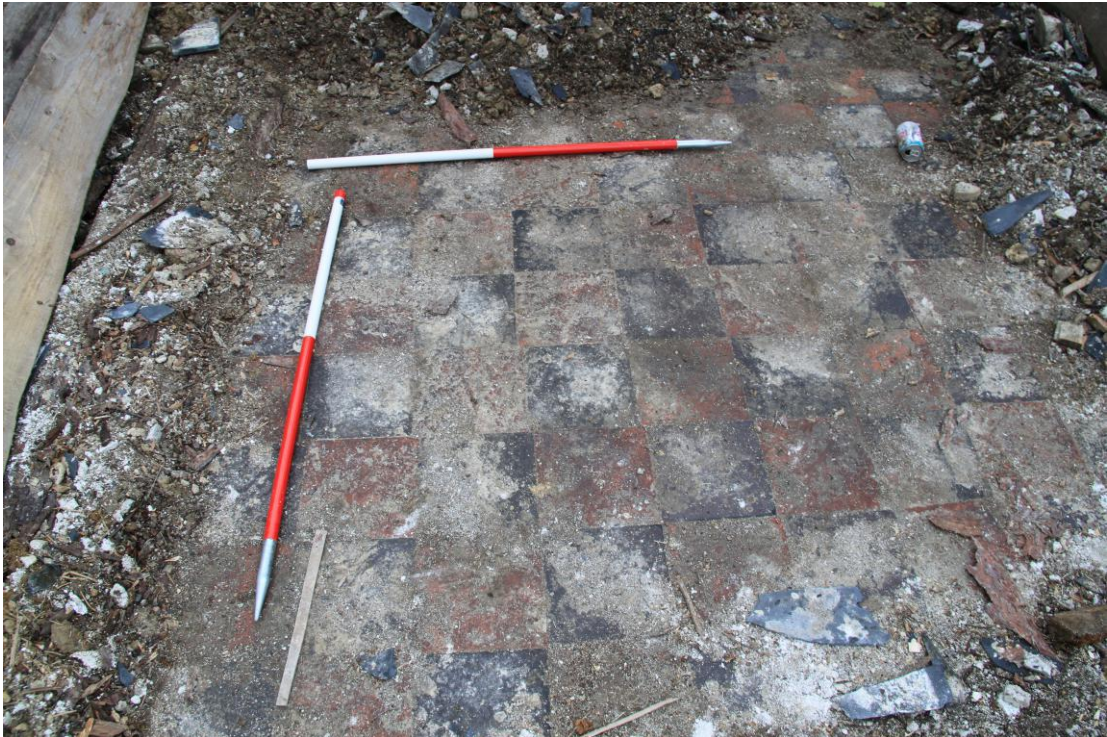
Plate 45 - AD004-D1-045 - Black and red quarry tile floor to kitchen.

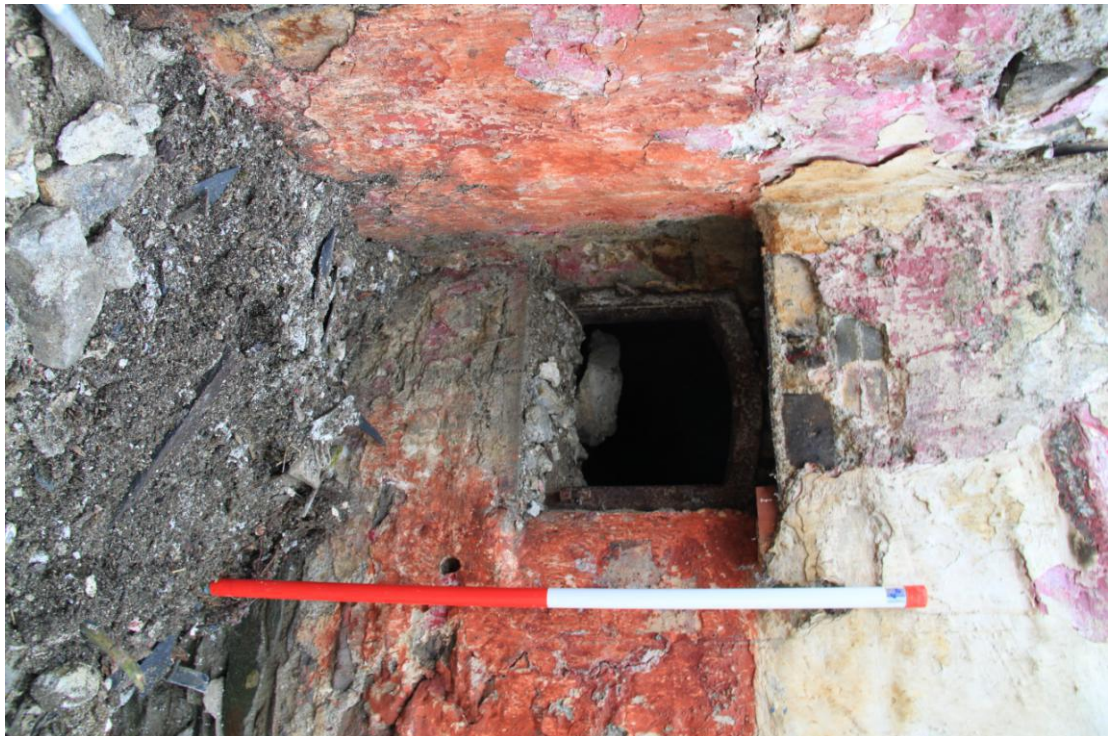
Plate 47 - AD004-D1-047 - Bread oven.

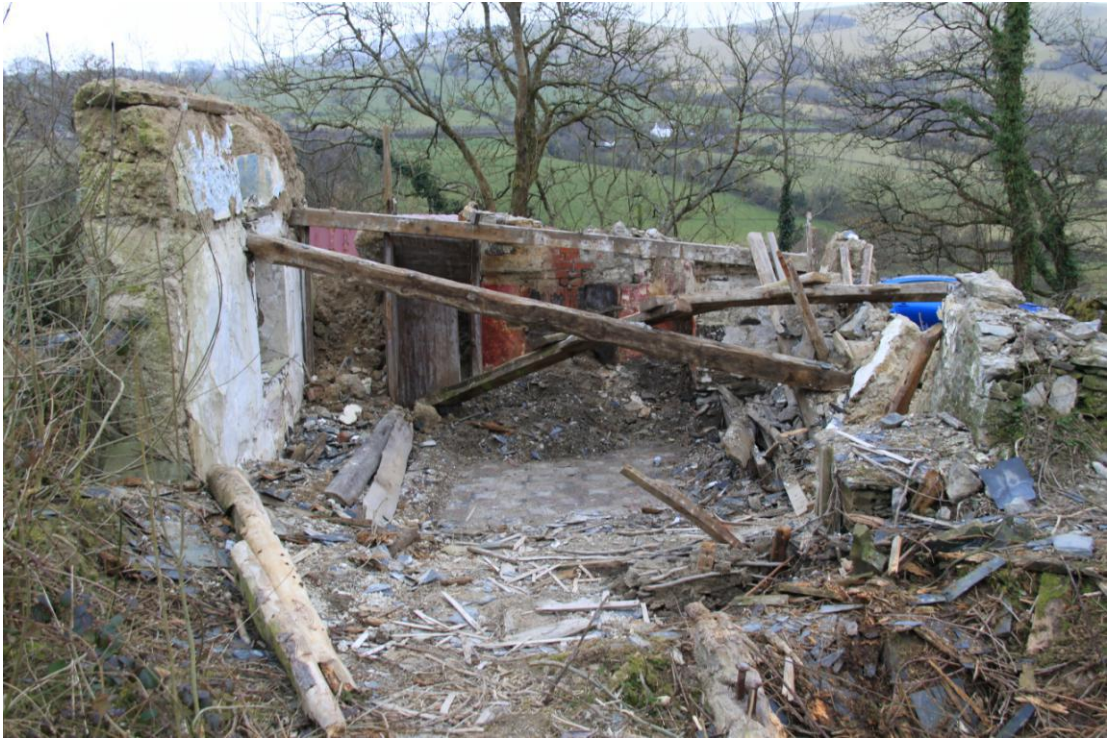
Plate 48 - AD004-D1-048 - Demolition, view towards south.

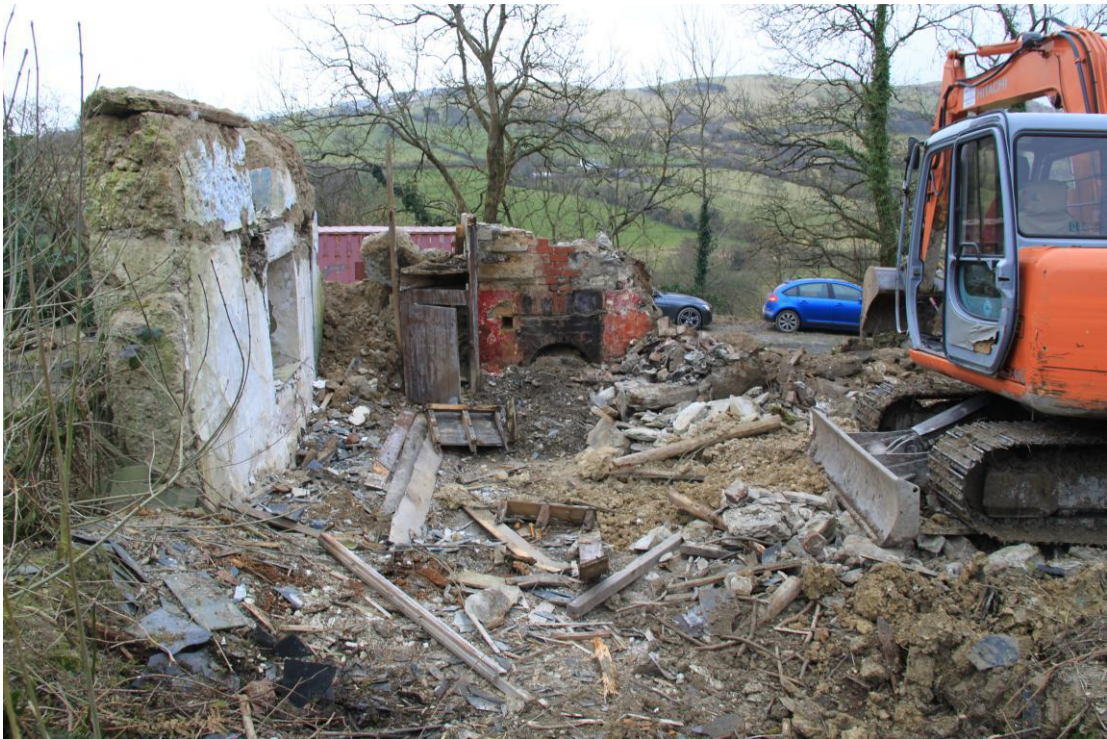
Plate 49 - AD004-D1-049 - Demolition, view towards south.

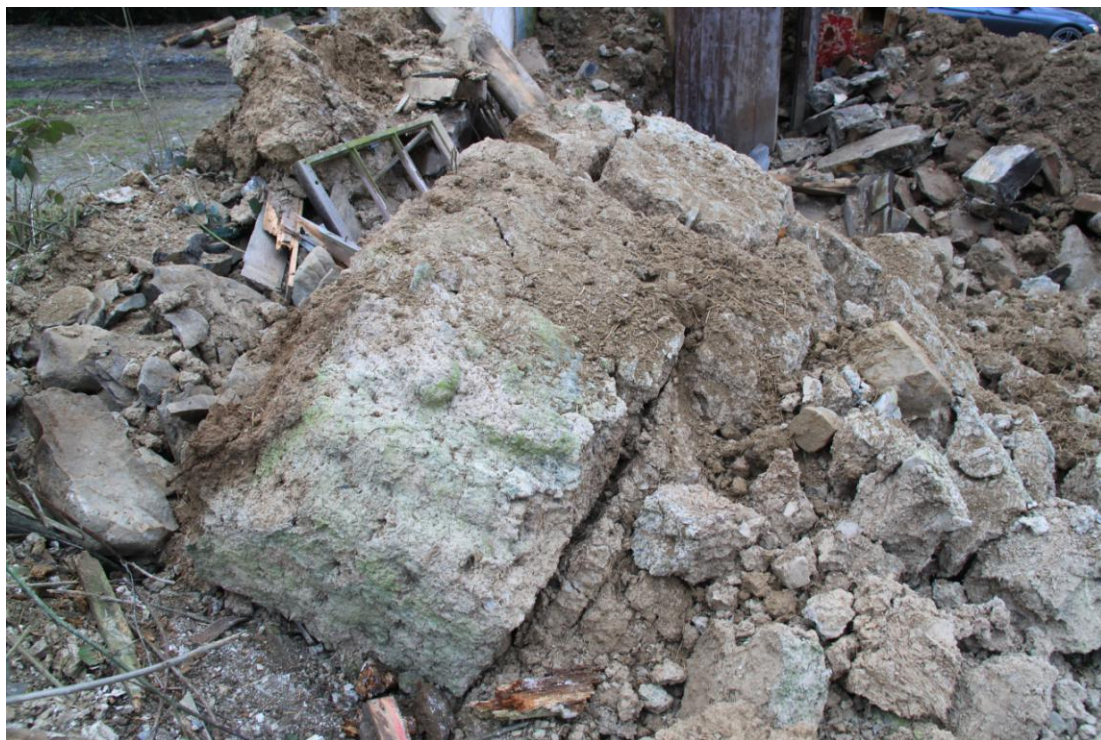
Plate 50 - AD004-D1-050 - Clom east elevation. N.B. Horizontal lines denoting construction layers.
