## Gilfach-y-berthog, Abergwilli, Carmarthenshire.

### Archaeological Watching Brief

HRSWales  
Report No: 131

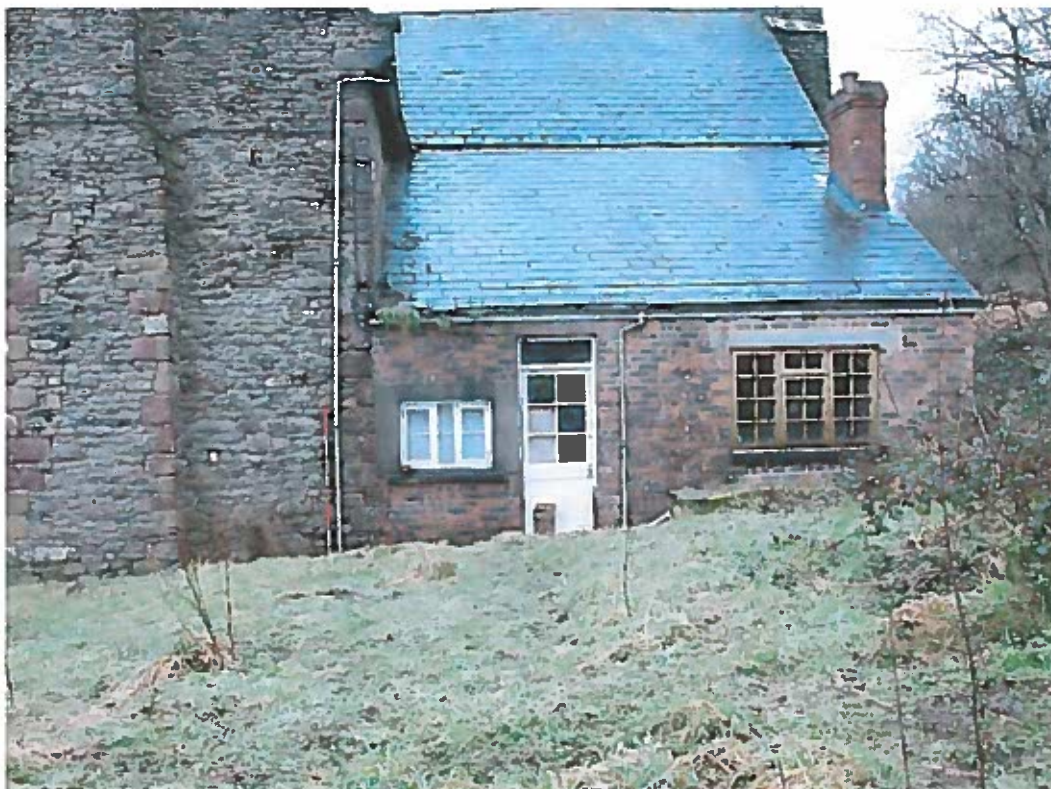
Plate 7. Gylfach-y-berthog - Existing 19th century kitchen extension. Northeast facing elevation. Looking southwest.

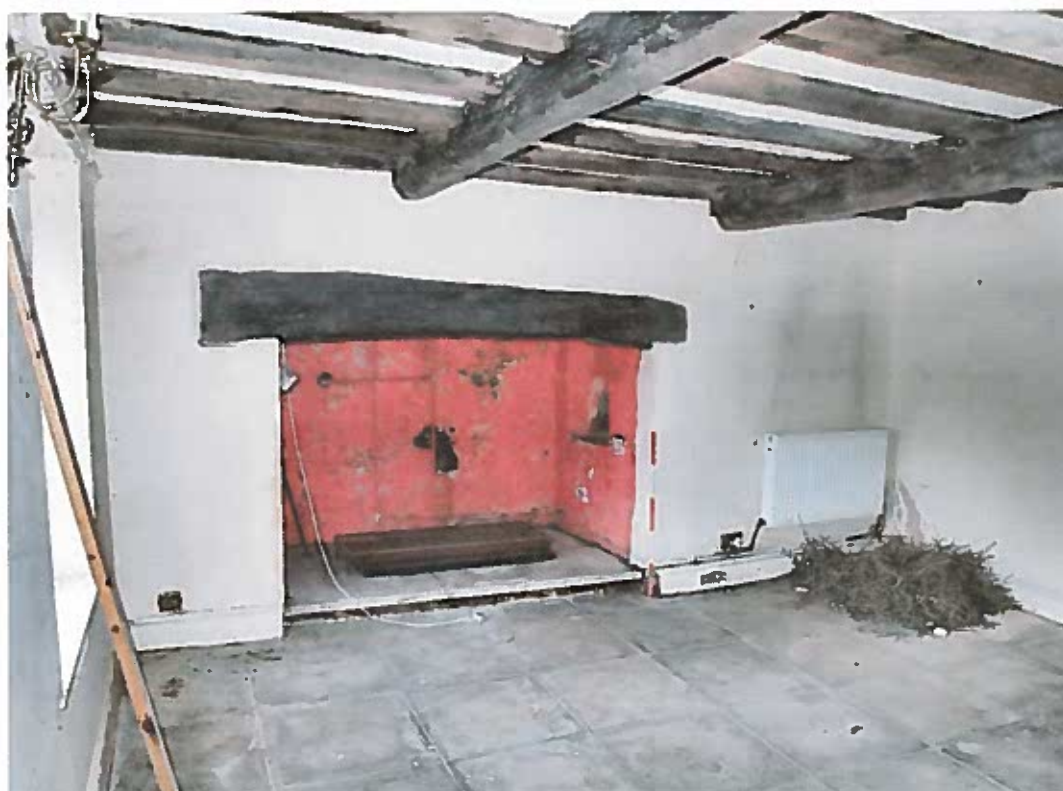
Plate 22. Gilfach-y-berthog - Lower Parlour rRoom prior to groundwork. Looking north.

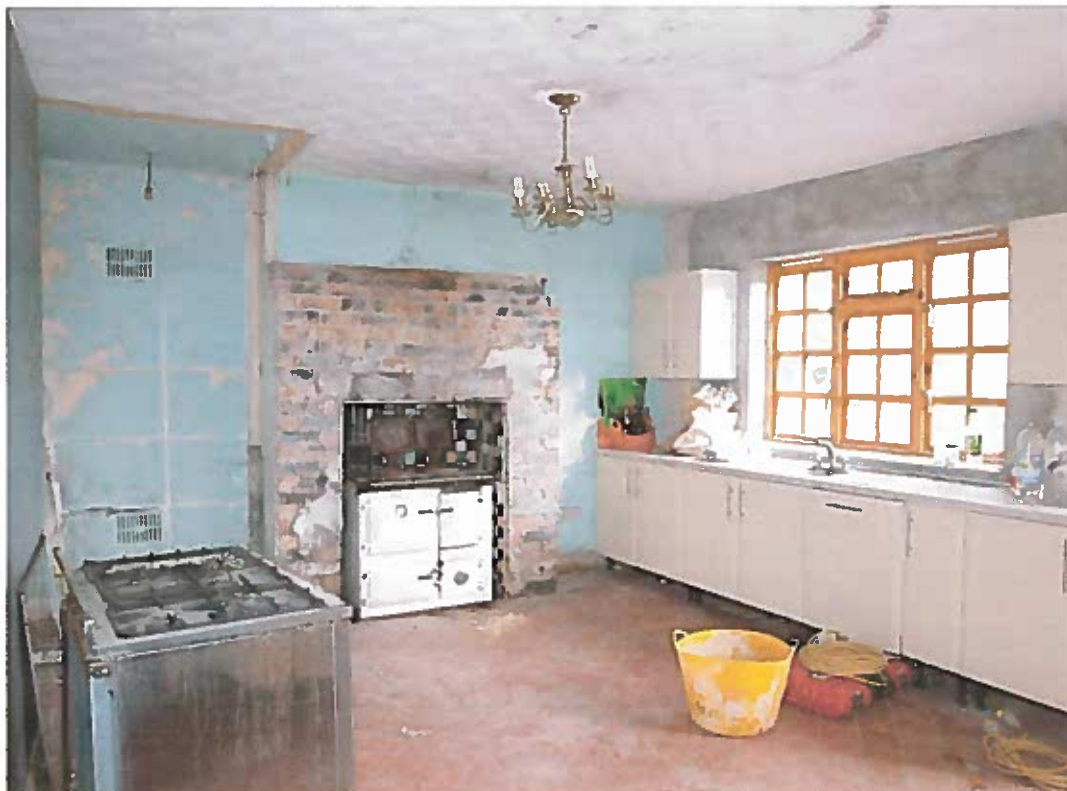
*Plate 25. Gilfach-y-berthog - Existing kitchen extension at east end of house. Looking north.*

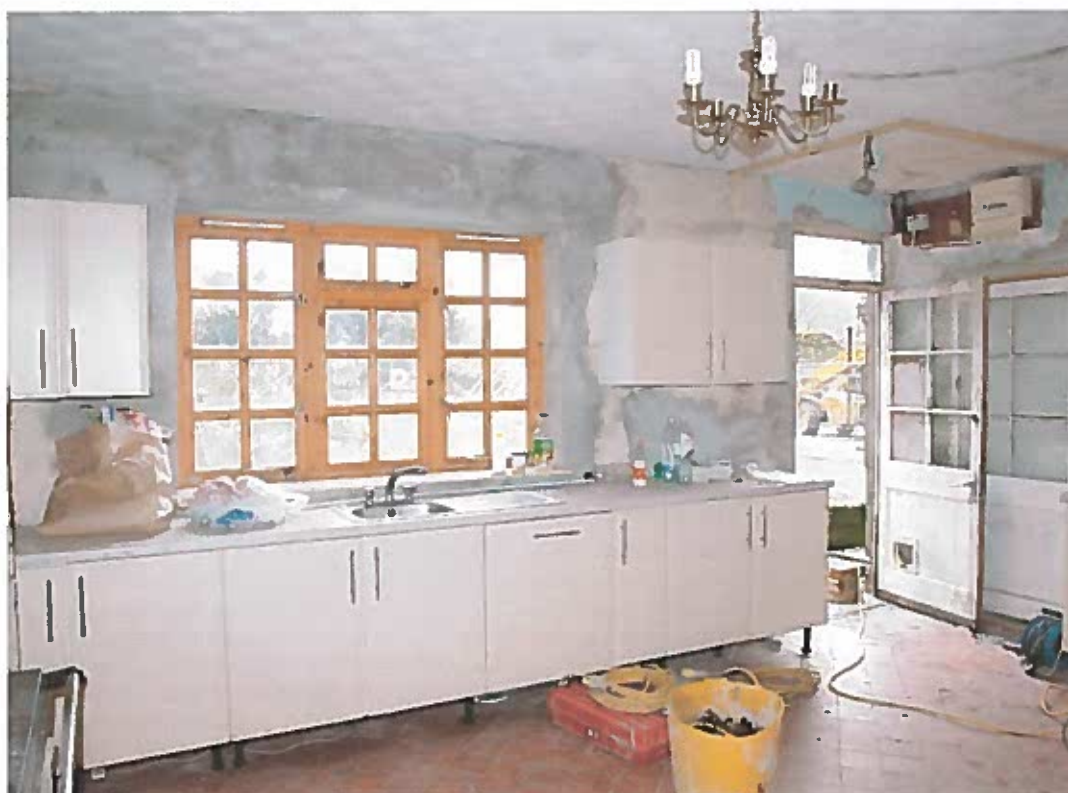
*Plate 26. Gilfach-y-berthog - Existing kitchen extension at east end of house. Looking southeast.*

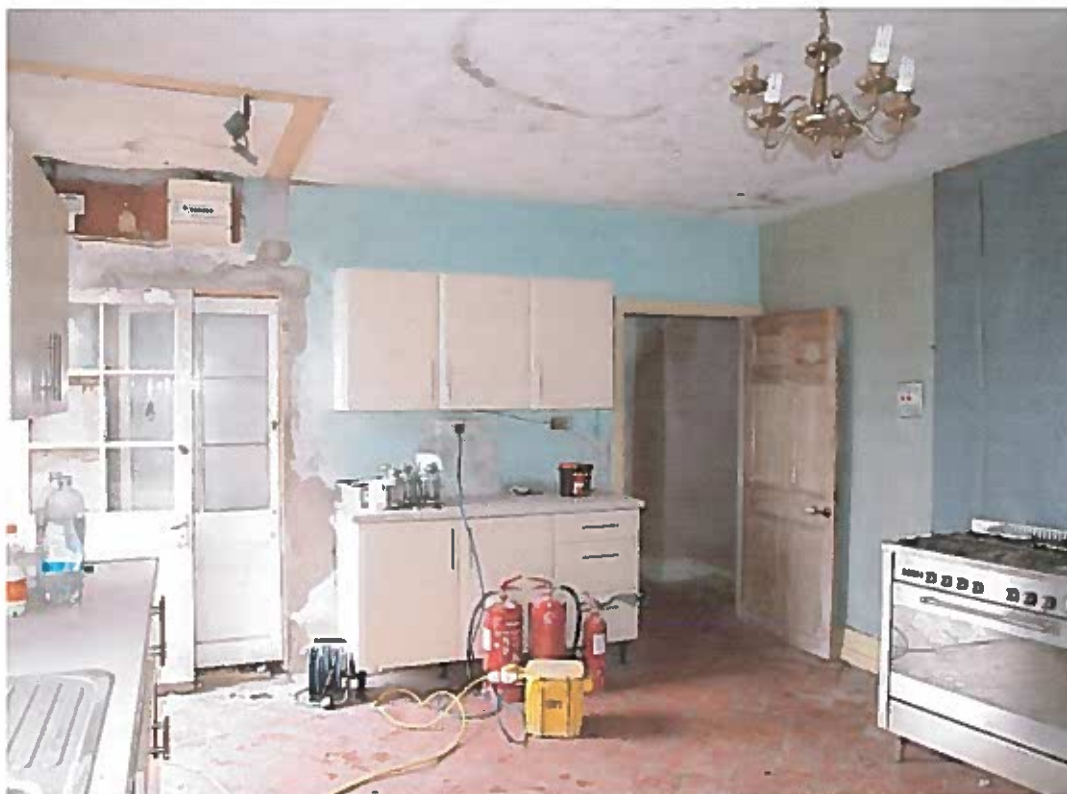
*Plate 27. Giffach-y-berthog - Existing kitchen extension at east end of house. Looking south.*

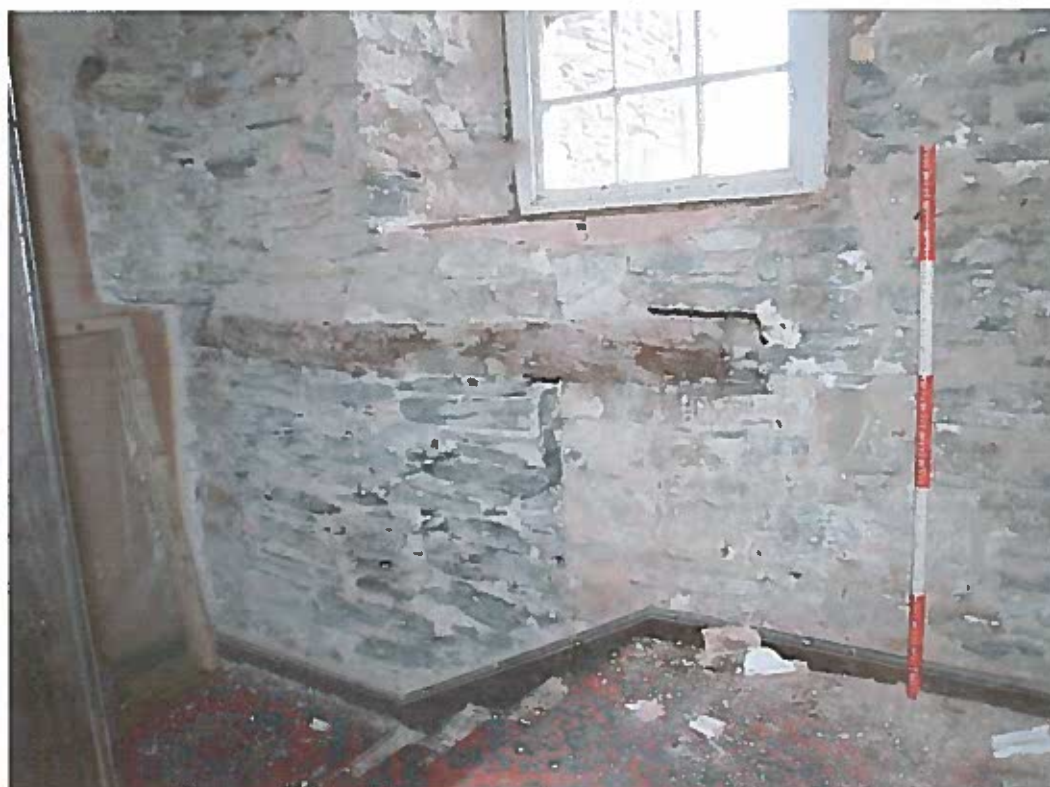
- 4.54 Following the removal of plasterwork from parts of the interior of the house, two significant features became exposed.
- 4.55 The first of these features was an apparent blocked in window on the first floor landing, within the west wall in the old part of the house (see Photo Plate 30). This former window opening would once have been part of the early 17<sup>th</sup> century house prior to the construction of the new extension house in the late 17<sup>th</sup> century. This is evident by the existence of the same fabric and mortar used as blocking in as the stone used in the main fabric of the later build.

*Plate 30. Gilfach-y-berthog - Evidence for blocked in 1st floor window in west wall of former early 17th century house. Looking west.*

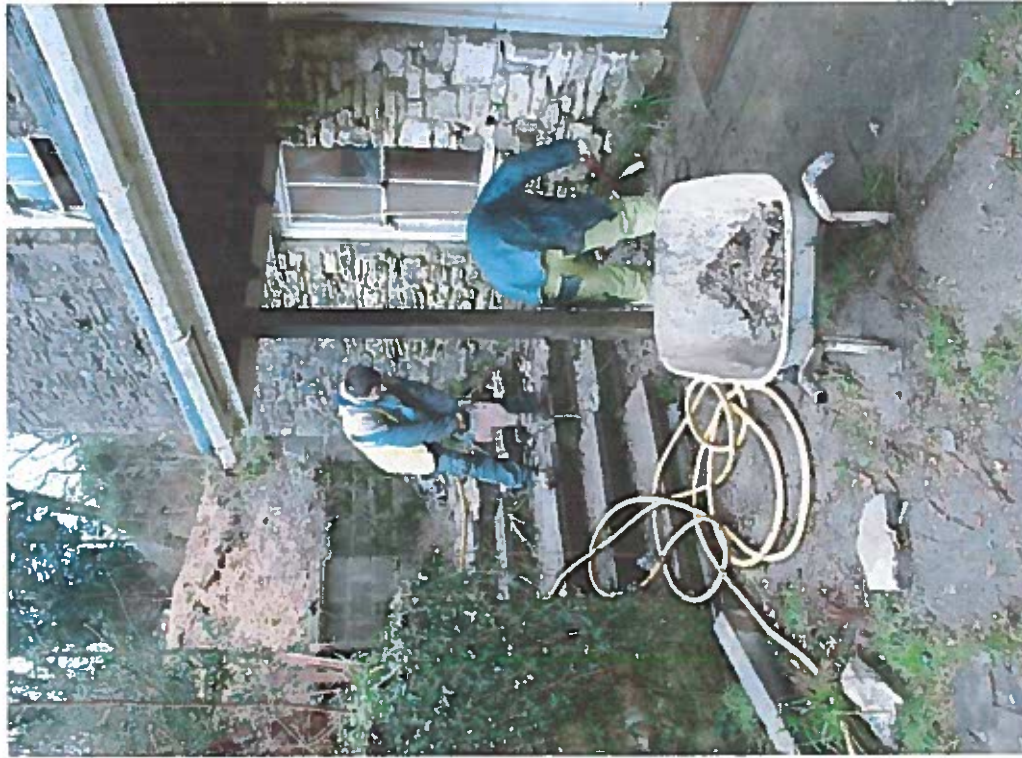
Plate 43. Working shot during removal of modern concrete steps for drainage services (ST1). Looking northeast.

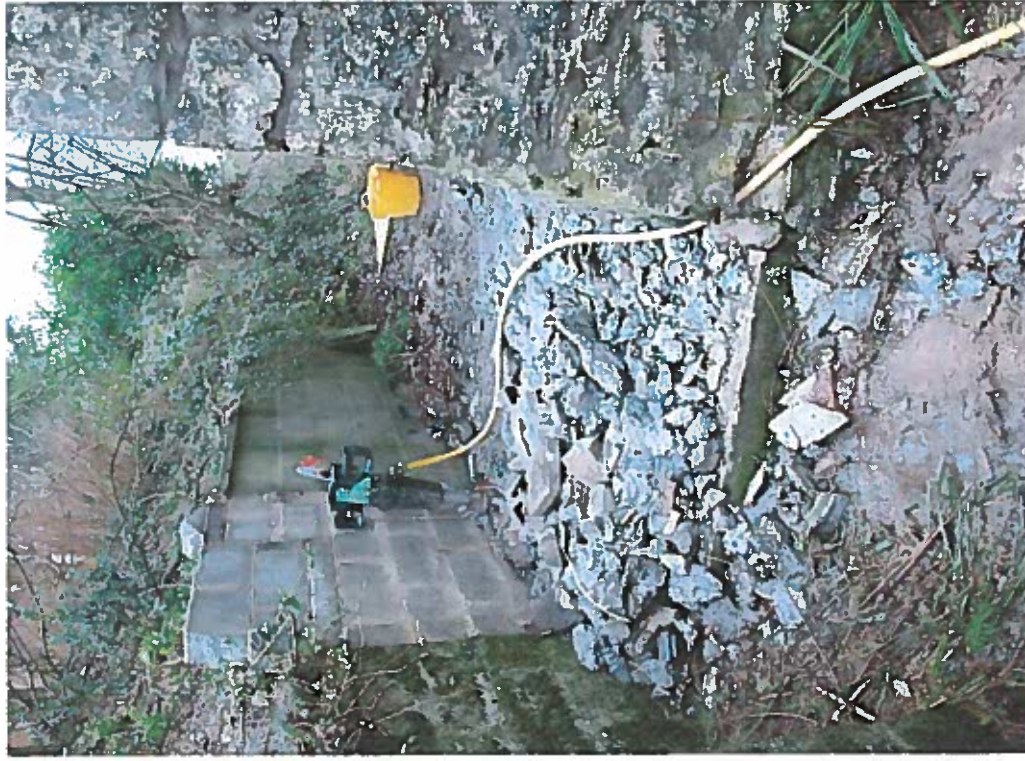
Plate 44. Working shot following removal of modern concrete base at rear of house (ST1). Looking east.

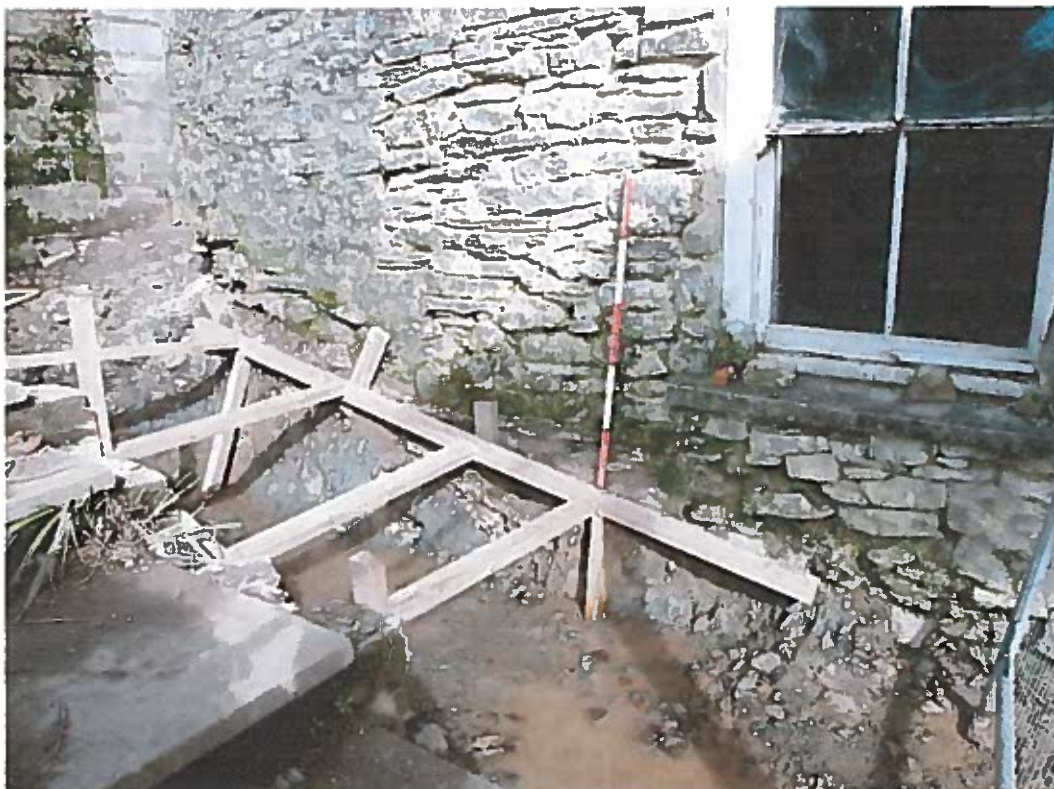
*Plate 45. Galfach-y-berthog - Northwestern corner of rear of house following removal of modern steps and concrete (ST1). Looking east.*

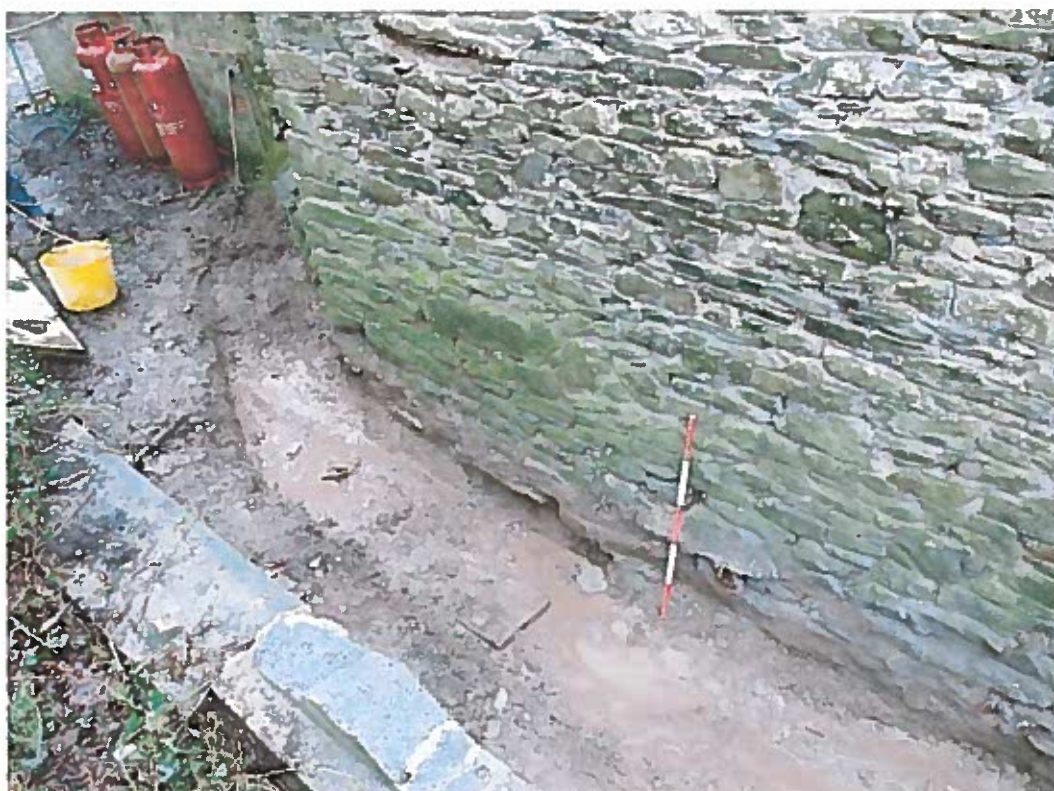
- 4.35 This trench was positioned at the rear of the house at the northern end. Proposals were to reduce the ground at the rear of the house in order to lay a series of drainage pipes to help direct water away from the house, which was suffering fairly severely from rain water that was running off the slope at the rear of the house and causing flooding, which was being detrimental to the foundations.

*Plate 46. Galfach-y-berthog - Rear of house following removal of modern concrete base and ground reduction for drainage (ST1). Looking west.*

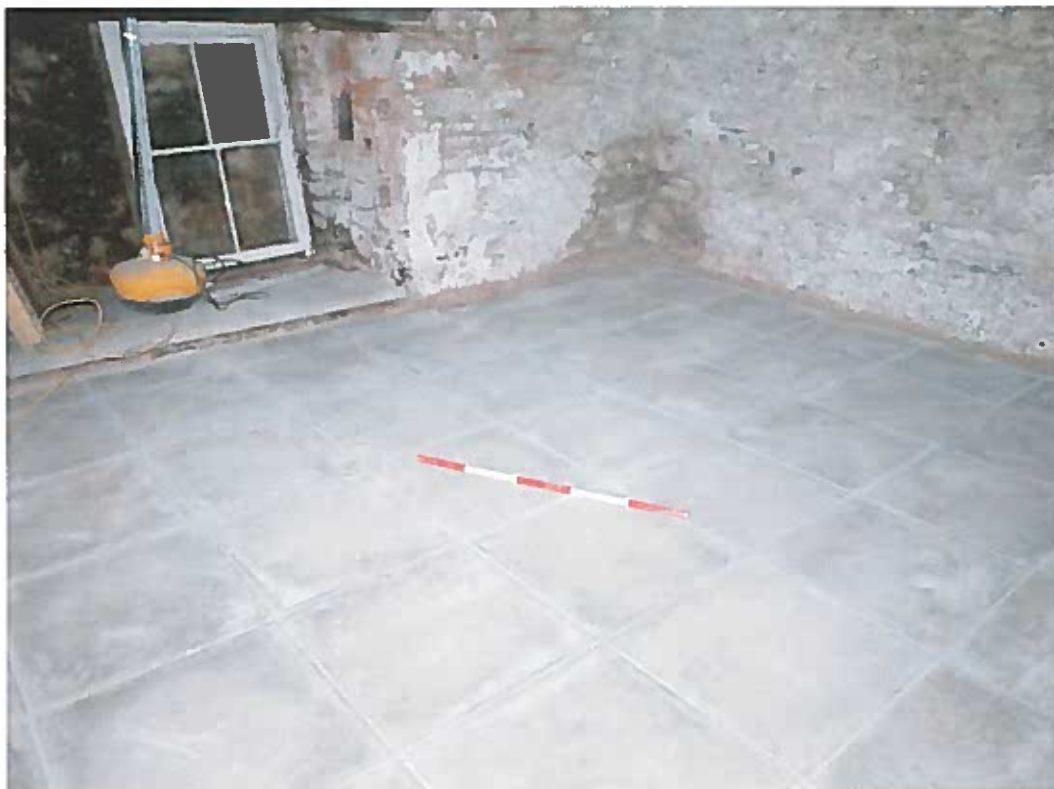
*Plate 47. Gilfach-y-berthog - Floor surface in Lower Parlour Room prior to floor reduction. Looking northeast.*

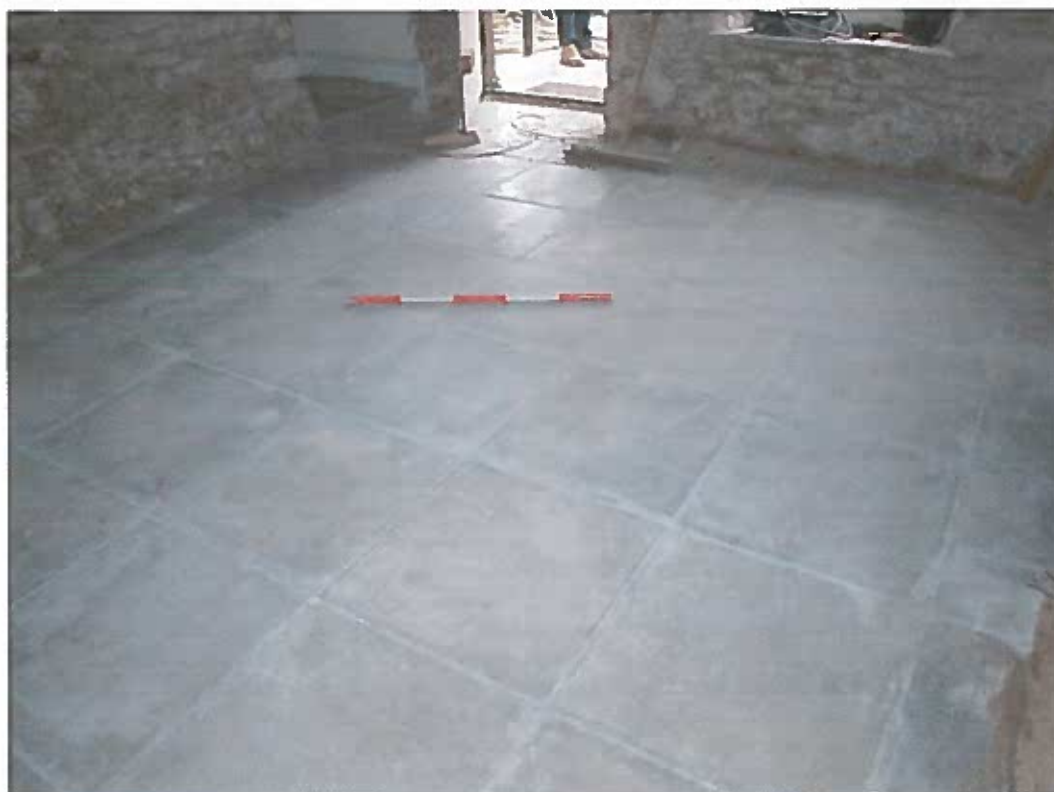
*Plate 48. Gilfach-y-berthog - Floor surface in Lower Parlour Room prior to floor reduction. Looking west.*

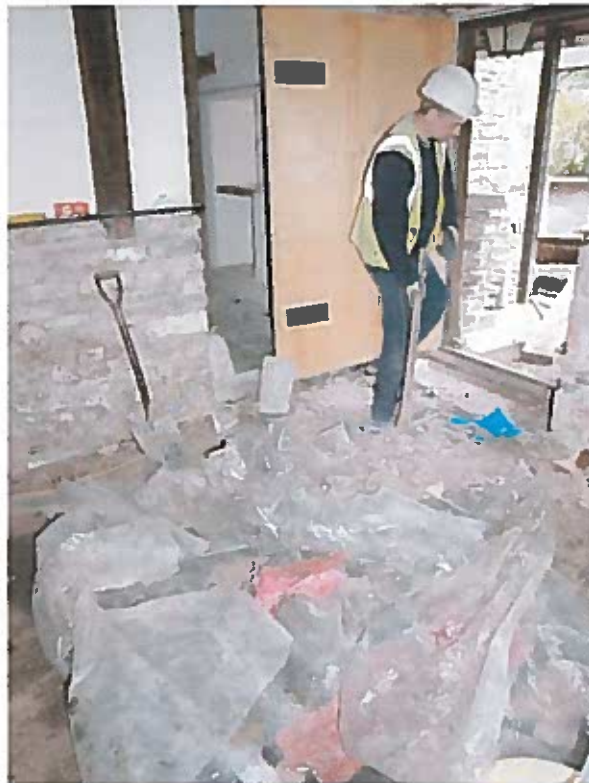
*Plate 49. Gilfach-y-berthog - Working shot during removal of modern stone floor tiles from Lower Parlour Room during ground reduction. Looking southwest.*

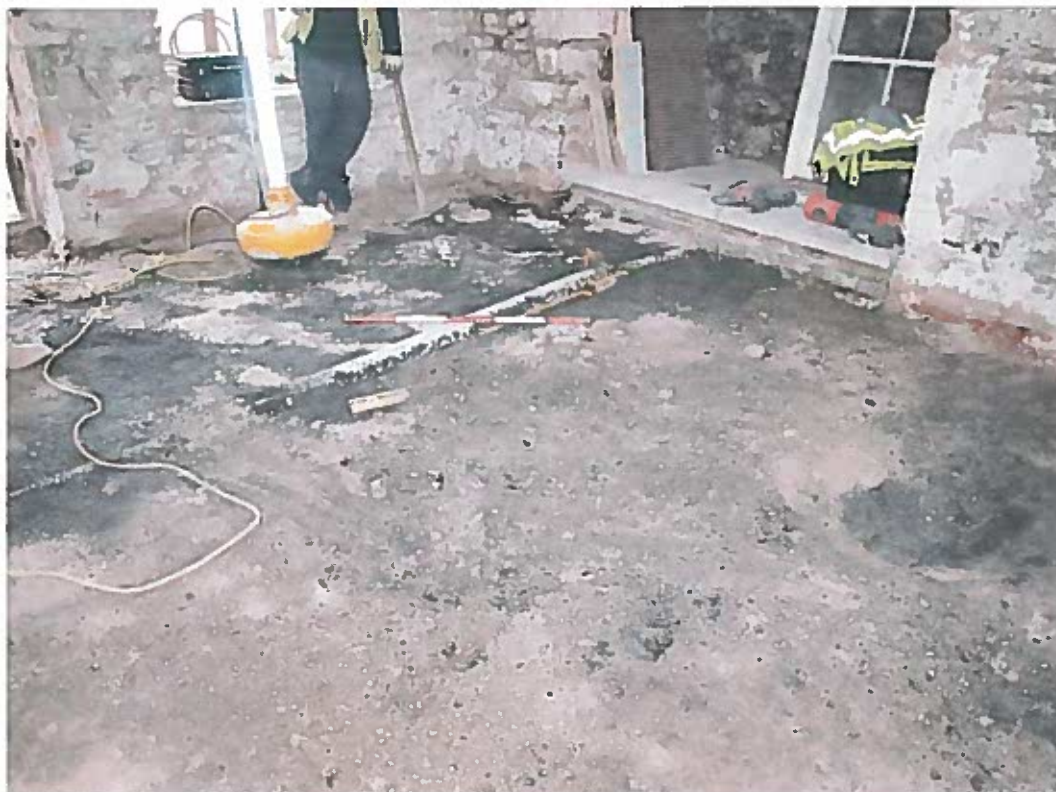
*Plate 50. Gilfach-y-berthog - Floor surface in Lower Parlour Room following removal of modern stone floor tiles. Looking northwest.*

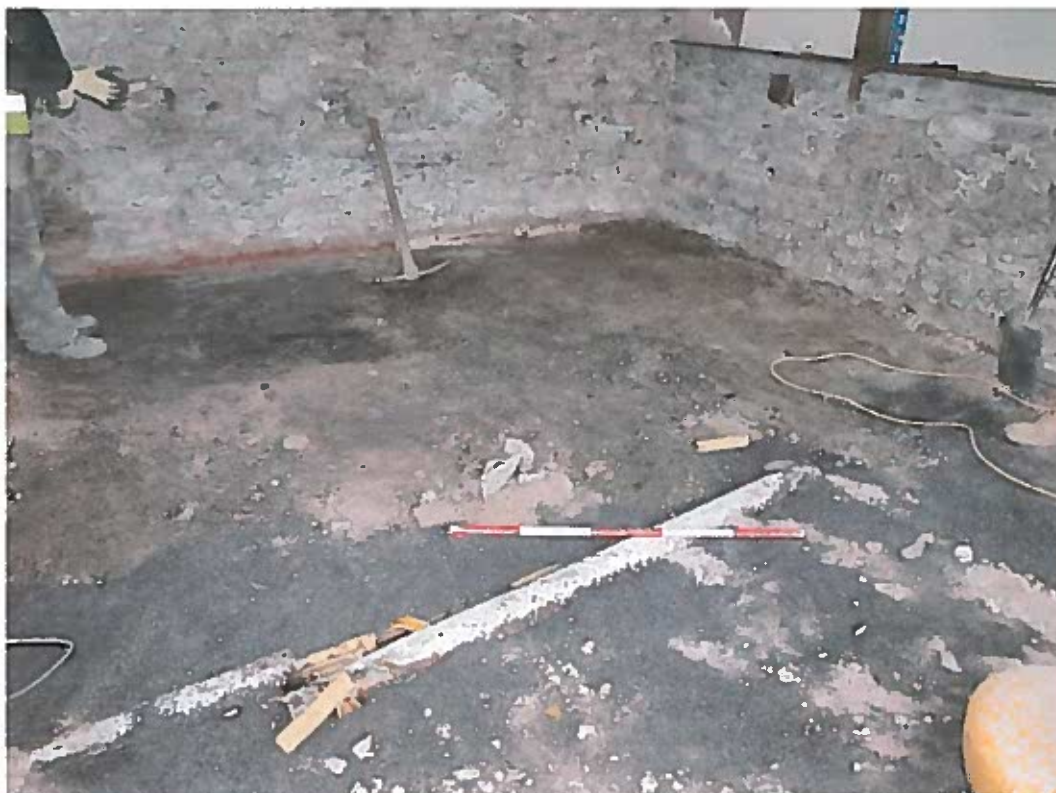
Plate 51. Gilfach-y-berthog - Floor surface in Lower Parlour Room following removal of modern stone floor tiles. Looking southeast.

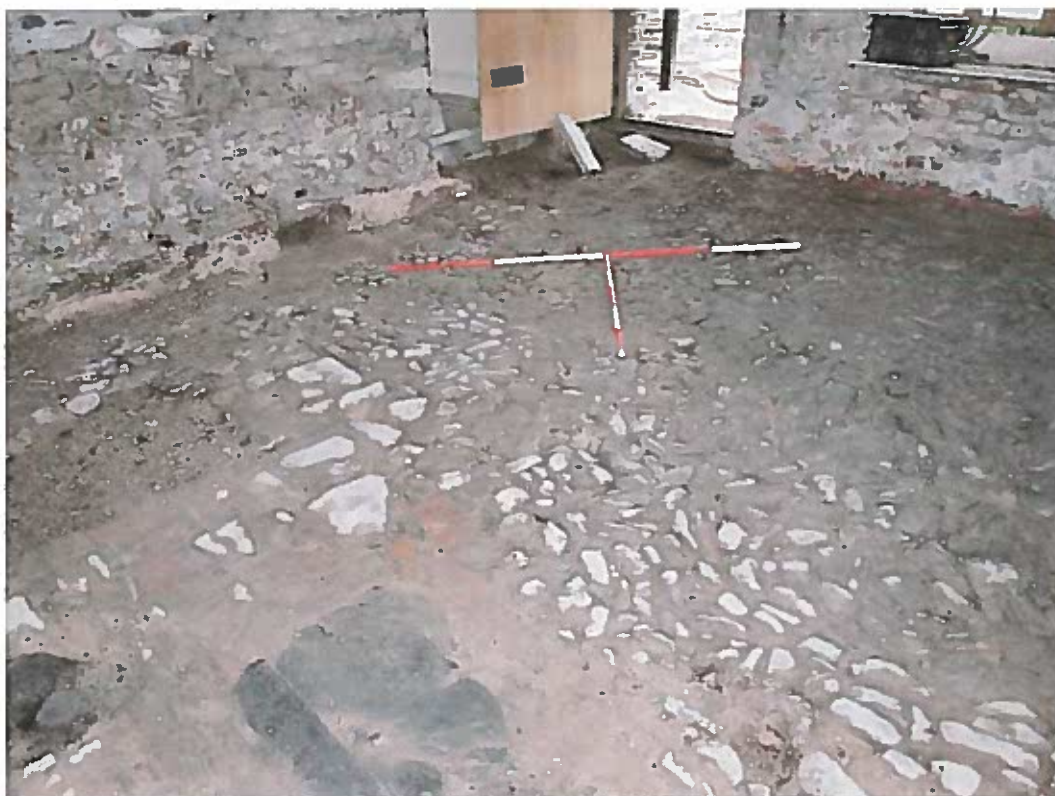
Plate 52. Gilfach-y-berthog - Floor surface in Lower Parlour Room following removal of modern stone floor tiles and underlying earth and mortar deposit, showing partial remains of former cobbled floor. Looking southwest.

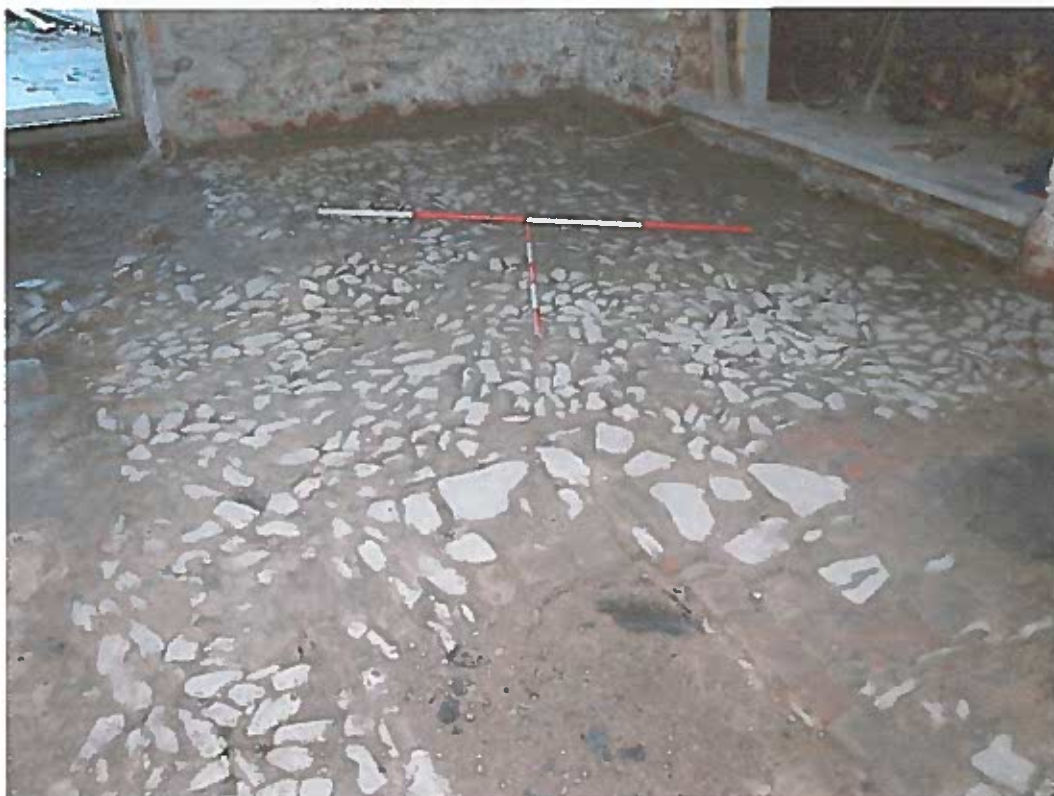
*Plate 53. Gilfach-y-berthog - Remains of former early 17th century cobbled floor in Lower Parlour Room following ground reduction work. Looking west.*

104 = Early 17<sup>th</sup> century cobbled floor. River cobbles vary in size from 0.05 – 0.20m. Cobbled floor covers approximately 70% of the parlour room floor, with areas alongside both doorways at the west end being absent of any stones, suggesting that these areas once held large slate slabs since robbed or removed prior to covering of floor in the later centuries. Evidence of cobbled floor repair at east end with replacement black slate and red brick.

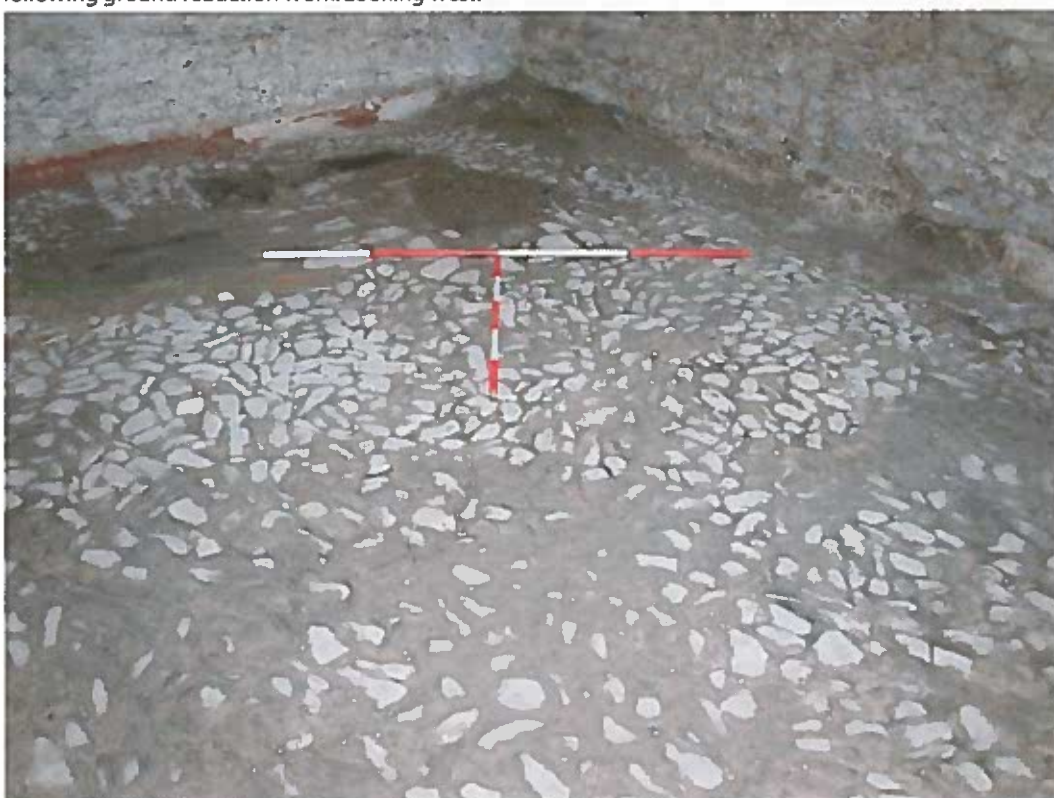
*Plate 54. Gilfach-y-berthog - Remains of former early 17th century cobbled floor in Lower Parlour Room following ground reduction work. Looking southeast.*

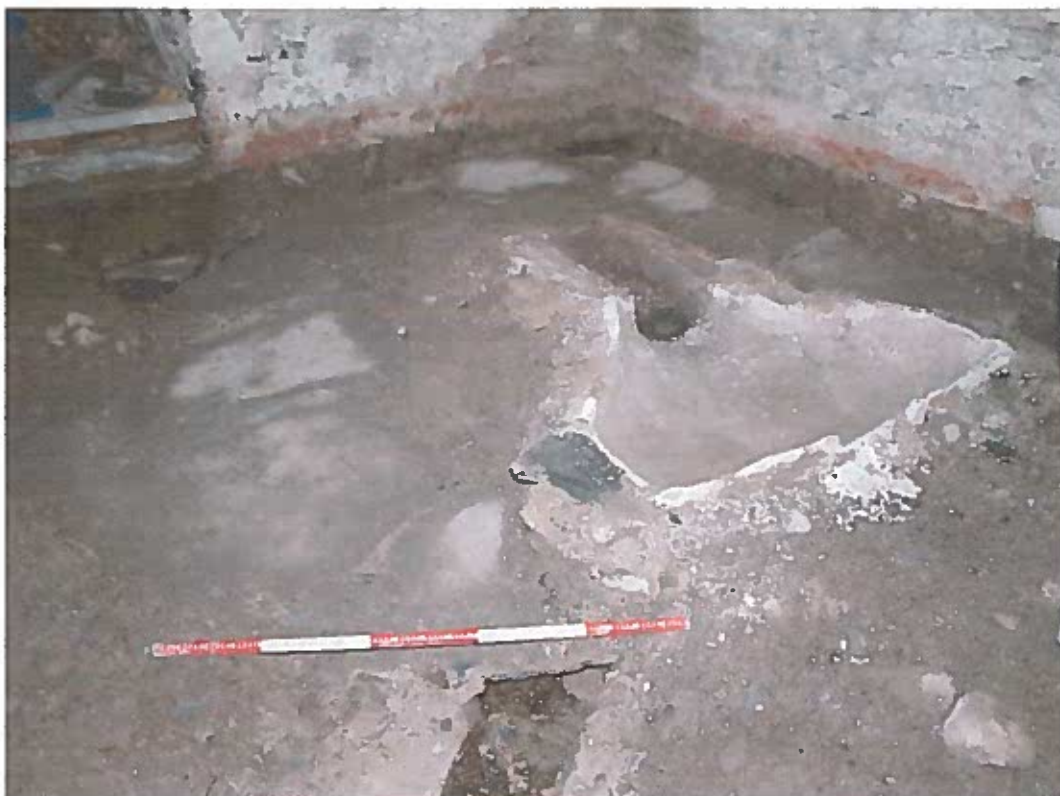
- 4.8 At the far east end of the room, the removal of a large outline of red brick, black slate and other stones, which were not river cobbles, exposed the remains of a former slaked lime processing pit (106). This feature obviously post-dated the cobbled surface as its original construction had caused the removal of part of the cobbled floor.

Remnants of slaked lime in the pit were identical to the remains of slaked lime that was found at the base of the east, north and southern walls (107), overlying the cobbled surface. This suggested that the processing pit had probably been constructed for the production of slaked lime for building use as well as to coat the interior walls of parts of the house in either the late 17<sup>th</sup> century or the 18<sup>th</sup> century.

removal of the cobbled floor and its associated bedding deposit from around the feature, revealed that the red brick structure at the northern end of the pit had remnants of soot and charcoal at the base of its internal opening, implying that this part of the structure was most probably used as a stoke hole or a grate to collect burnt ashes from a fire that had been lit from above in another now absent structure, perhaps even a very small lime kiln. Fumes from this burning were probably extracted from the room through a chimney flue arrangement that had once been punctured through a hole in part of the north wall alongside the eastern side of the inglenook fireplace.

Plate 70. Gilfach-y-berthog - Exposed slaked lime pit following removal of cobbled floor and exposing of culvert channels. Looking northeast.

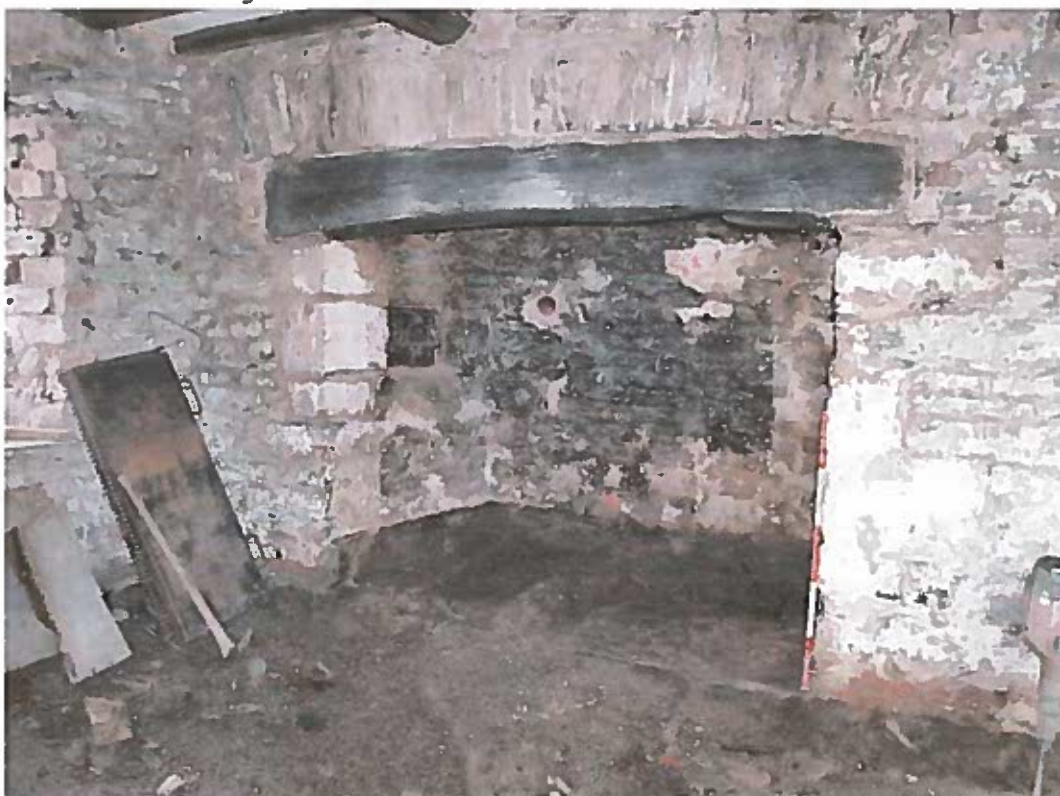
Plate 71. Gilfach-y-berthog - Fireplace opening with exposed cobbled floor at base. Looking northwest.

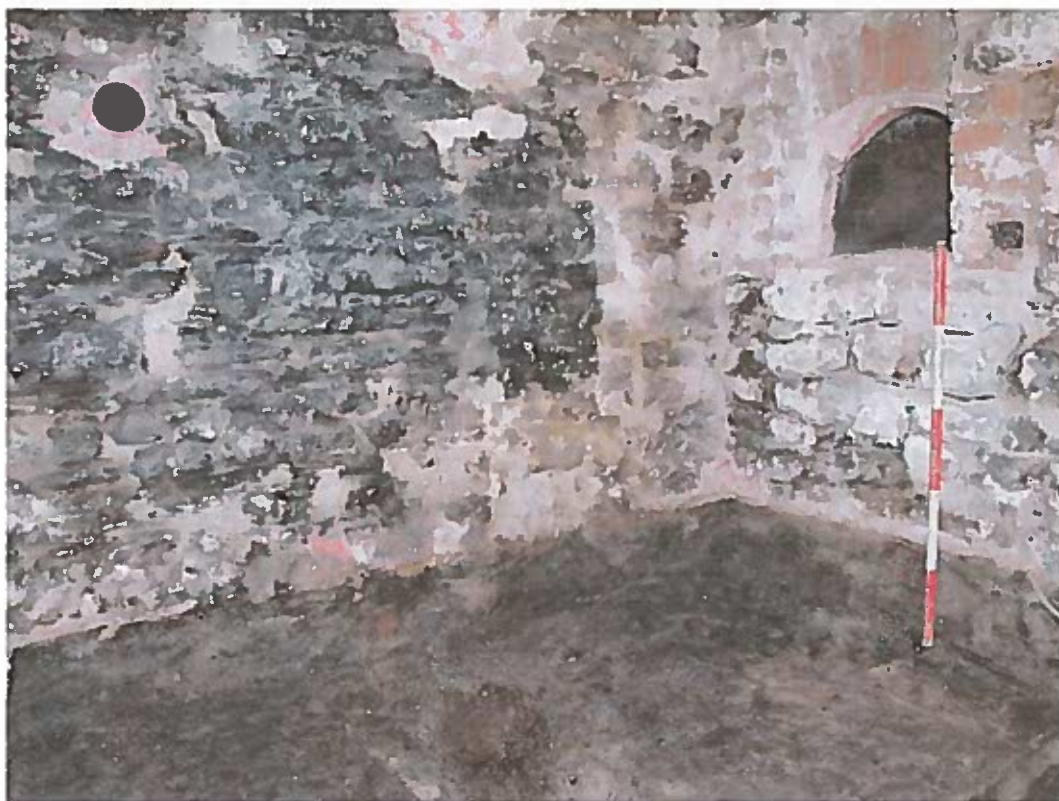
*Plate 72. Gylfach-y-berthog - Cobbled surface in area of fireplace and bread oven in fireplace side wall. Looking east.*

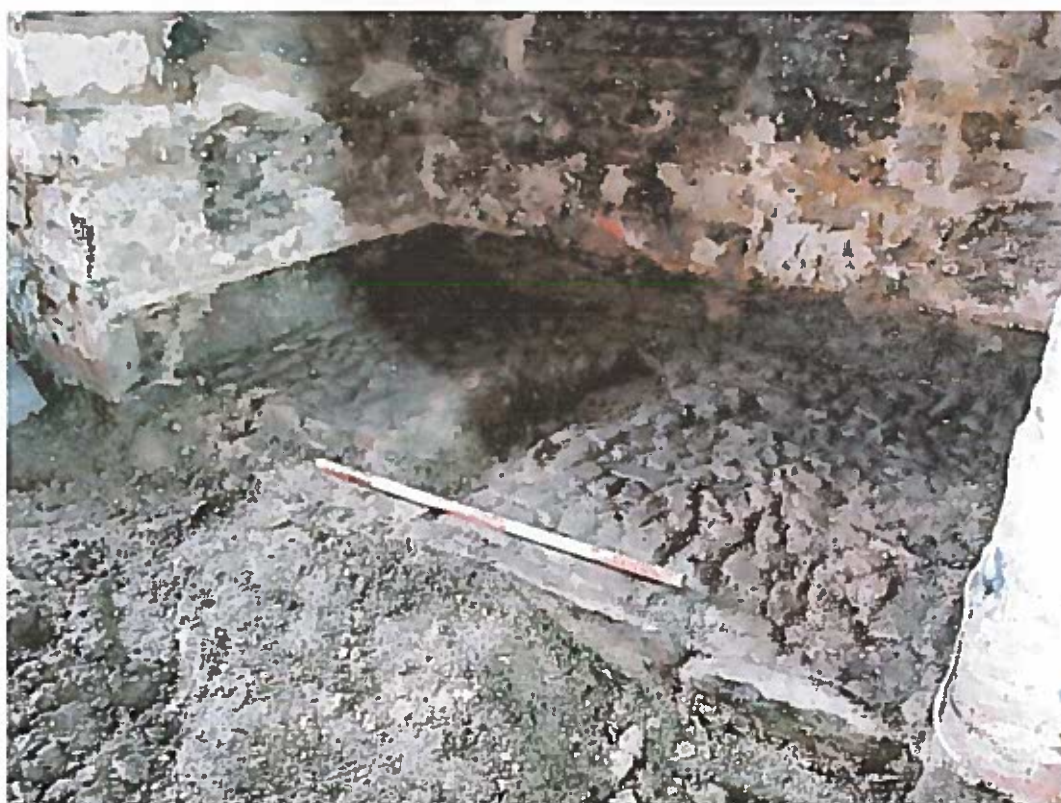
*Plate 73. Gylfach-y-berthog - Remains of cobbled surface in fireplace opening. Looking northwest.*

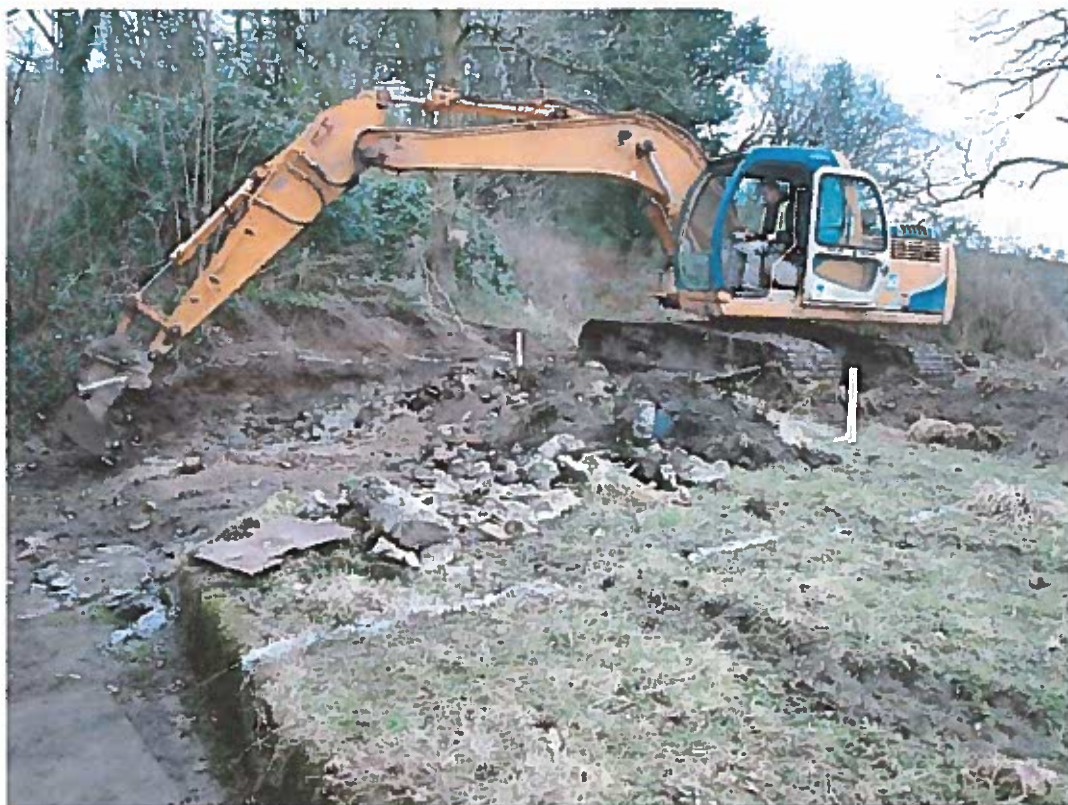
Plate 76. Gilfach-y-berthog - Working shot during groundwork for proposed kitchen extension. Looking northeast.

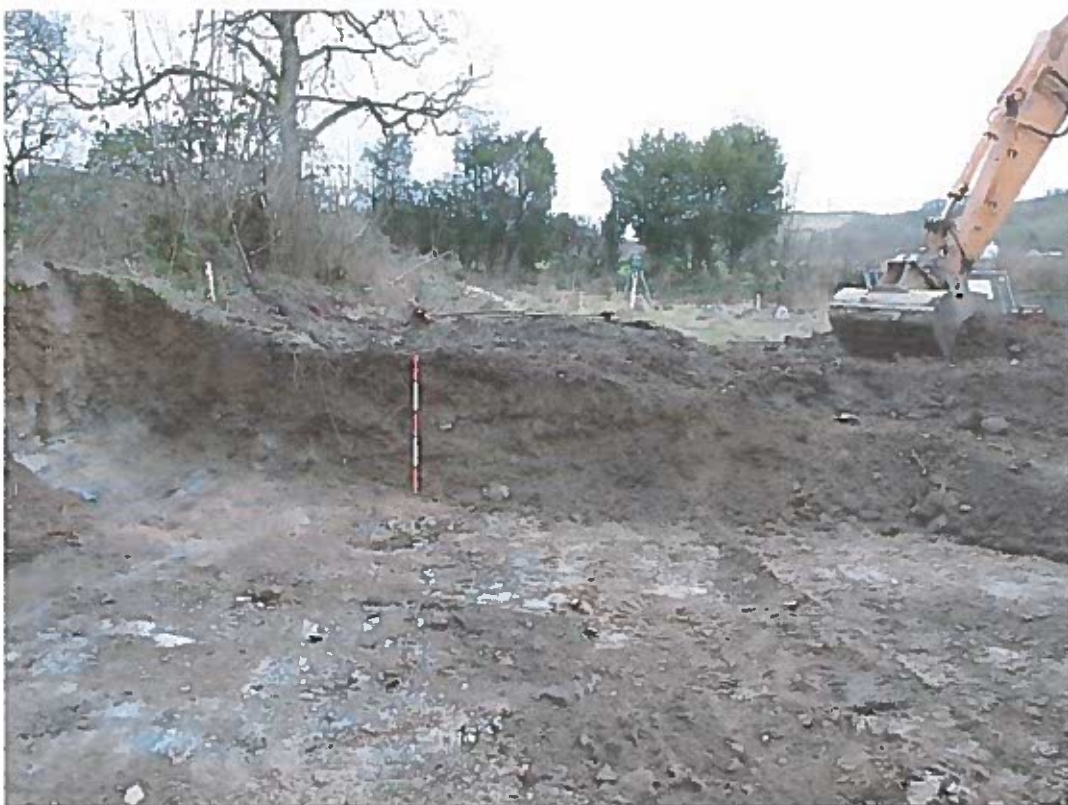
- 5.7 The groundwork for the demolition of the existing 19<sup>th</sup> century kitchen and the cutting of new footings for the new extension exposed no archaeological features or deposits, revealing only that the 19<sup>th</sup> century kitchen extension appeared to have caused extensive landscaping of the immediate area and its walls had been built directly onto the natural shale bedrock.

Plate 77. Gilfach-y-berthog - Stratigraphy in area of proposed kitchen extension following groundwork. Looking east.

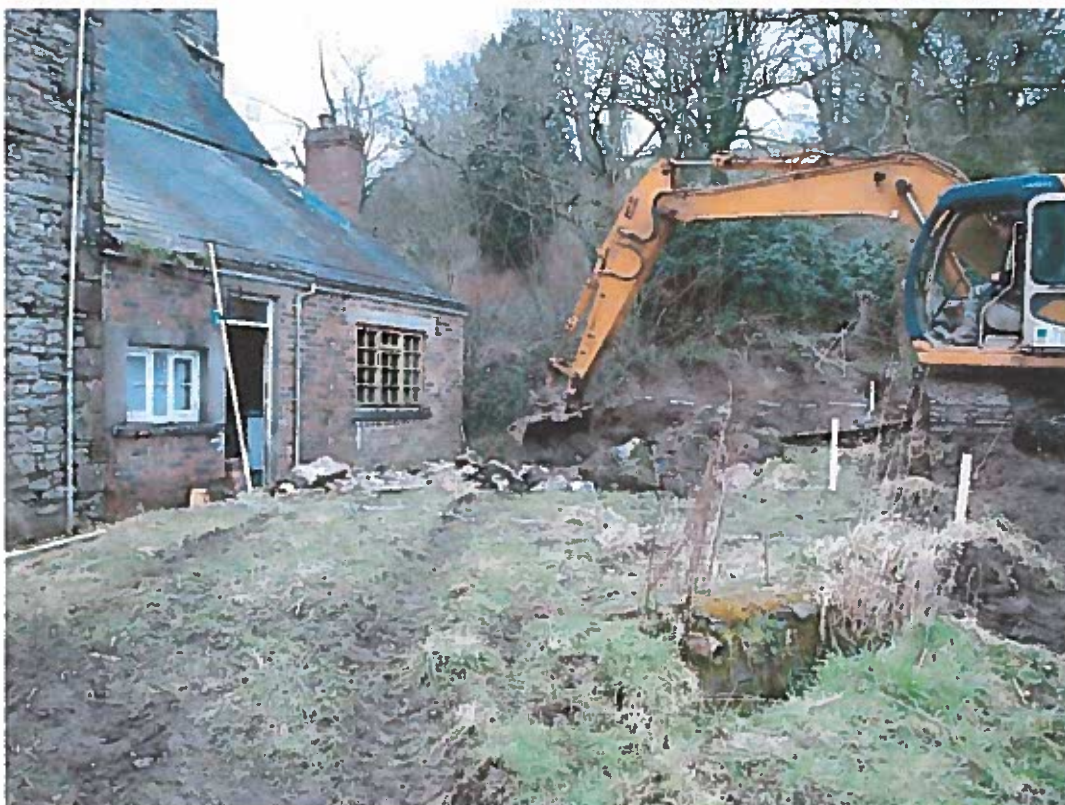
*Plate 78. Gilfach-y-berthog - Working shot during groundwork for proposed kitchen extension. Looking north.*

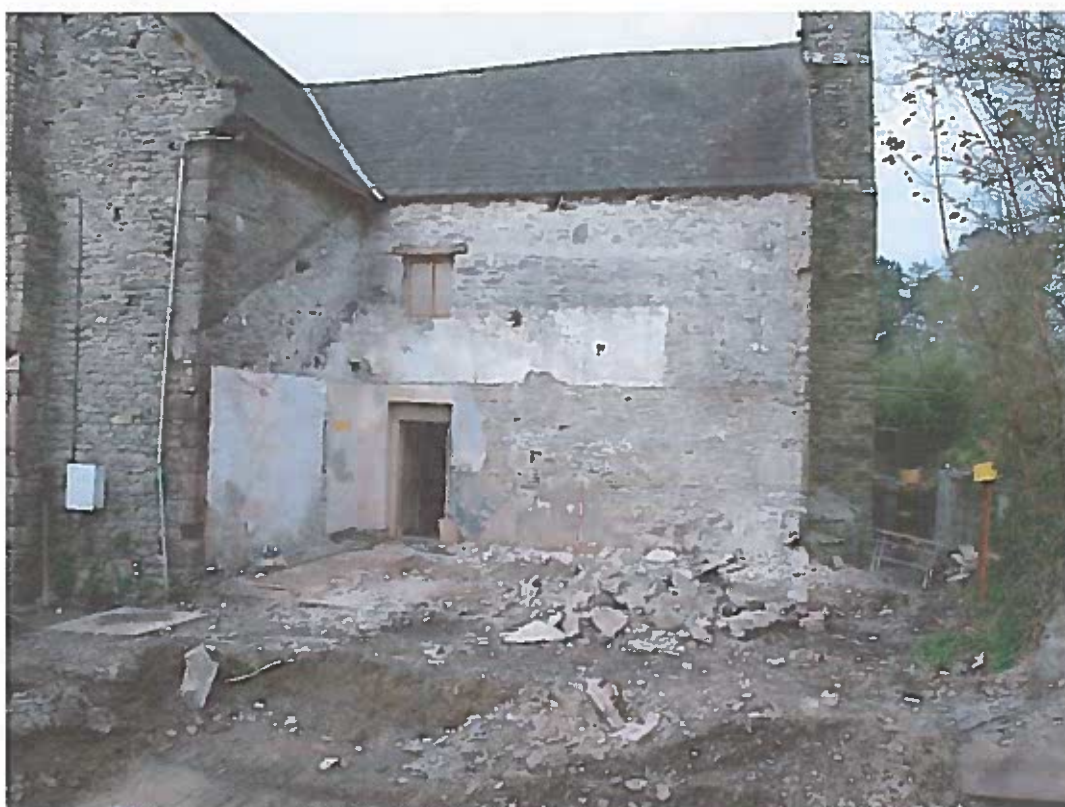
*Plate 79. Gilfach-y-berthog - Former 19th century kitchen extension demolished in preparation for new proposed kitchen extension.*
