## Gilfach-y-berthog, Abergwilli, Carmarthenshire.

### Archaeological Watching Brief

HRSWales  
Report No: 131

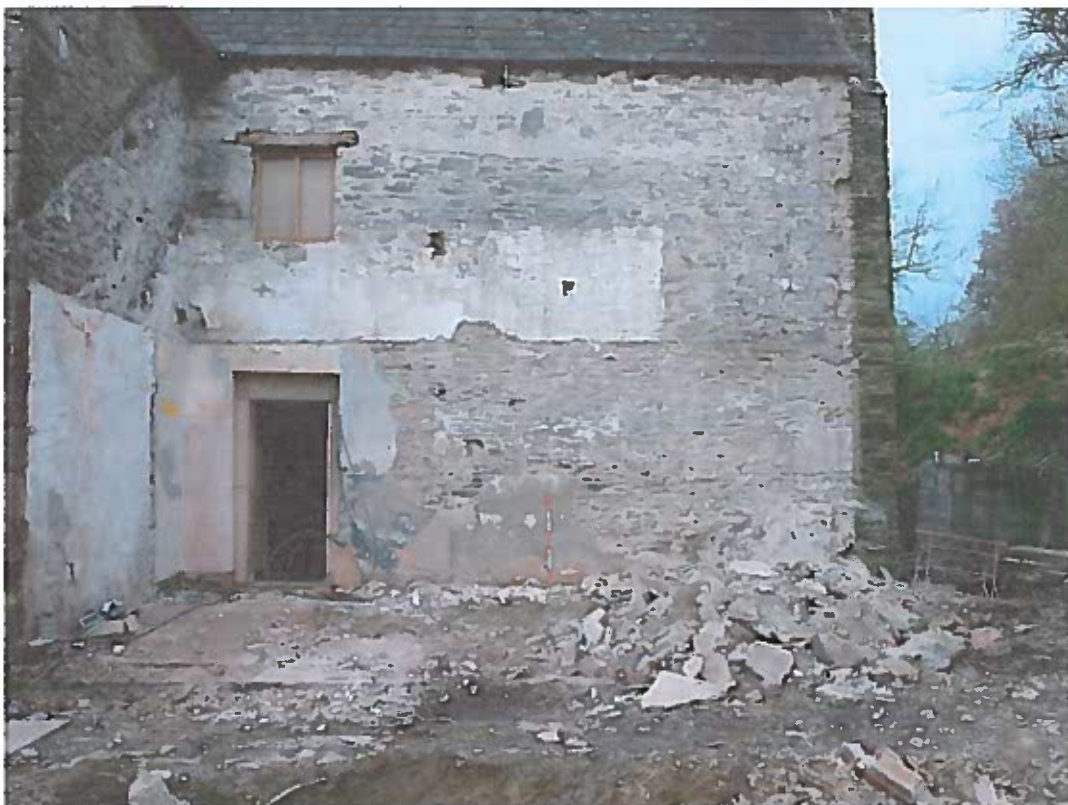
*Plate 80. Gilfach-y-berthog - Former 19th century kitchen extension demolished in preparation for new proposed kitchen extension. East facing elevation.*

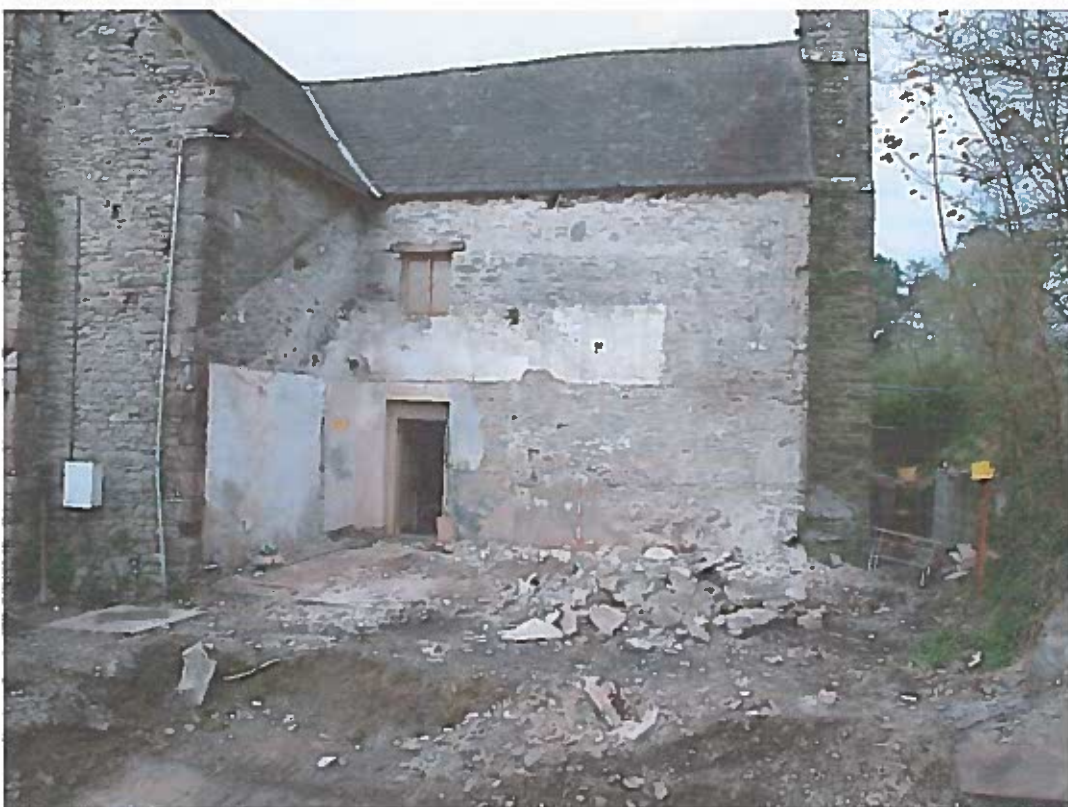
*Plate 81. Gilfach-y-berthog - Former 19th century kitchen extension demolished in preparation for new proposed kitchen extension. East facing elevation.*

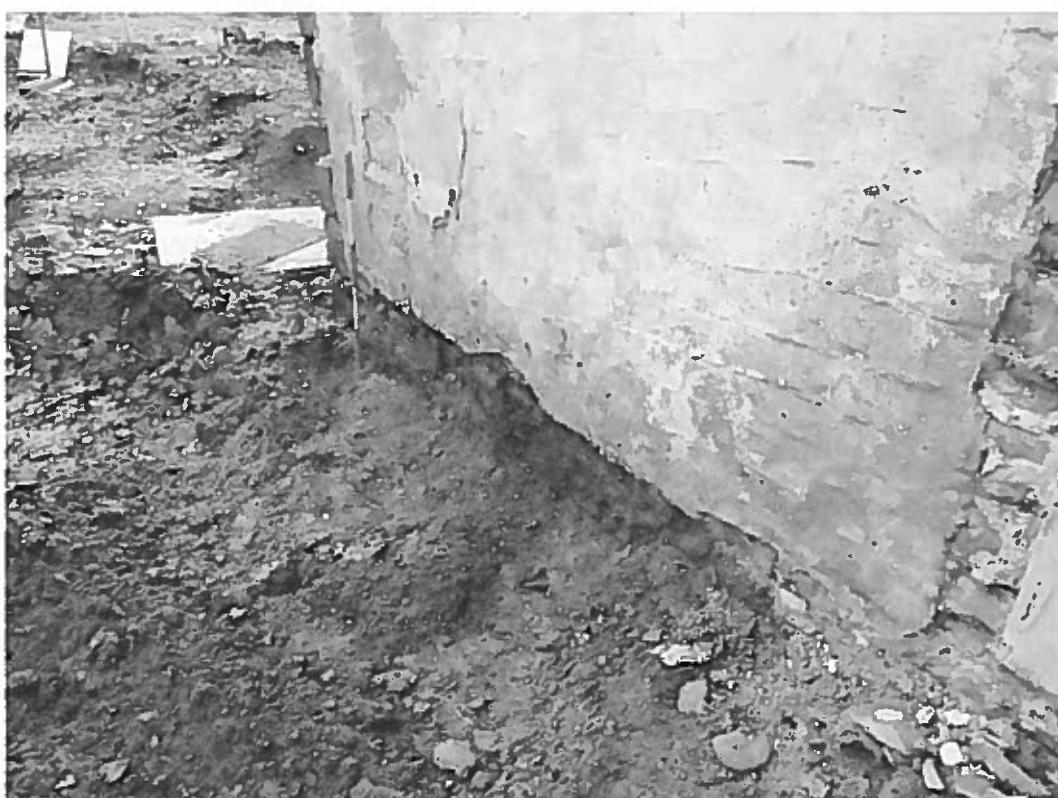
*Plate 83. Gylfach-y-berthog - Former 19th century kitchen extension demolished in preparation for new proposed kitchen extension. Detail at base of north facing rear wall of late 17th century house. Looking southeast.*

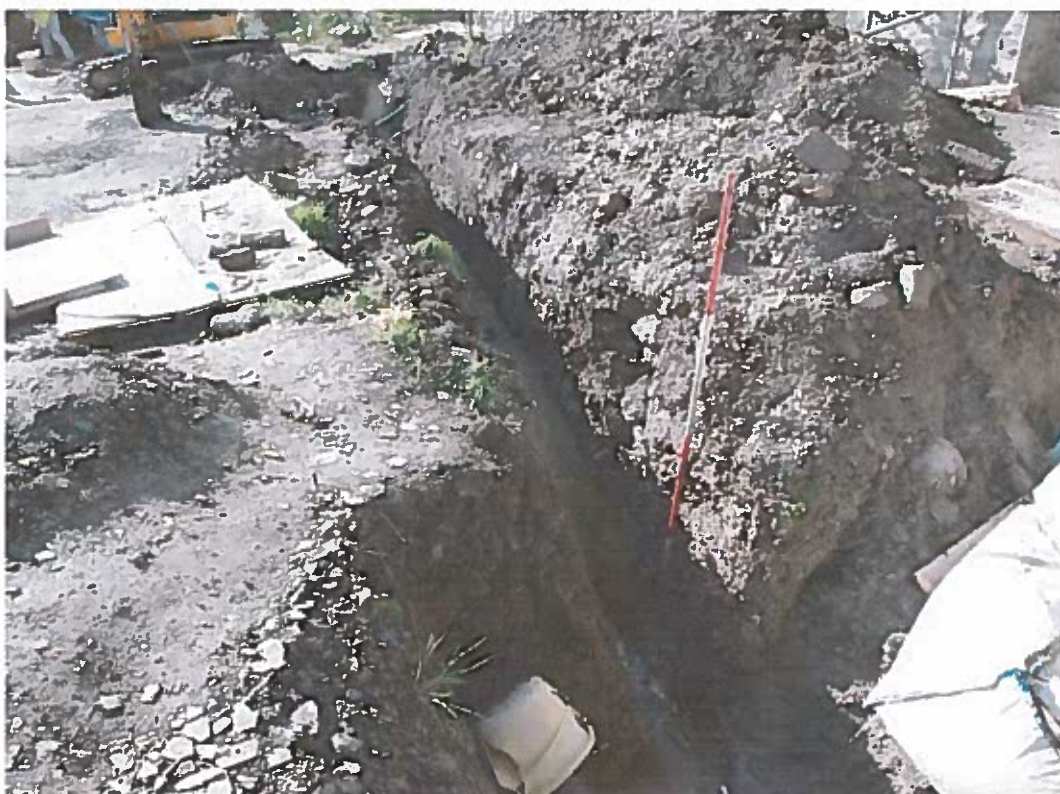
*Plate 84. Gylfach-y-berthog - Service trench (ST2) alongside new kitchen extension. Looking south.*

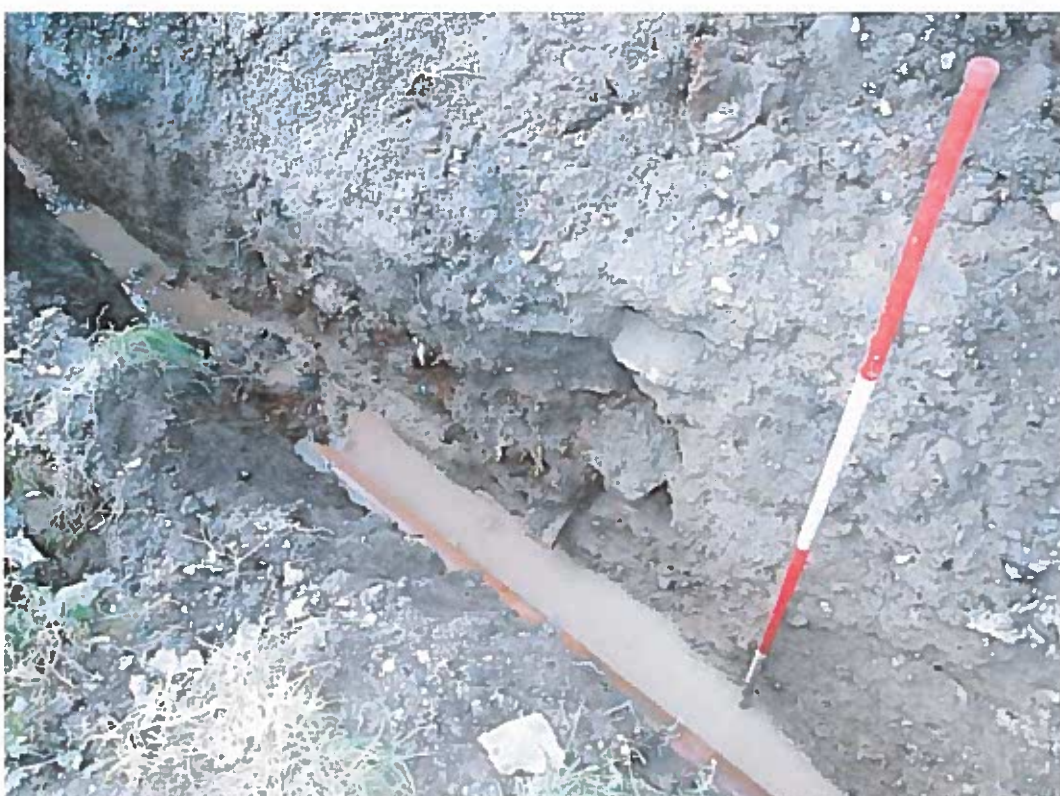
*Plate 85. Gylfach-y-berthog - Service trench (ST2) alongside new kitchen extension. Looking south.*

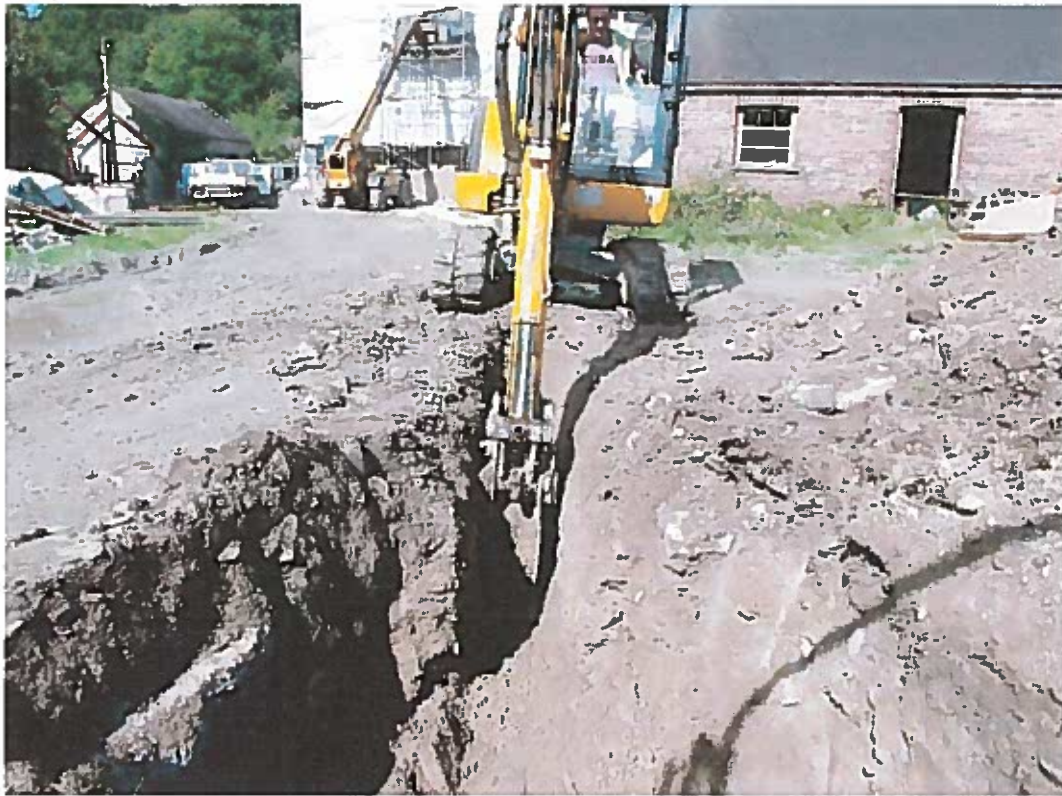
*Plate 86. Gylfach-y-berthog - Service trench at front of house (ST4). Looking northwards.*

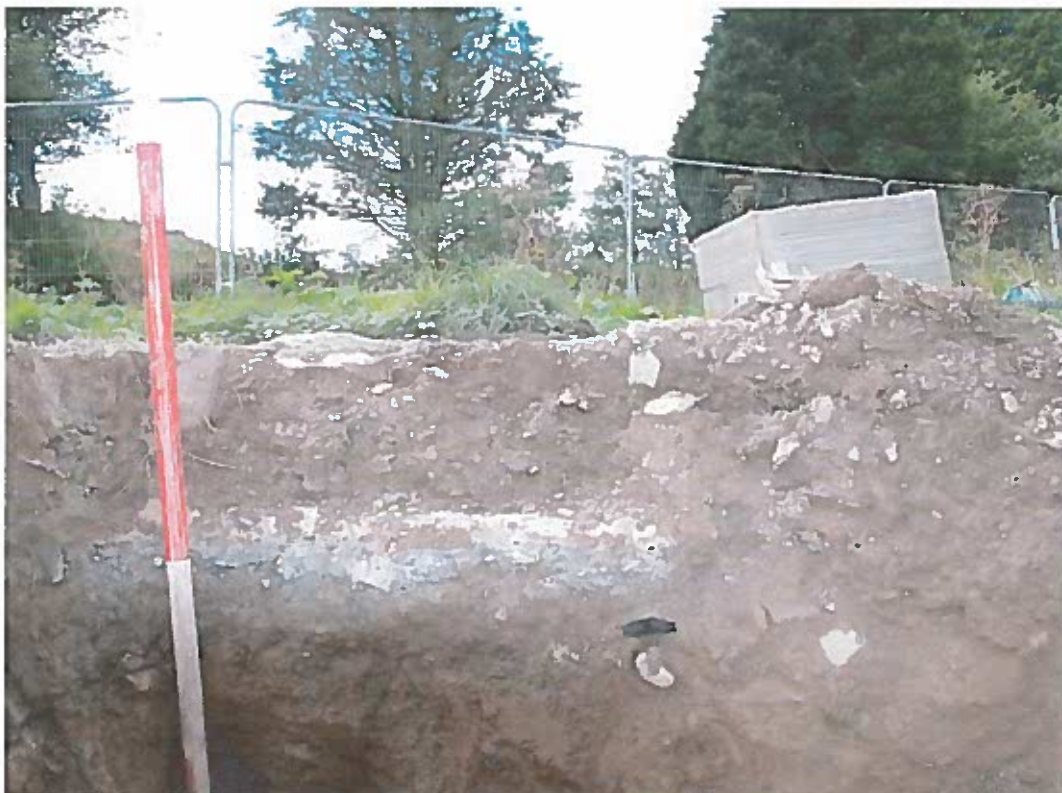
- 4.52 With regard the stratigraphy in this trench, a typical section comprised approximately 0.20m of compacted earth and shale (133). This deposit averaged approximately 0.20m in depth. Finds recovered from this deposit included occasional 19<sup>th</sup> century pottery fragments (not retained). Below this context was a deposit of loose earth and shale (134) with the occasional lens of ash intermixed with earth. This deposit averaged approximately 0.20m in depth. Below this deposit was a natural pale grey and iron stained shale grit (135).

*Plate 87. Gylfach-y-berthog - Detail showing stratigraphy along length of service trench in front of house and red brick barn (ST4). Looking southwards.*

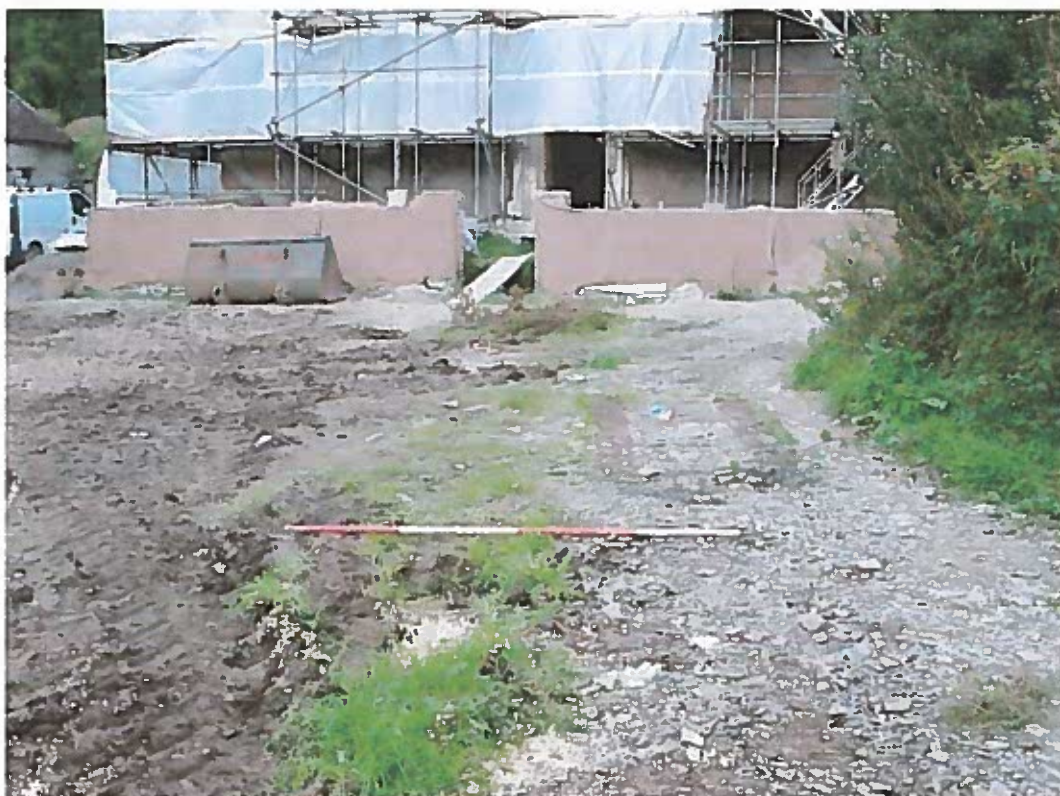
*Plate 88. Gilfach-y-berthog - Route of service trench in front of house (ST4). Looking northwards.*

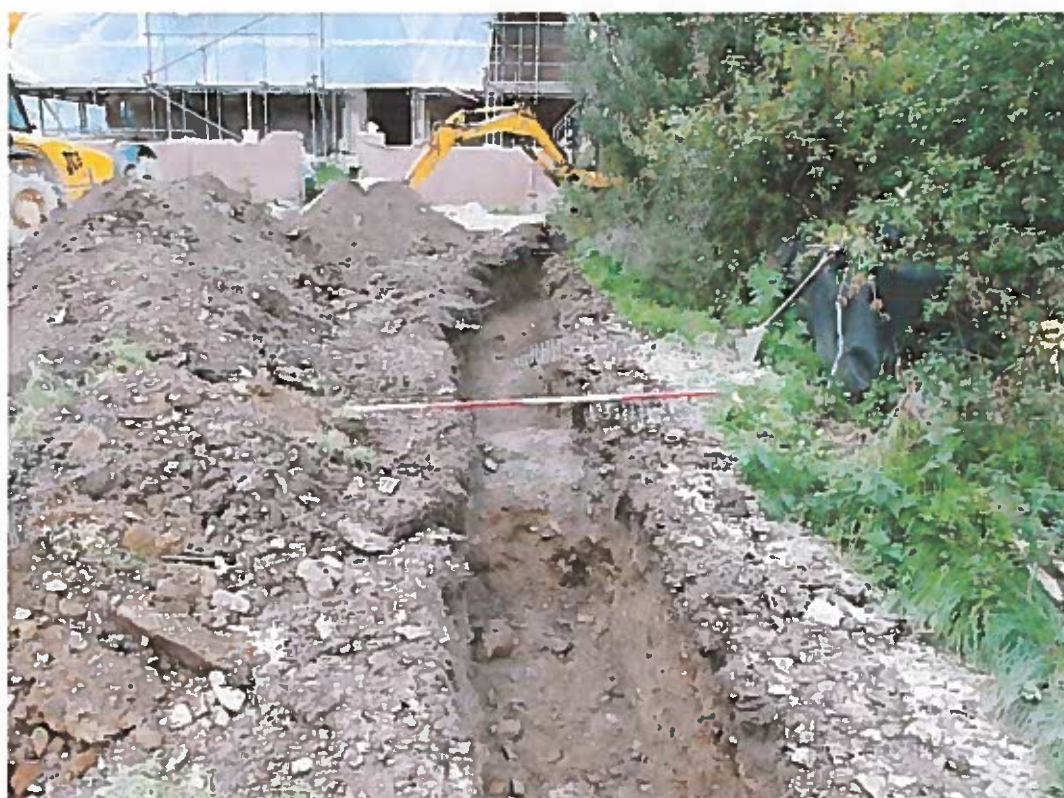
*Plate 89. Gilfach-y-berthog - Service trench (ST4) following groundwork. Looking northwards.*

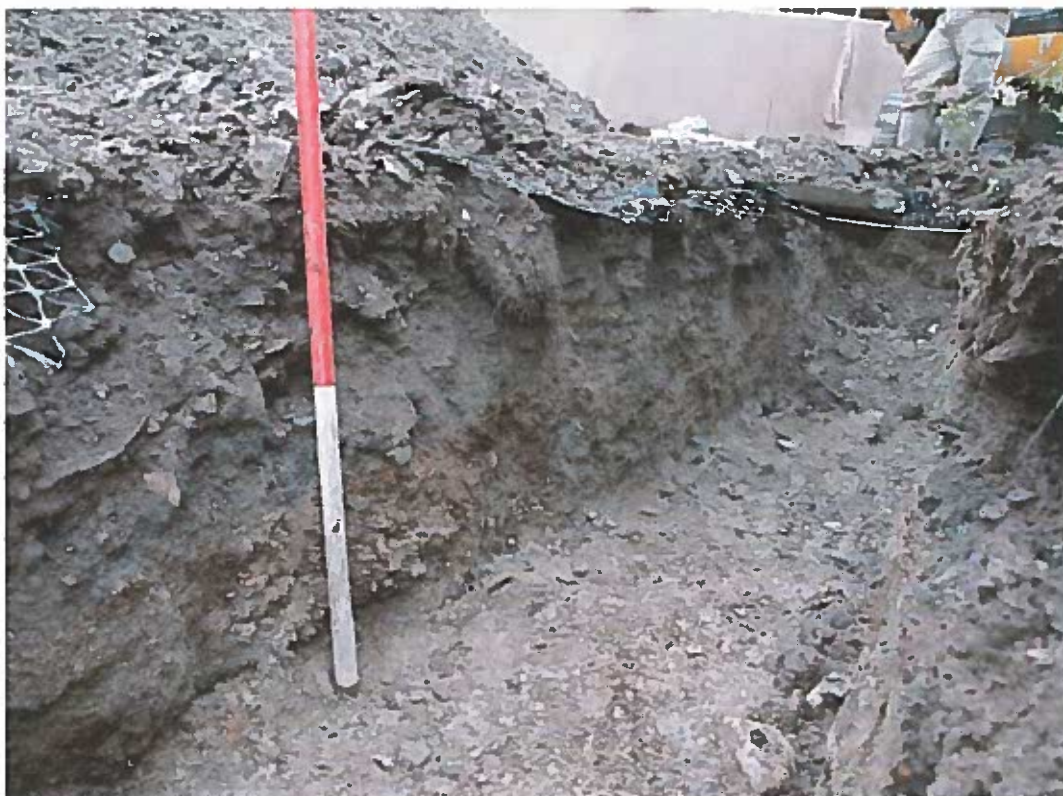
*Plate 90. Gilfach-y-berthog - Stratigraphy in service trench (ST4). East facing section. Looking northwards.*

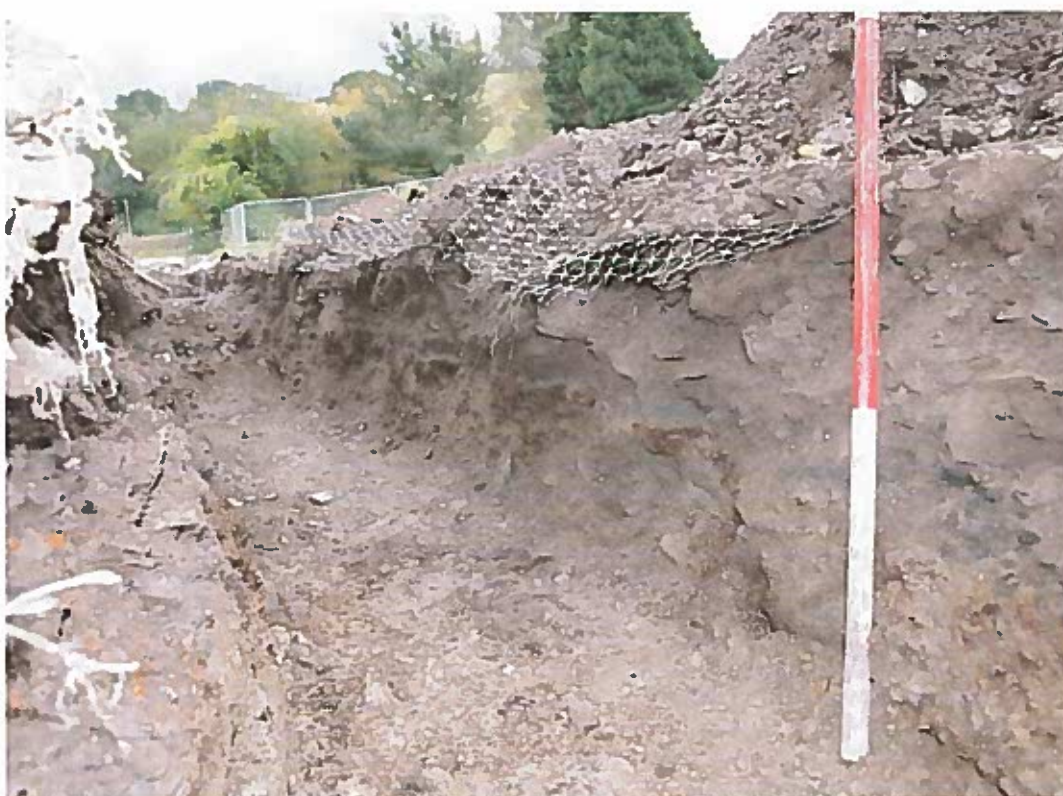
*Plate 91. Gilfach-y-berthog - Stratigraphy in service trench (ST4). East facing section. Looking southwards.*

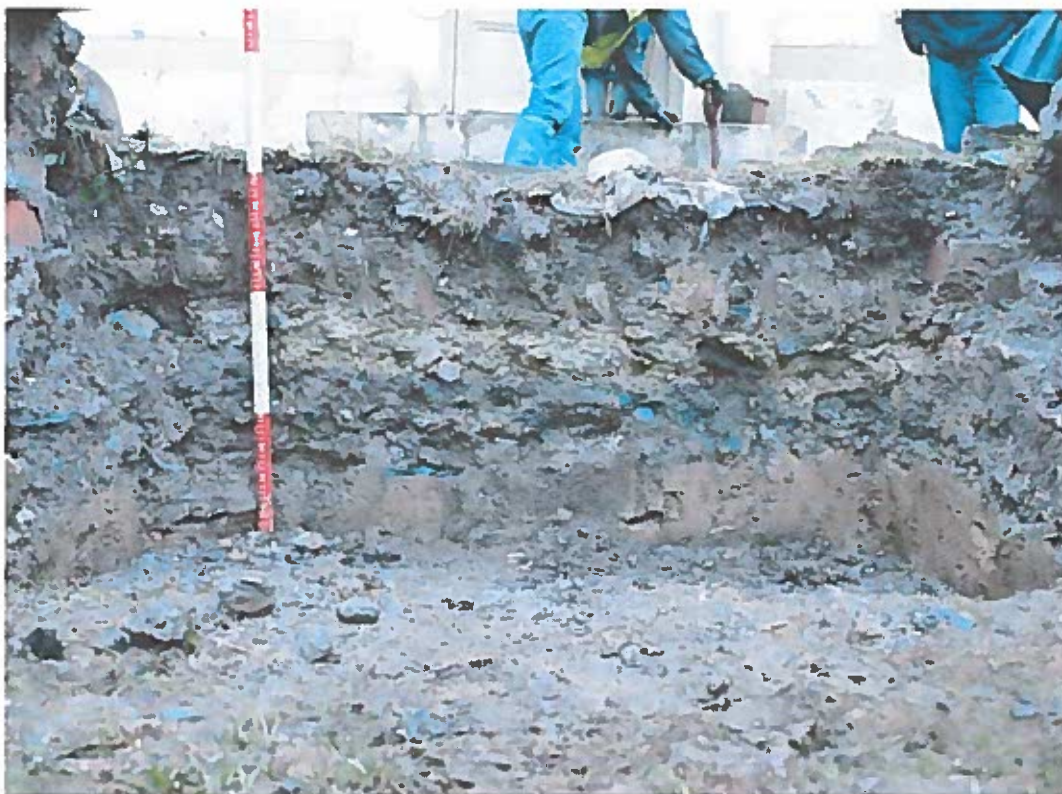
Plate 92. Gilfach-y-berthog - Stratigraphy in front of house alongside former entrance steps (ST3). Looking northwards.

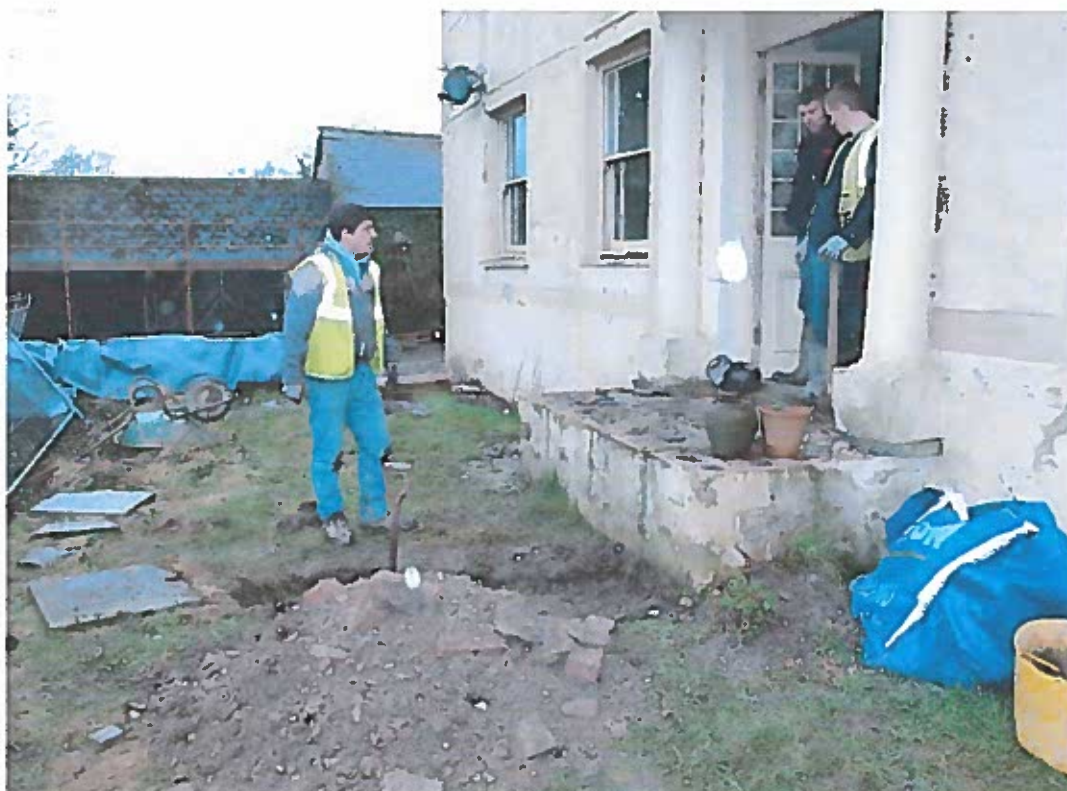
Plate 93. Gilfach-y-berthog - Working shot during groundwork for services (ST3) in front of house. Looking west.

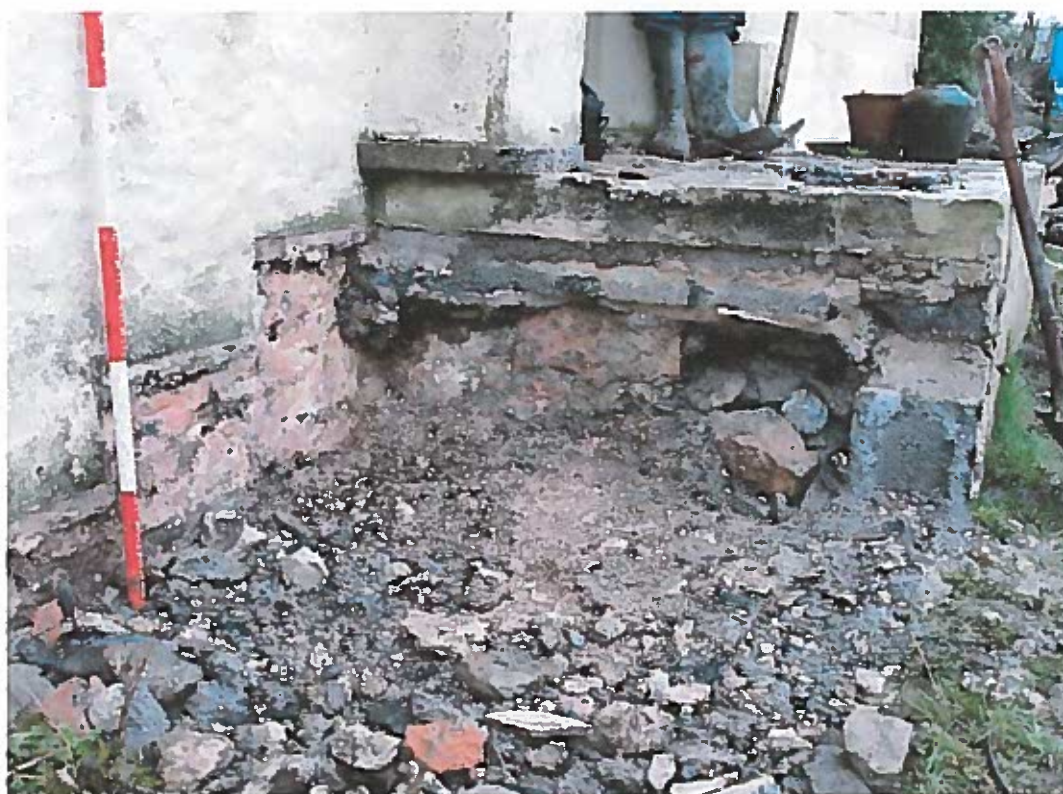
*Plate 94. Galfach-y-berthog - Demolition of former steps at front of house. Looking eastwards.*

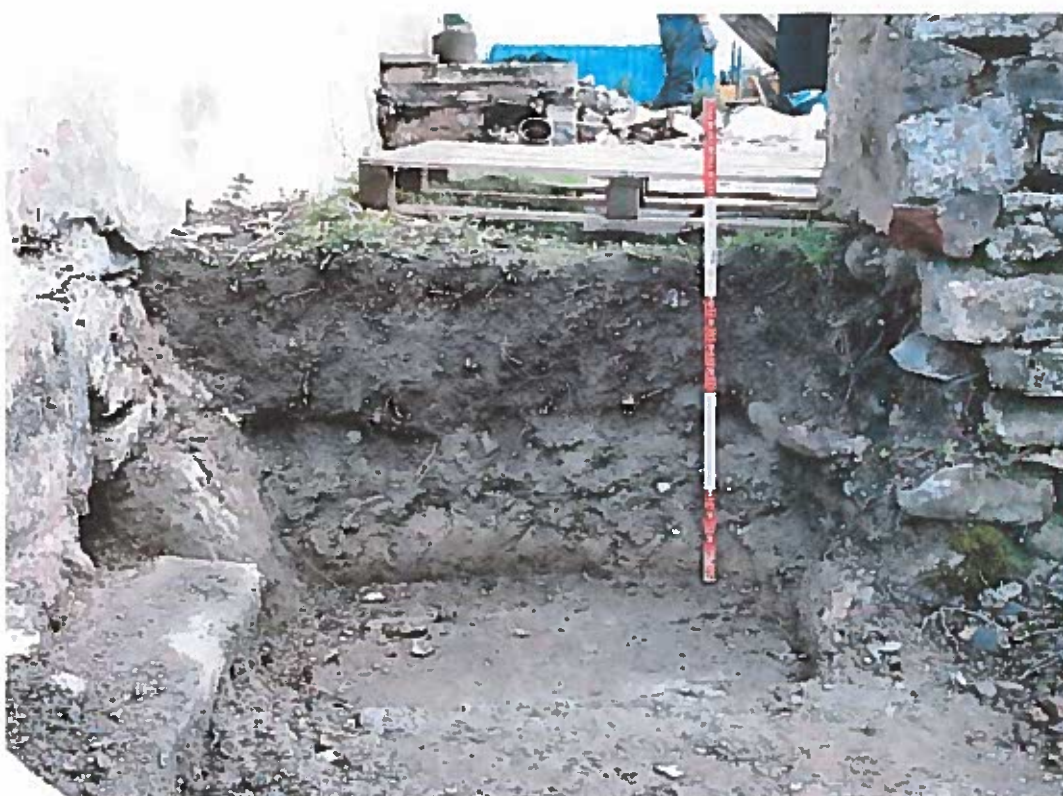
*Plate 95. Galfach-y-berthog - Exposed stratigraphy in raised area alongside front of house. Looking eastwards.*
