## **Tudno Castle Hotel, Vaughan Street, Llandudno**

### Level 2 Building Survey

Report No. 1532

**Prepared For: Tudno Developments Ltd.  
on behalf of Opus Land (North) Ltd.**

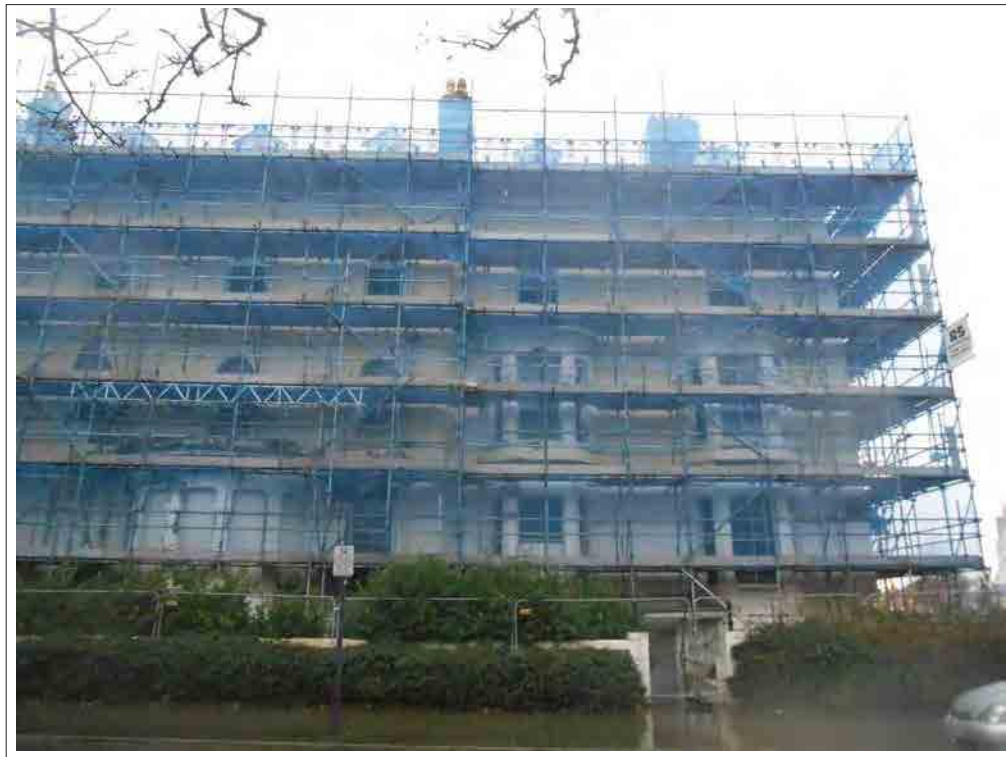
*Plate 8:* This photograph illustrates the first and second bays. Two round-headed sash windows with archivolt are located on the second floor. The basement, ground floor and first floor of the first bay contain canted three-light windows. While the first floor window contains a hipped roof over it, the ground floor window is further defined by a decorated stringcourse. The latter forms a pediment over the second bay ground floor window. A segmental pediment is located over the second floor window. At the time of the survey, all openings from the basement, first and second floor were blocked either by concrete or by wooden boards.

Plate 8. View of Mostyn Broadway elevation, looking S.

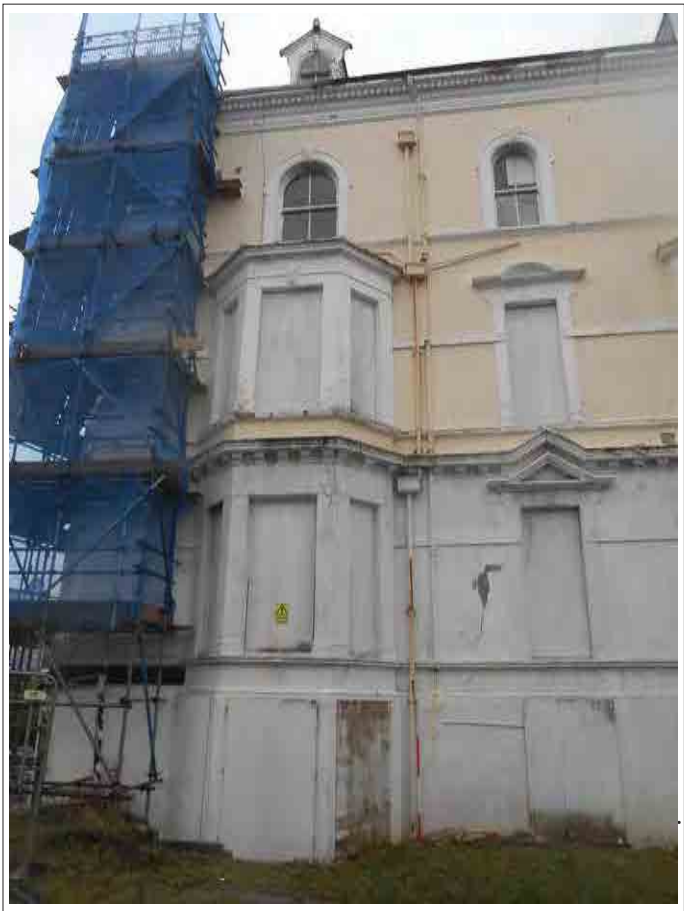
*Plate 9:* This photograph illustrates the third bay. A round-headed sash window is located on the second floor, while the remaining windows are canted three-light windows. Resembling the first bay, the second floor window was a hipped roof over it and the ground floor window is further garnished by a decorated stringcourse running over it. A quoin defines the edge of this projected area. All windows from the basement to the first floor included are currently blocked either by concrete or by wooden boards.

A building addition is also illustrated on this photograph. This addition was the space for toilet facilities on the basement area and for a kitchen on the first floor, at least during the last use of the building. A detailed examination of this addition from the view depicted on Plate 9 suggests that the existing wall was first constructed as a concrete masonry wall which was initially coated with light yellow render. A further event of rendering is observed on this wall. Given the materials used to construct the extension, it may be suggested that the latter dates to the early to mid-20<sup>th</sup> century. However, a detailed examination of historic maps suggests that an extension on this area already existed as early as 1890s (see Figure 2).

Plate 9. View of eastern elevation, looking NW.

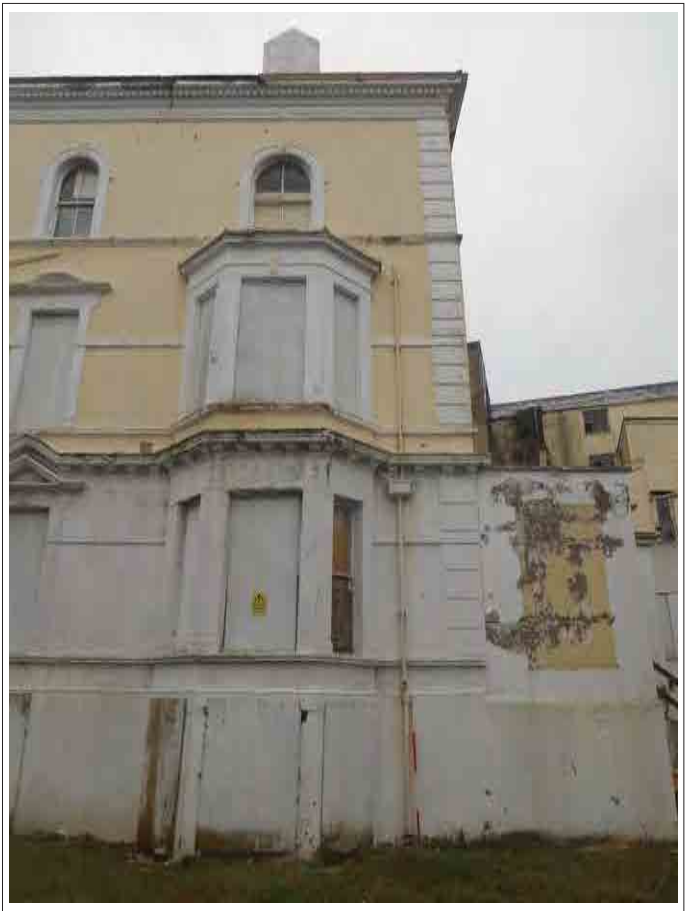
*Plate 10:* This image depicts another face of the original building as well as the extension already introduced on Plate 9.

A close view of the extension allows defining multiple events of alteration. The oldest evidence is found with a flight of stairs. These stairs appear depicted in historical maps dating to the 1890s. However, this entrance was blocked at the time in which the extension ceased to be defined by a rectangular space to be defined as T-shape in plan. At this point, a window and a door are cut through the main wall. These elements still are visible to date however are currently blocked by wooden boards. The flight of stairs leading to the existing door is no longer in place. However, it may be noted that these stairs existed, at least, until the time in which the latest drawings for the side were made (see Figure 5).

Plate 10. View of eastern elevation, looking NW.

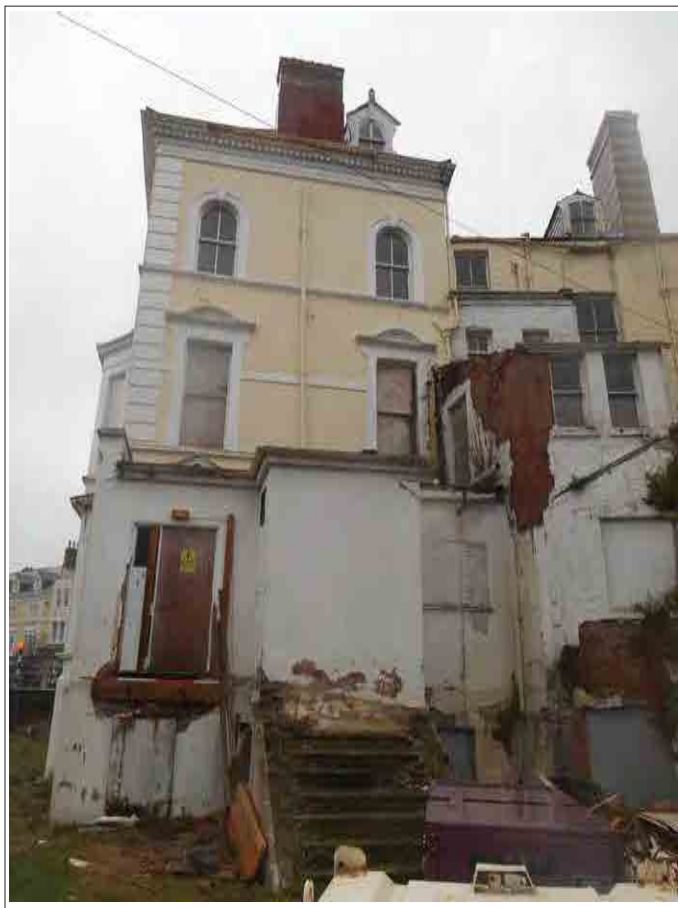
*Plate 11:* This image depicts some of the original building layout as well as another extension which, judging from the brickwork and from historical maps (see below) can be dated to the early 1900s.

Plate 11. View of extension 1, looking NW.

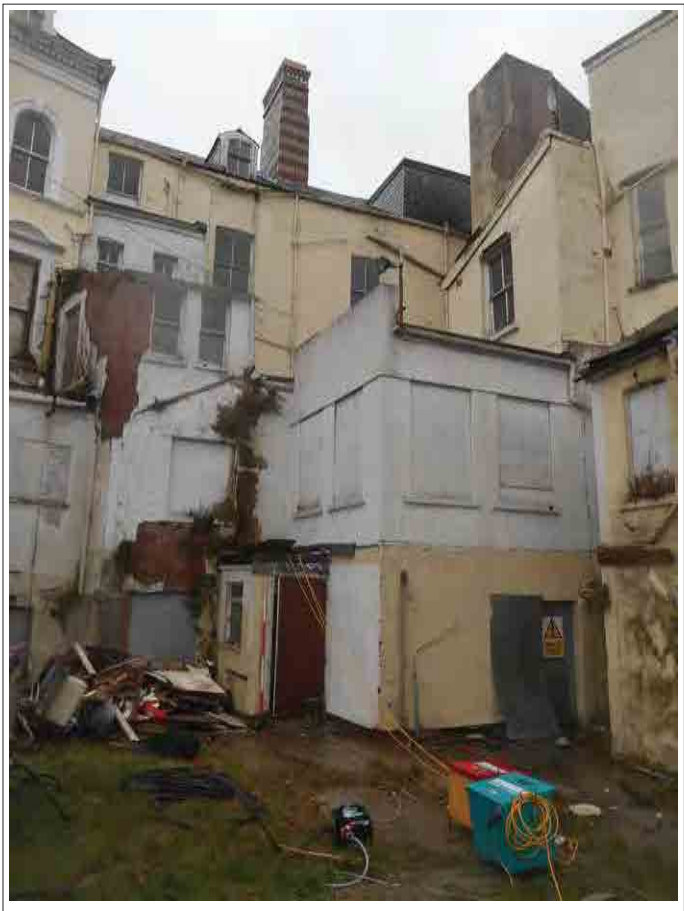
*Plate 13 and 14:* Plate 13 illustrates another view of the extension described in Plate 12. It also illustrated the corner of a further extension to the main building. The latter is best illustrated on Plate 14.

Plate 13. View of extension 2, looking NW.

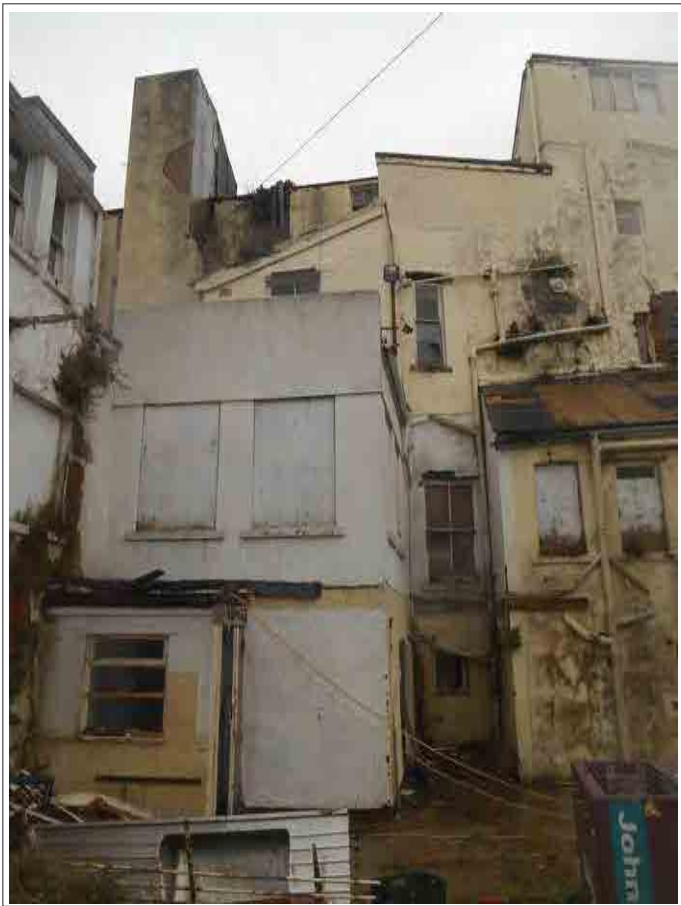
Plate 14. View of extension 2 and 3, looking N.

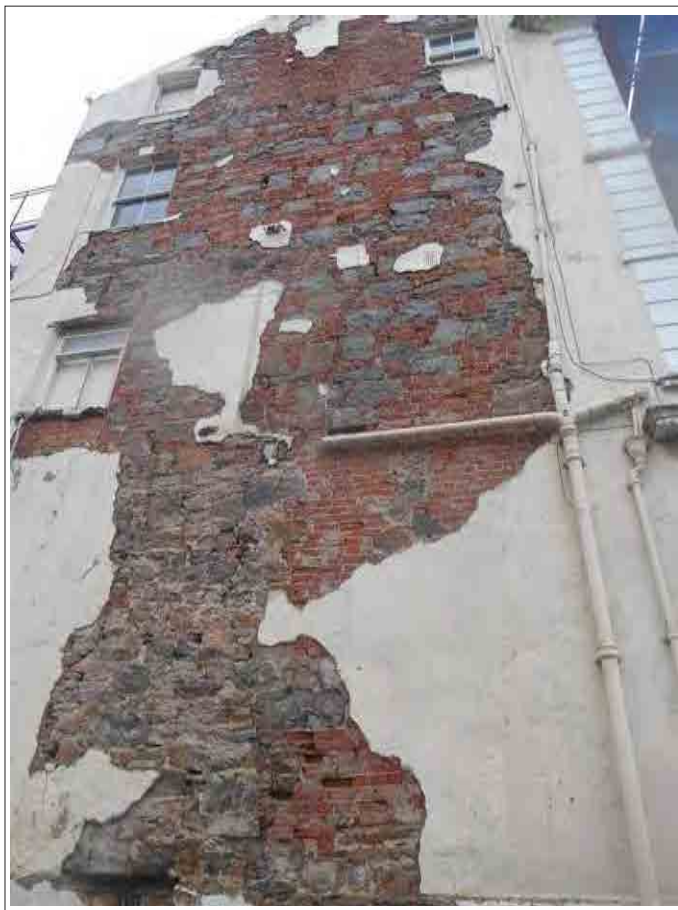
Plate 17. Detail of wall construction and alterations, looking W.

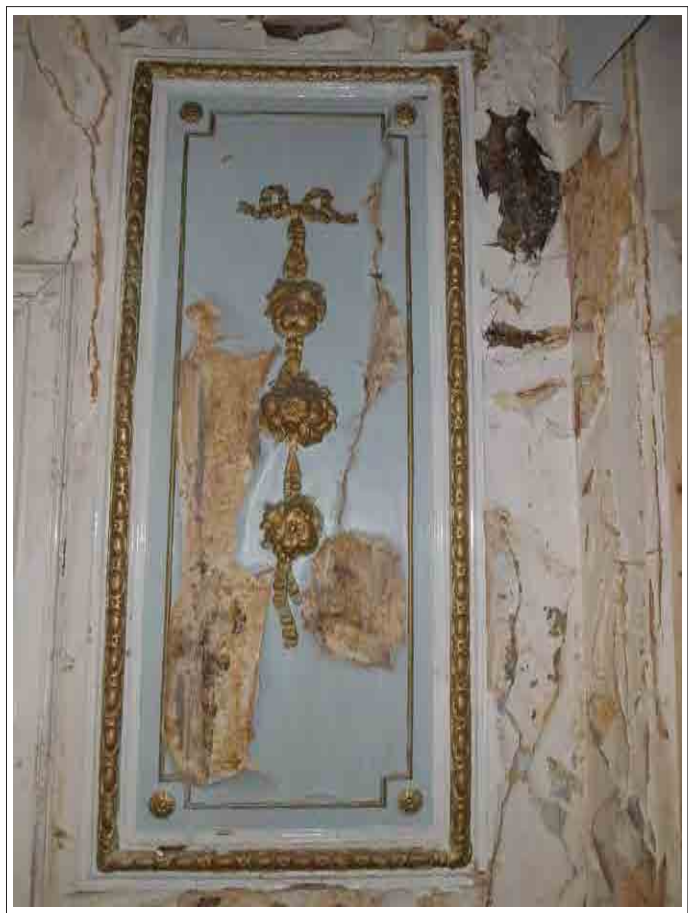
Plate 20. Detail of decorated panel adjacent to blocked door, looking S.

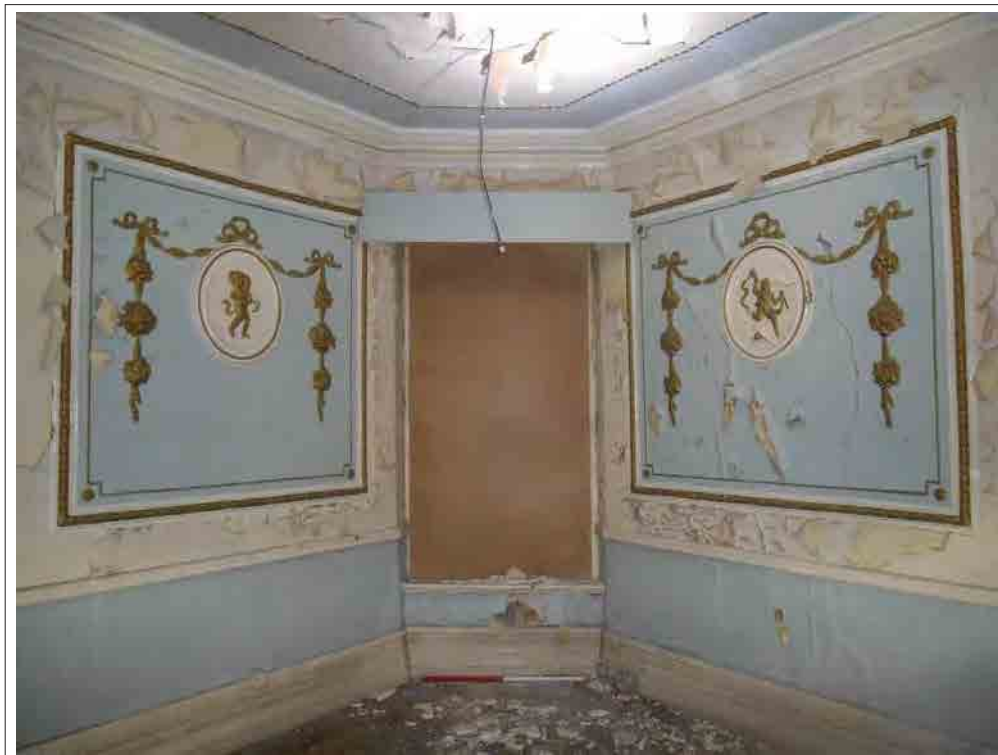
Plate 24. Blocked sash window from ballroom, looking SW.

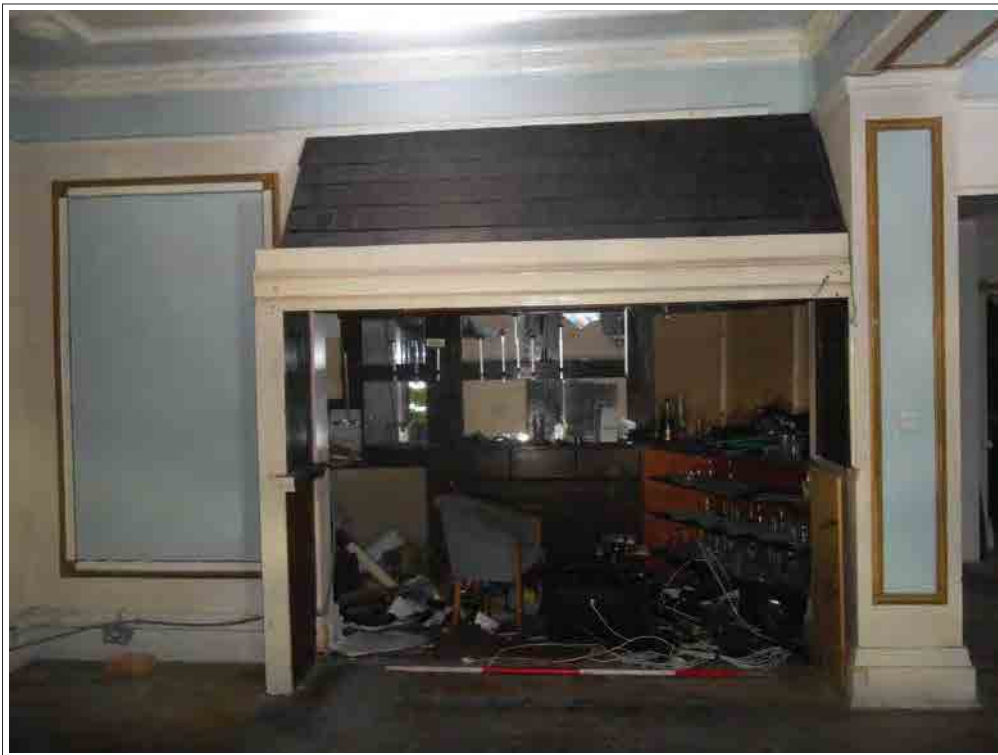
*Plate 29:* The bar appears to be a later addition to the space of the ground floor. All fittings, fixtures and appliances appear to be modern. The bar is covered by a single pitch slate roof.

Plate 29. Bar area, looking E.

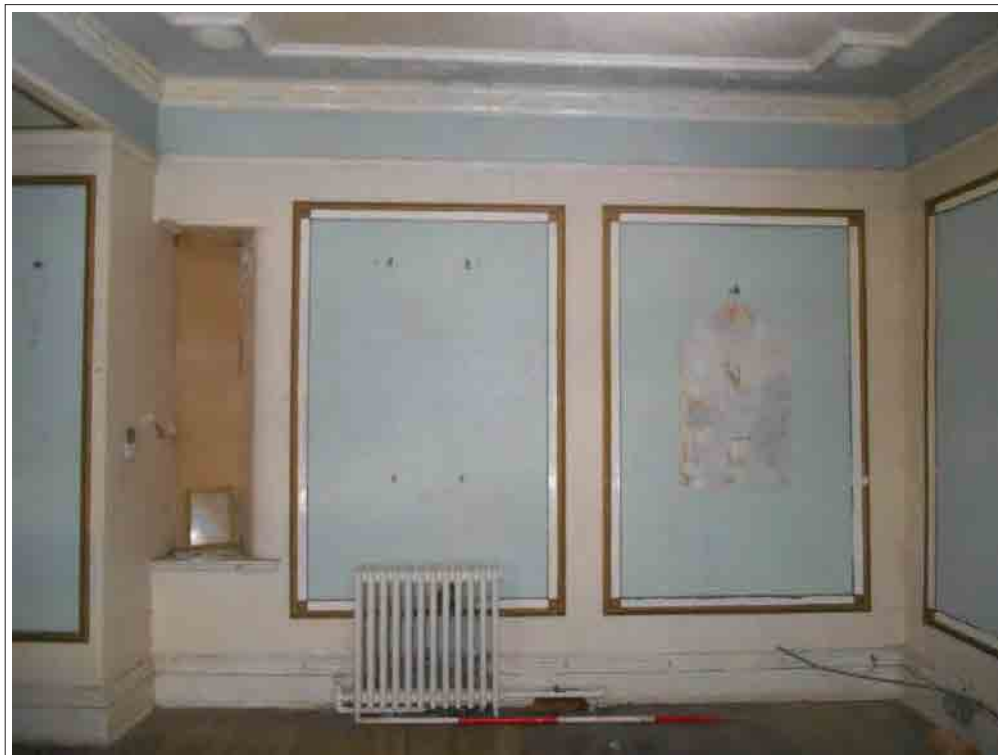
*Plate 30:* This plate illustrates a window opening currently block by wooden boards which had previously been partly obstructed by the construction of a projecting wall related to the bar area.

Plate 30. Detail of blocked window using projected wall, looking SW.

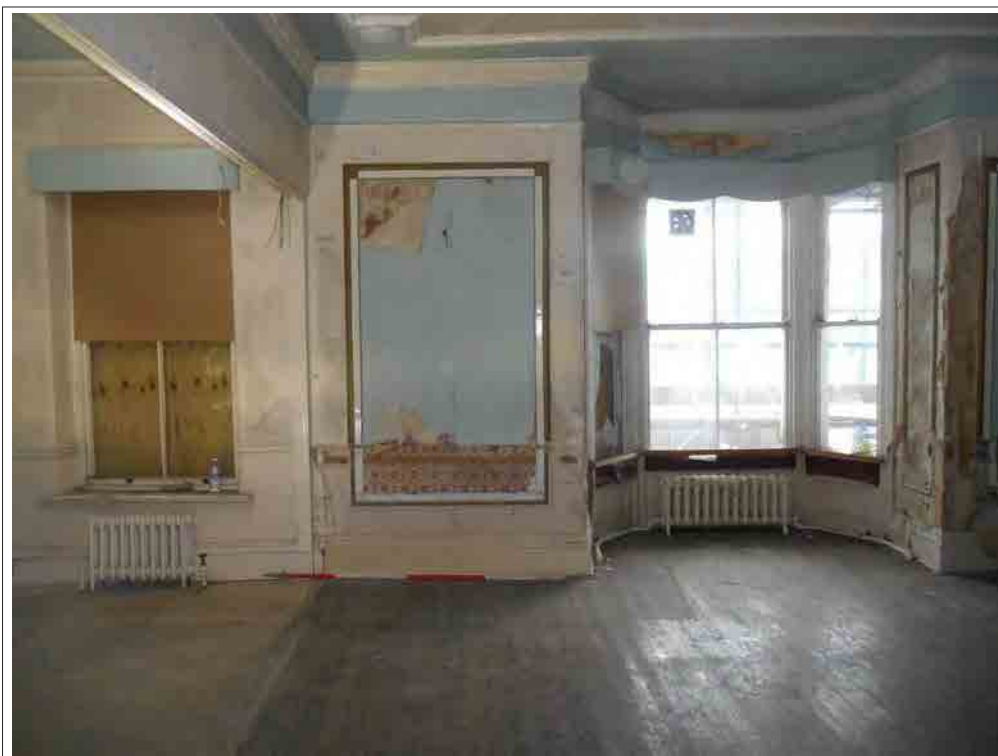
*Area A (Plates 32 and 33):* As already noted, this area appears to respect the general decoration encountered throughout the ground floor. However, it is noted that, in contrast to the ballroom and bar, this area contain the characteristic rectangular panels on the walls without any further decoration within the panels. Moreover, similarly to that stated in Plate 31, resulting from decay, it is possible to observe previous decorative episodes characterised by wall paper floral geometric patterns.

Plate 33. Detail of wall evidencing different layers of decoration, looking NW.

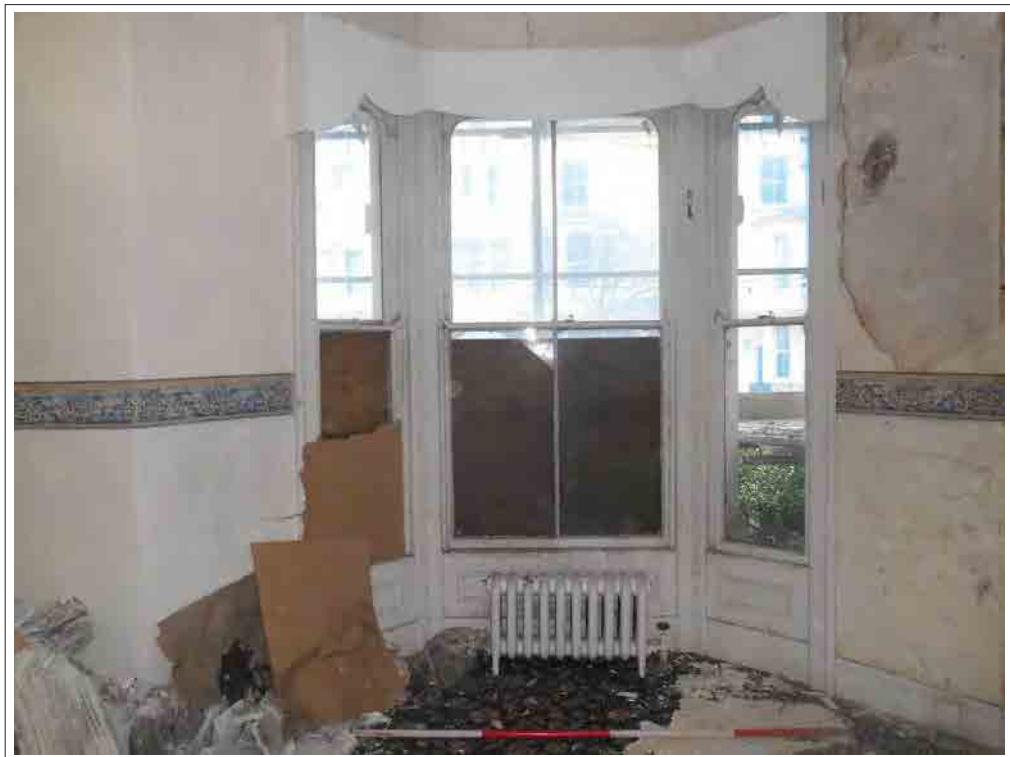
*Plate 41:* This image illustrates a canted three-light window with upper curved corners and step straight curtain mouldings. Contrastingly, plate 43 illustrates scalloped curtain mouldings.

Plate 41. Canted three-light window. Looking W.

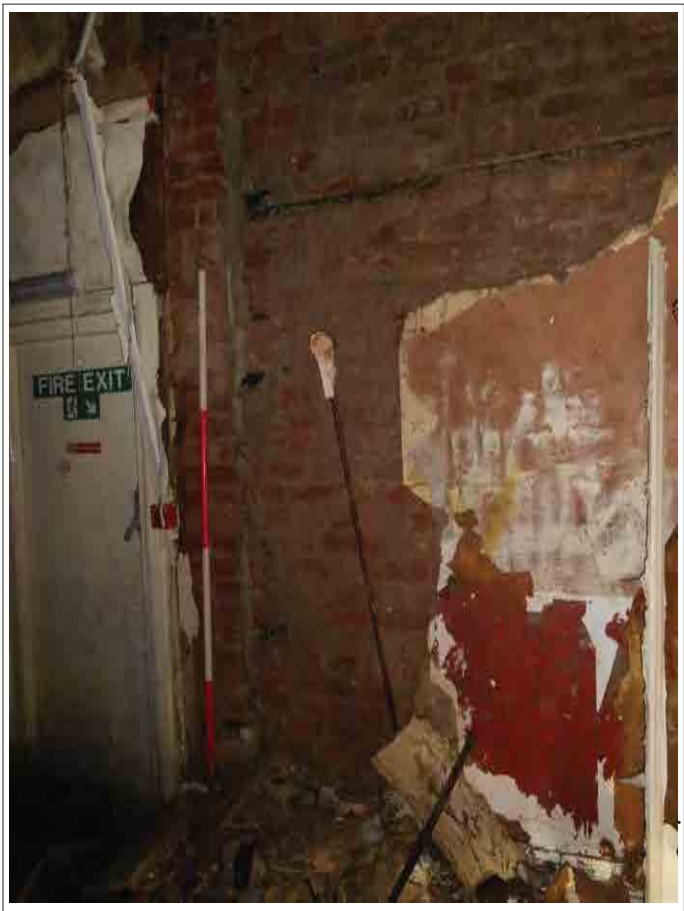
*Plate 50 and 51:* These images depict earlier decoration and original structural components displayed as result of decay. Plate 50 illustrates the existence of earlier floral patterned wall paper and Plate 51 displays the walls original brickwork.

Plate 50. Detail of wall paper and mirror decoration, looking ESE.

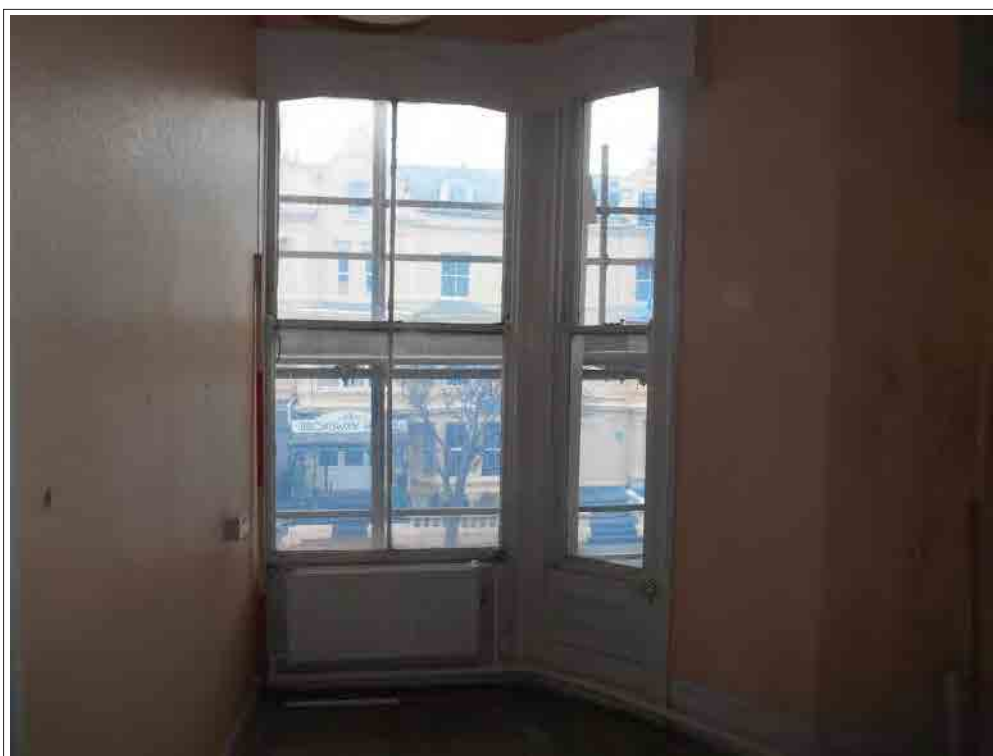
A major alteration event is observed in this room with the construction of an en-suite bathroom. Plates 68 and 70 evidence the division of the canted three-light window of this room by one of the bathroom walls. While two thirds of the window remain within the room, one third becomes the window opening for the bathroom. Furthermore, resulting from decay, it is possible to see the remains of the original fireplace in this room (see Plate 69). A similar situation is found in Room 7 (see Plate 71).

Plate 68. View of Room 8. Storeyed canted three-light window blocked by wall addition, looking N.

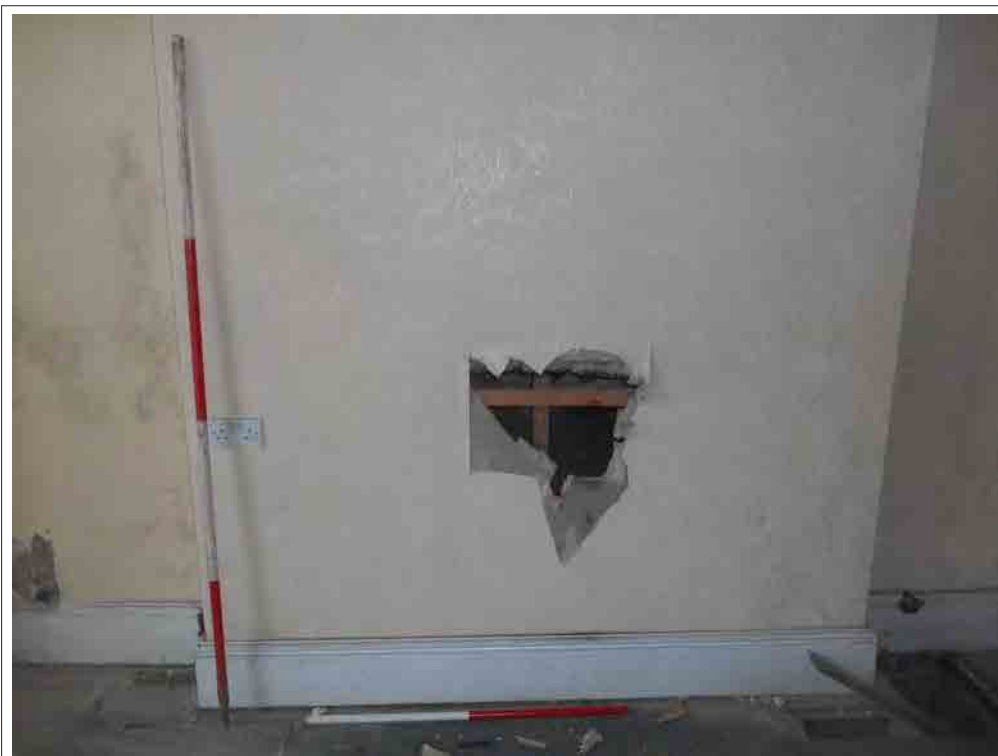
Plate 69. Location of original fireplace. Room 8, looking E.

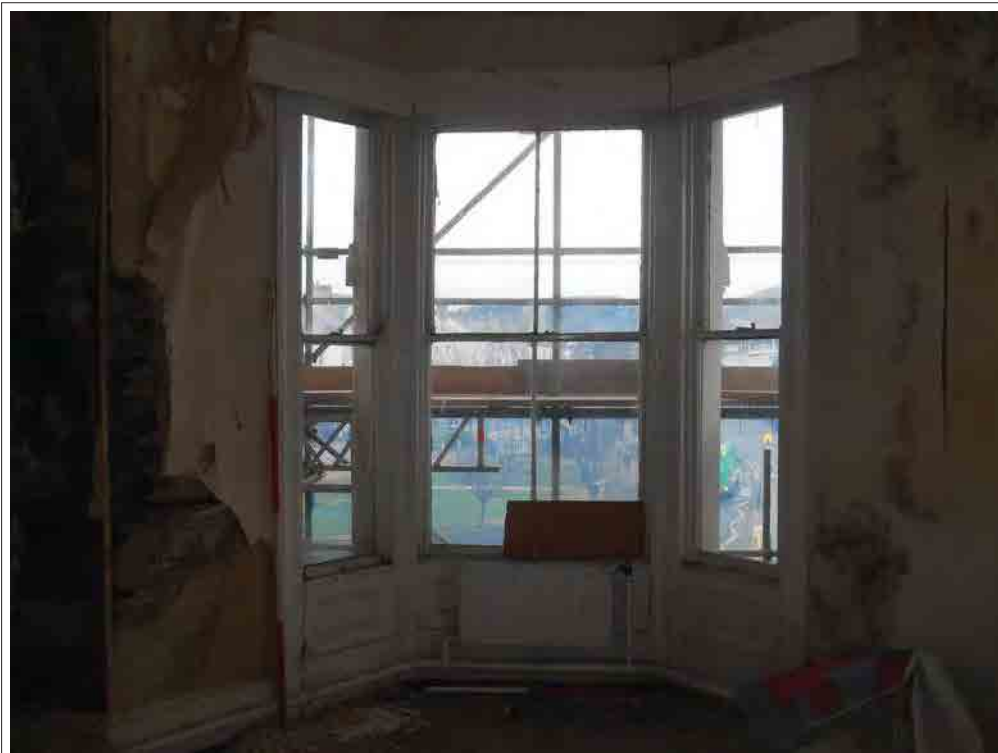
Plate 71. View of Room 7 with storeyed canted three-light window, looking W.

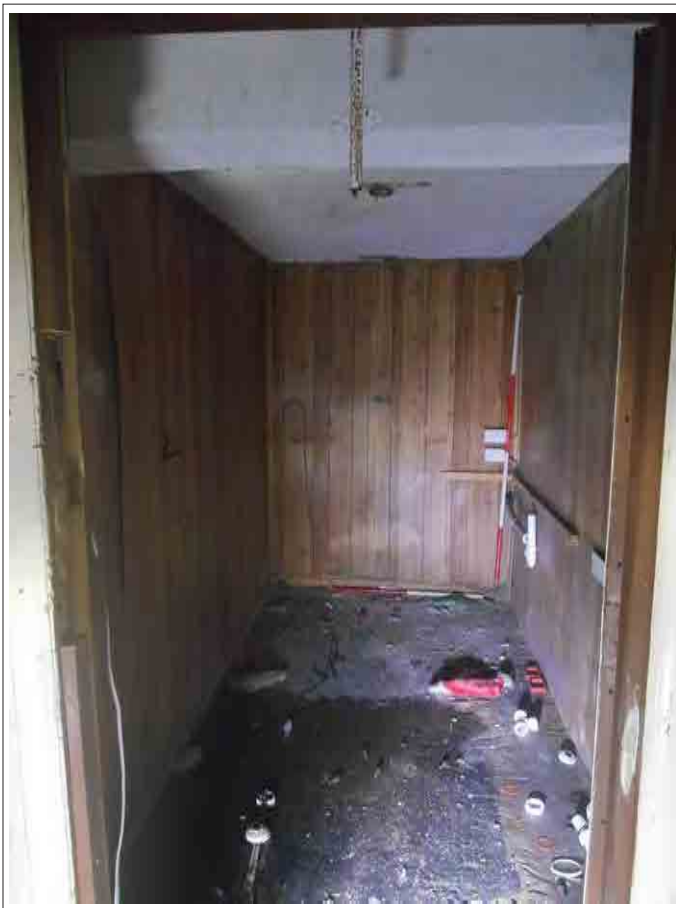
Plate 108. View of basement corridor, looking W.

*Plate 108:* This image shows the view of the main basement corridor. Spaces are found at either side of it. All rooms N of corridor belong to the original layout of the hotel and despite having suffered multiple events of repair and alteration, they were originally hotel rooms. In contrast, rooms to the S of the corridor are established within the extension areas and mostly correspond to kitchen, cellars and other spaces reserved for the hotel staff.

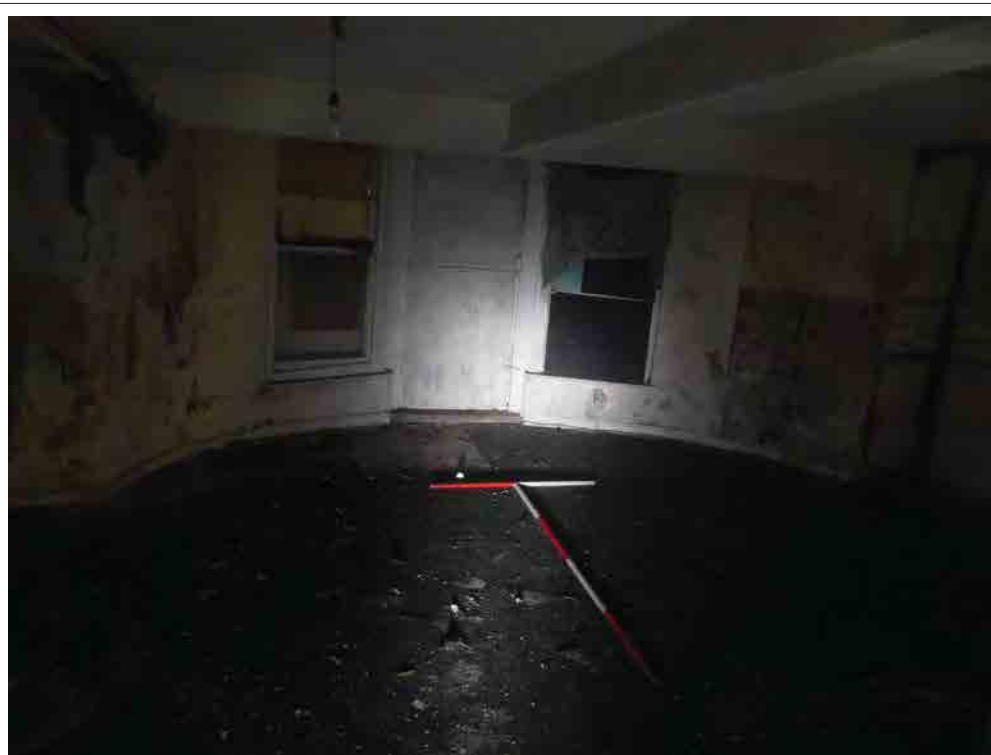
Plate 109. View of room addition, looking ESE.

*Plate 109:* This image shows the layout of an addition created within one of the main basement rooms. This rectangular space has its walls covered by wooden boards and all its fittings and fixtures appear to be modern. The lack of material associated to this room make it difficult to determine its function.

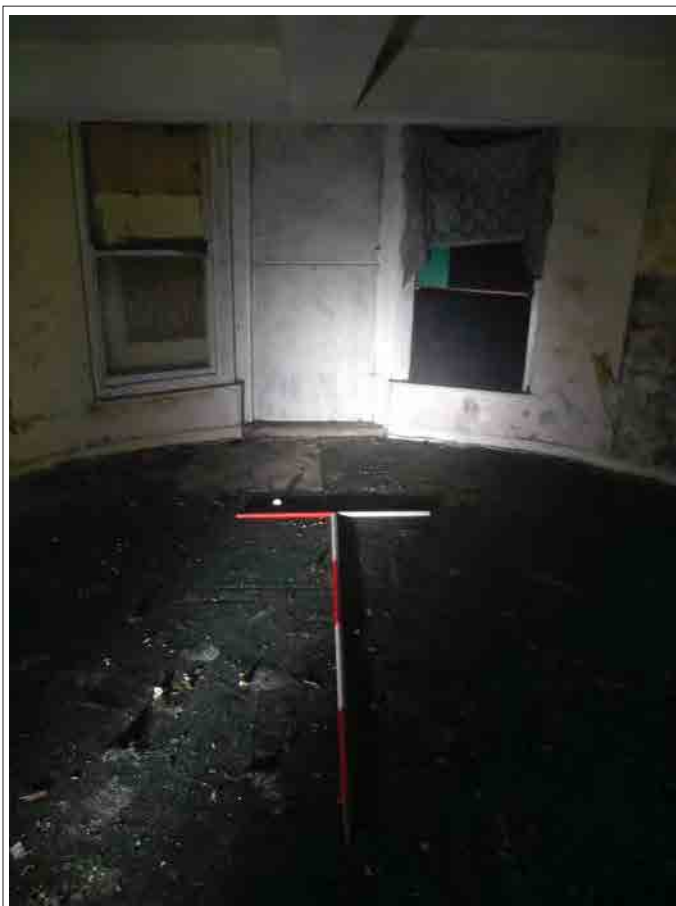
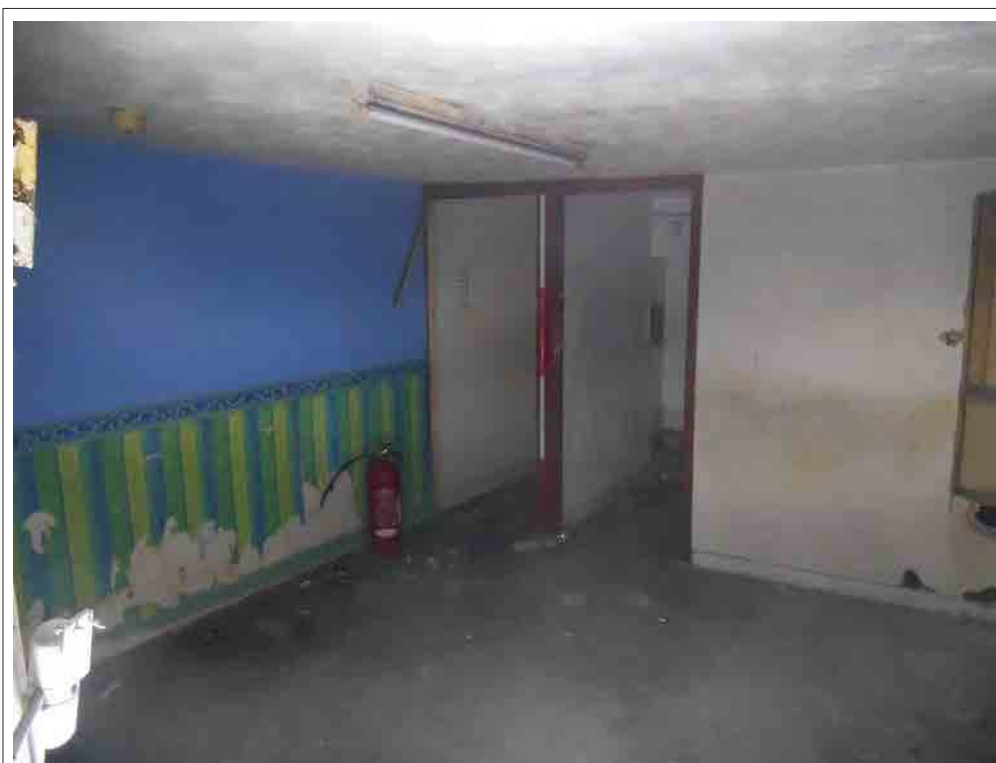
*Plate 110:* This image illustrates one of the canted five-light windows located within the area of the basement. This window is currently blocked off by wooden boards. While the room appear to have been painted white during its last stages of use, resulting from decay, it is possible to observe different events of wall paper decoration.

Plate 110a. Canted five-light window currently blocked, looking NE.

Plate 110. Canted five-light window currently blocked, looking NE.

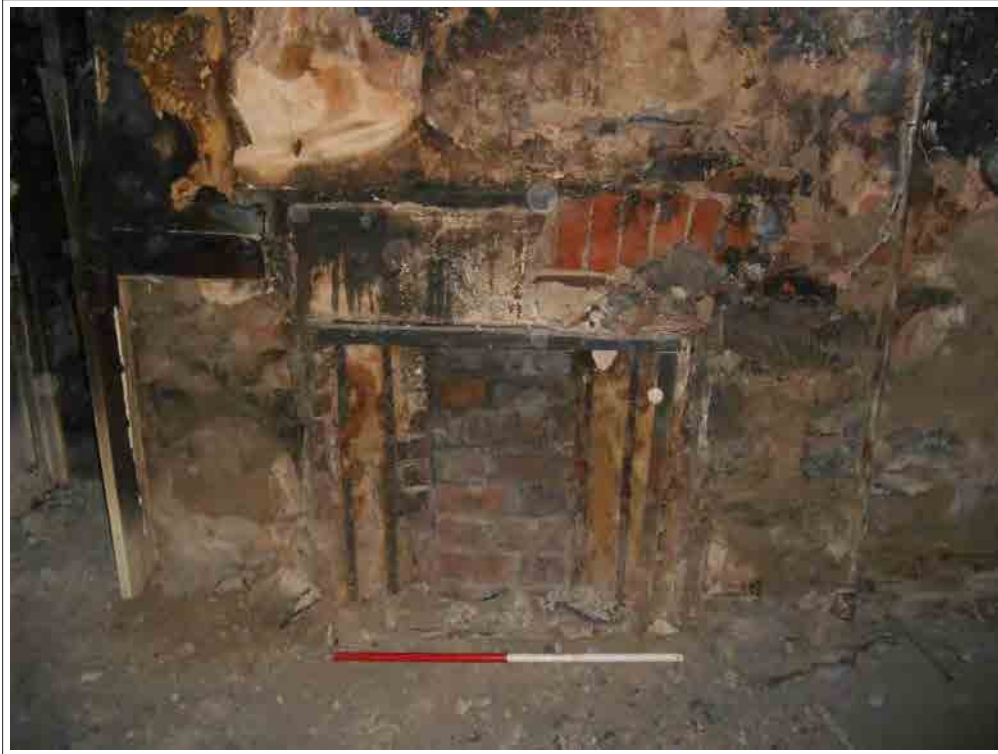
*Plate 126 and 127:* These images illustrate one the surviving rooms from the basement area. An examination of this space allow noting that this room was badly damaged as result of a fire. Despite its derelict state, it was possible to identify an original fireplace blocked off by course of bricks and a caned three-light window currently blocked off by wooden boards.

Plate 125. Original construction materials, looking NNE.

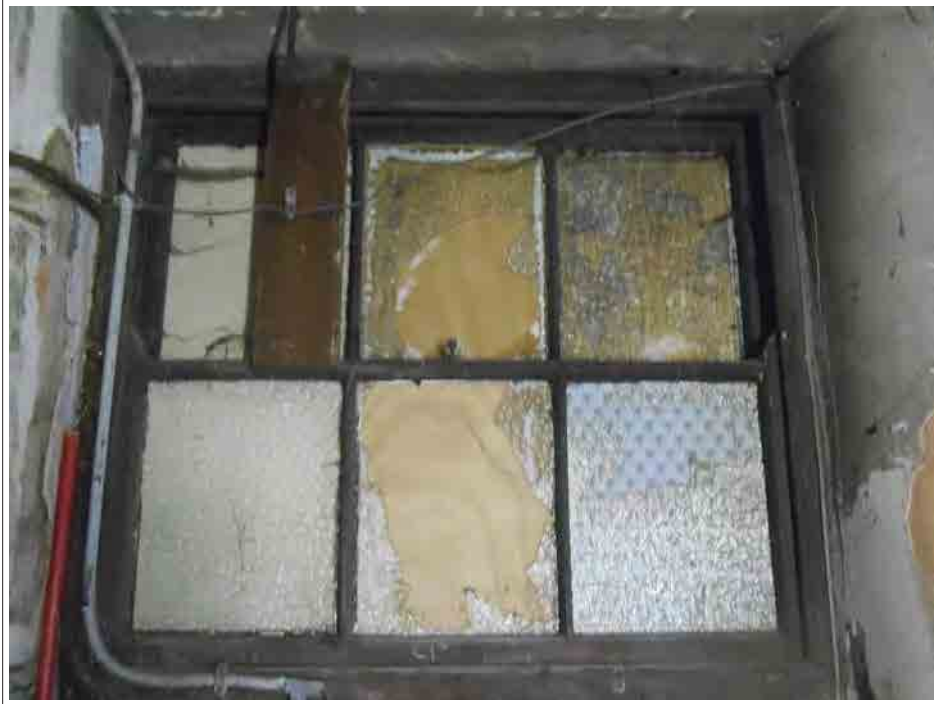
Plate 133. Remains of early door, subsequently transformed into a window which is currently blocked. Eastern facing interior wall.

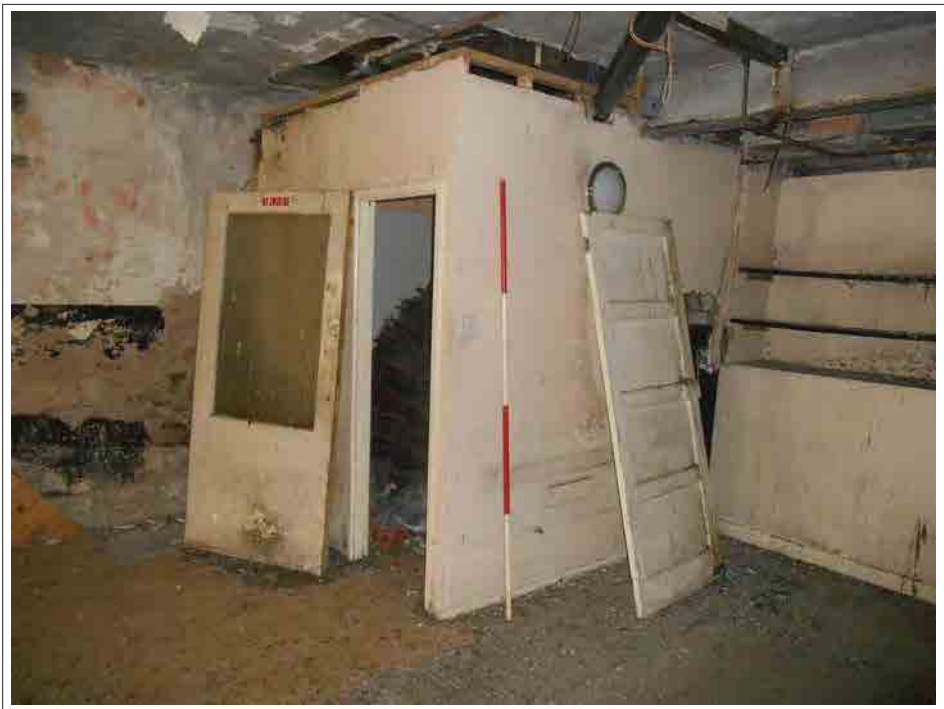
Plate 137. North facing wall. Inset blocked window transformed into shelving.

136	East facing wall. 1960's window subsequently repaired. North facing wall with back entrance. Not original.
137	North facing wall. Inset blocked window subsequently transformed into shelving.
138	Modern studded wall. Facing W.
139	West facing wall.
140	West facing wall with dado rail.
141	Possible vent, west facing wall.
142	West facing wall.

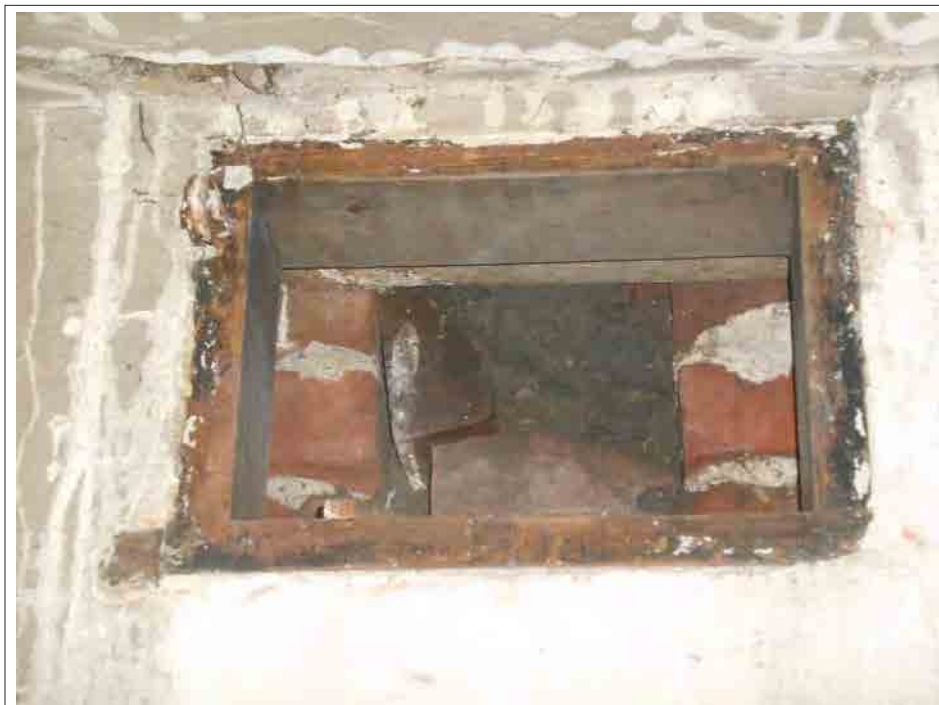
Plate 143. Blocked vent, west facing wall.

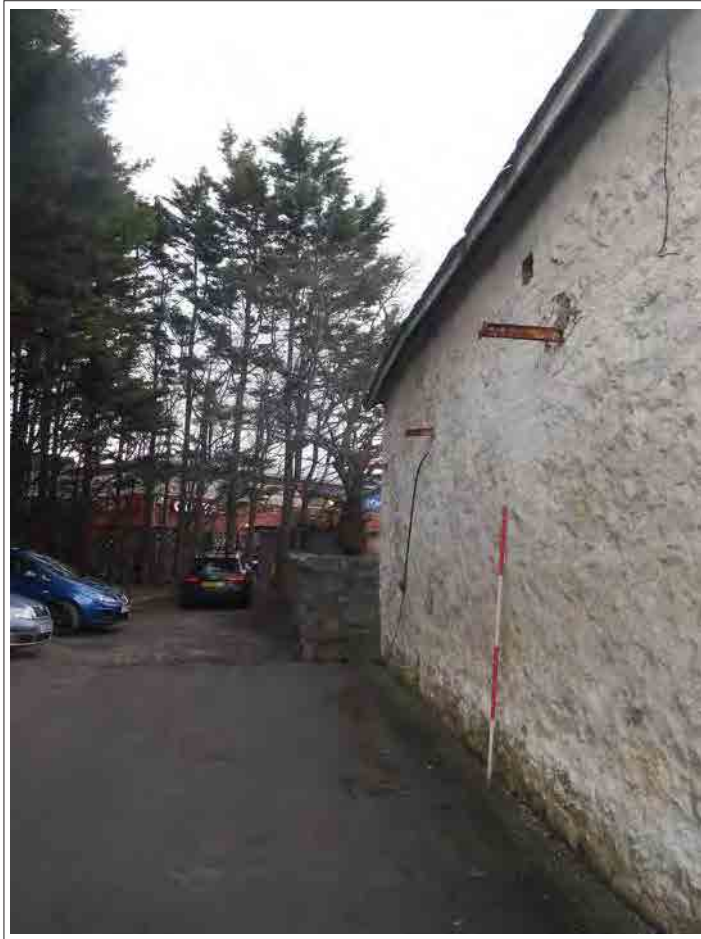
Plate 149. Detail of repair or alteration of possible window or vent.

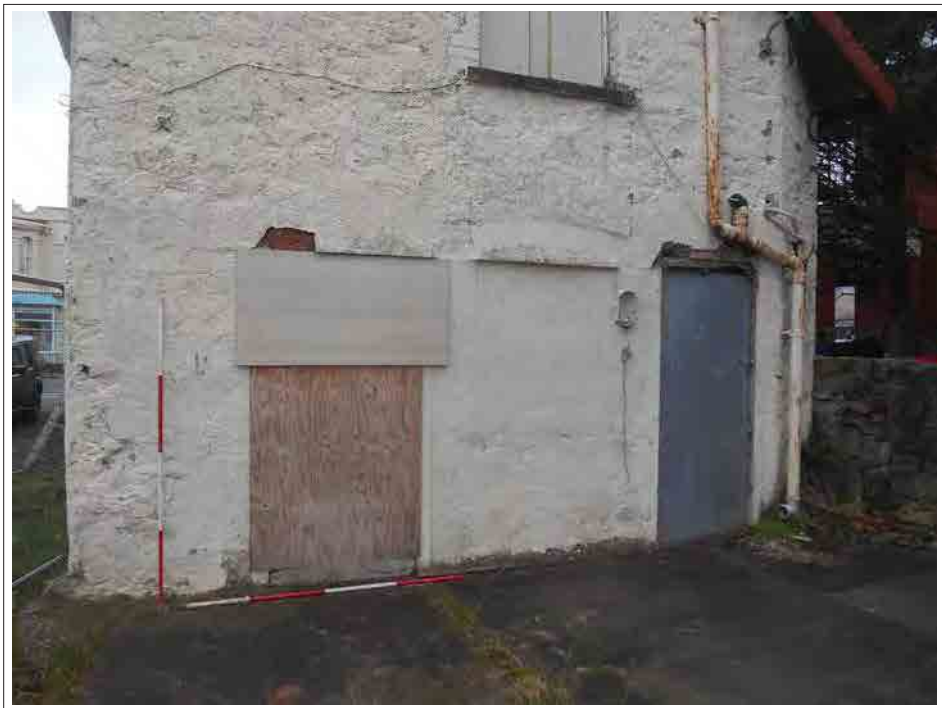
Plate 151. View of back entrance. Windows and doors are not original and demonstrate a number of alterations over time. 1960's hoods. First floor window with reveal toothed brick effect. Scales 2 x 2m

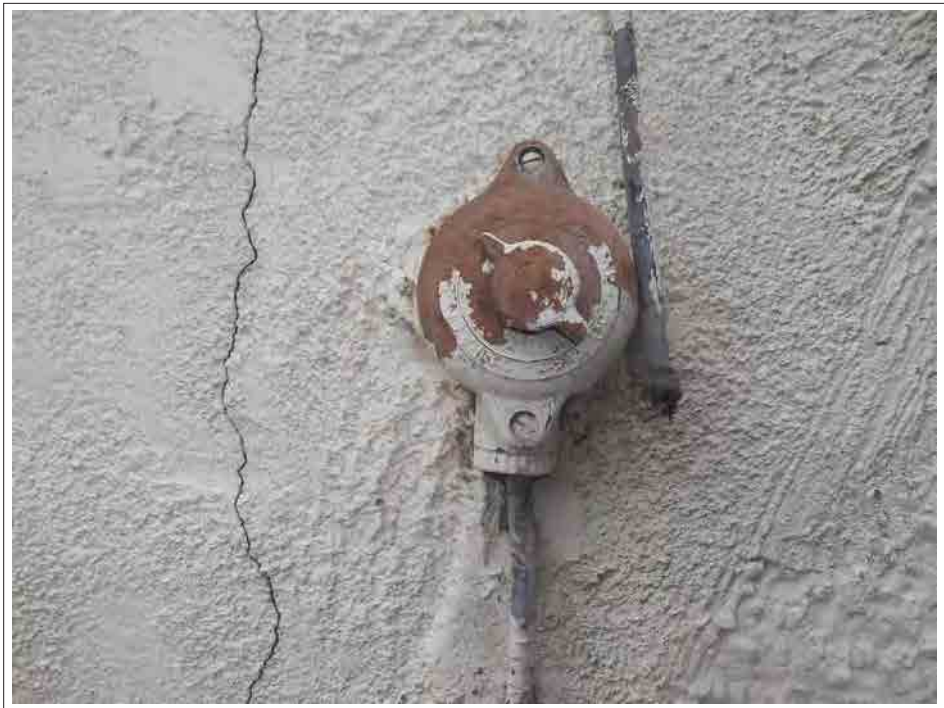
Plate 157. Detail shot of switch.

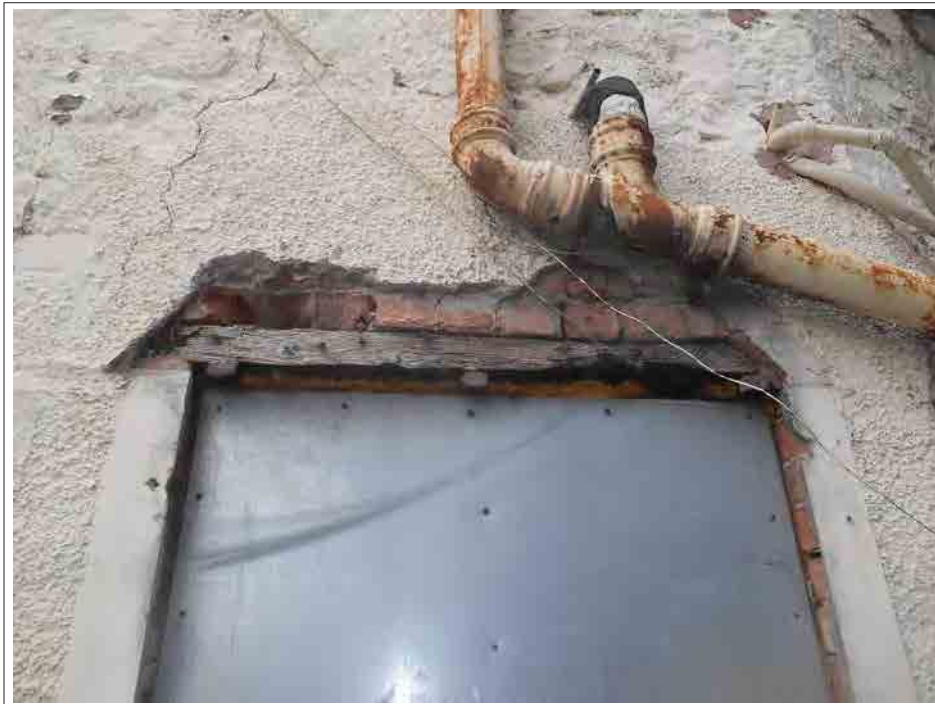
Plate 158. Detail of wooden lintel.

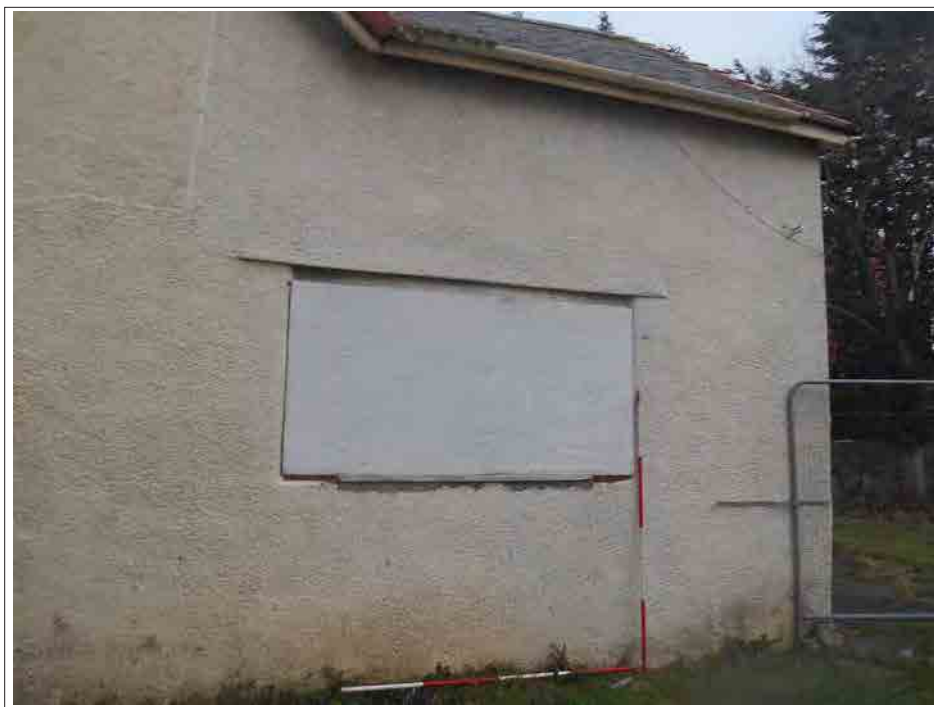
Plate 159. 1960's Window with hood. Pebble dashed wall, east facing.
