## **Tudno Castle Hotel, Vaughan Street, Llandudno**

### Level 2 Building Survey

Report No. 1532

**Prepared For: Tudno Developments Ltd.  
on behalf of Opus Land (North) Ltd.**

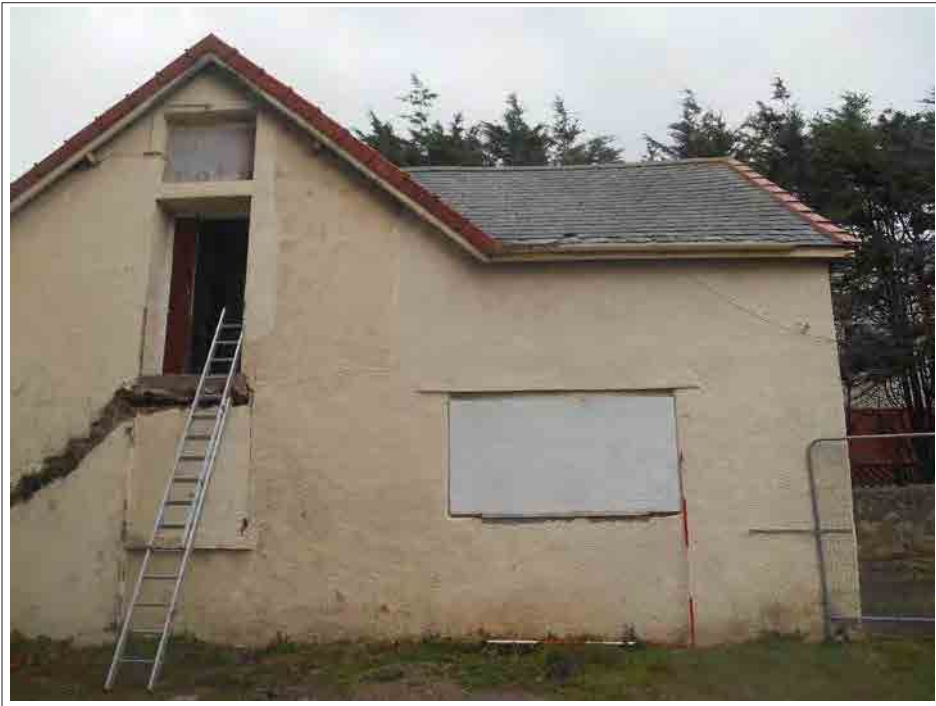
Plate 160. View of east facing wall.

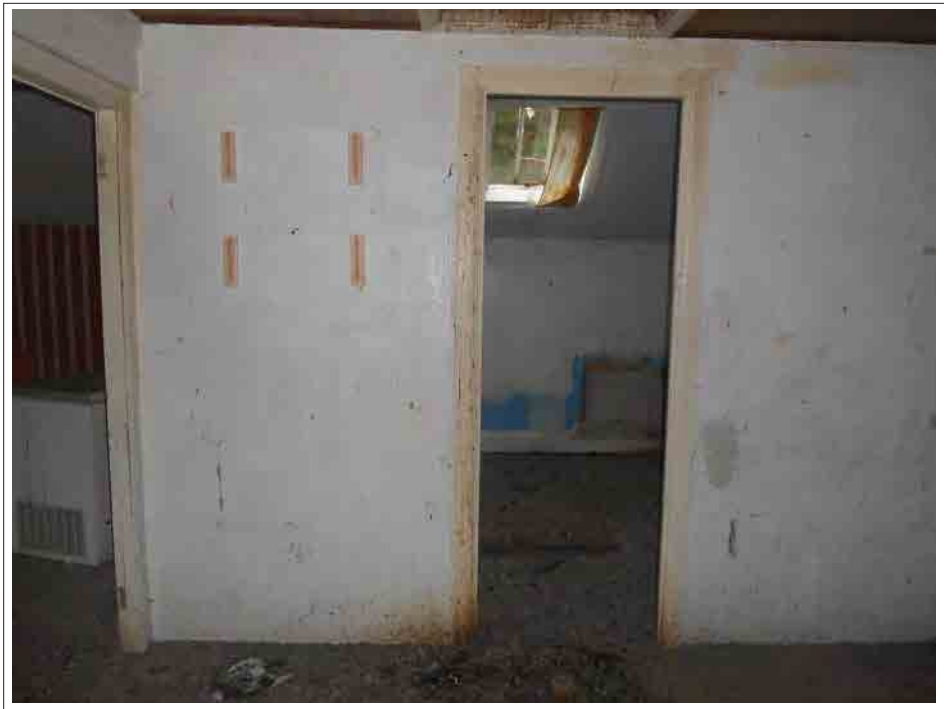
Plate 161. First floor, looking west.

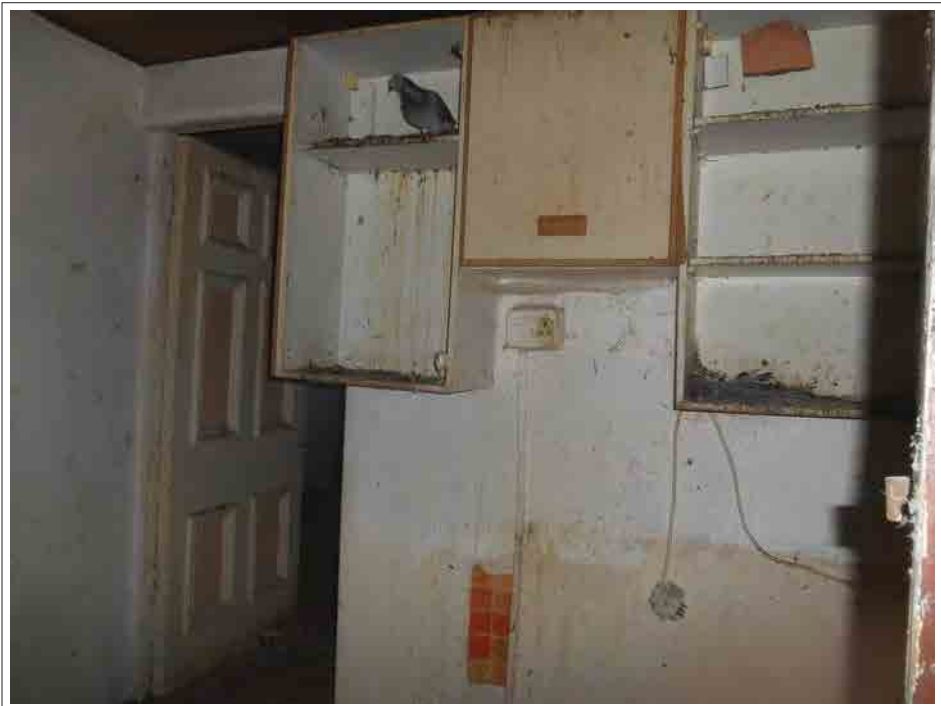
Plate 162. First floor, looking south.

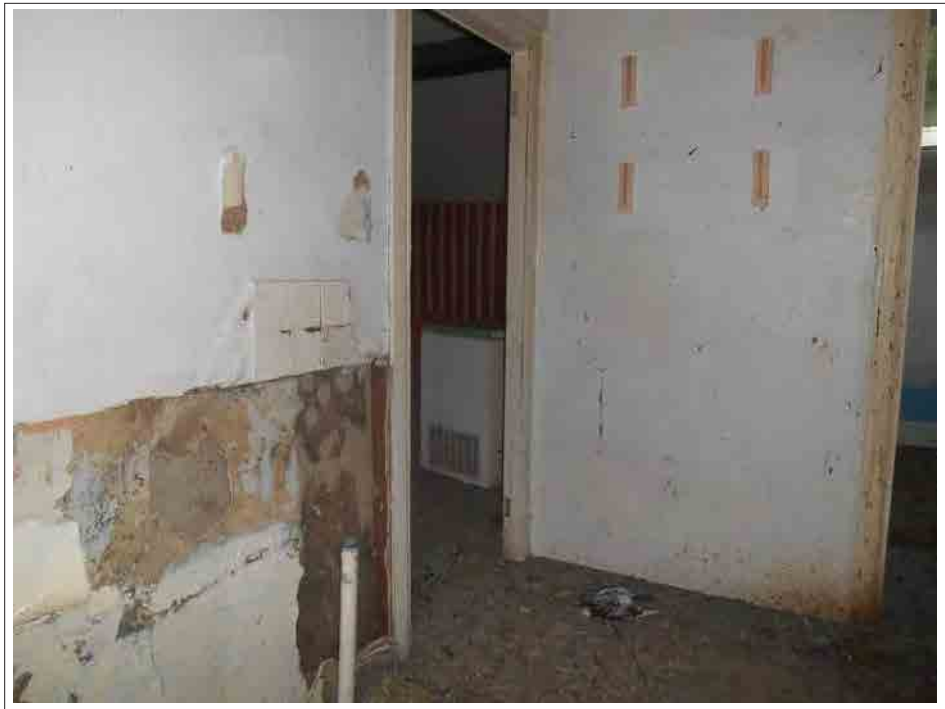
Plate 163. First floor, looking north.

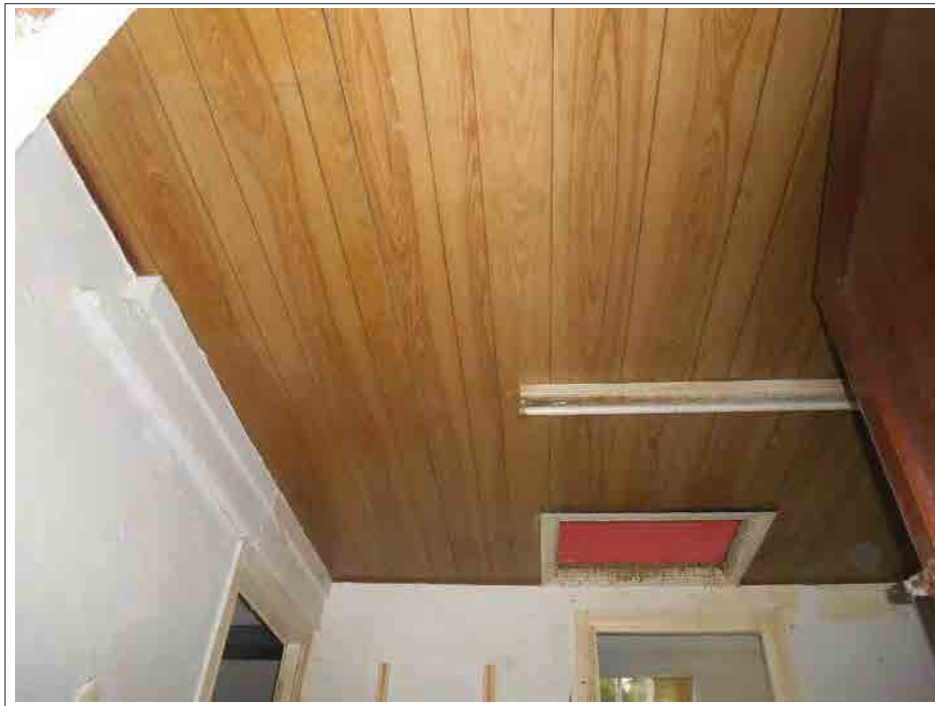
Plate 164. First floor sealing.

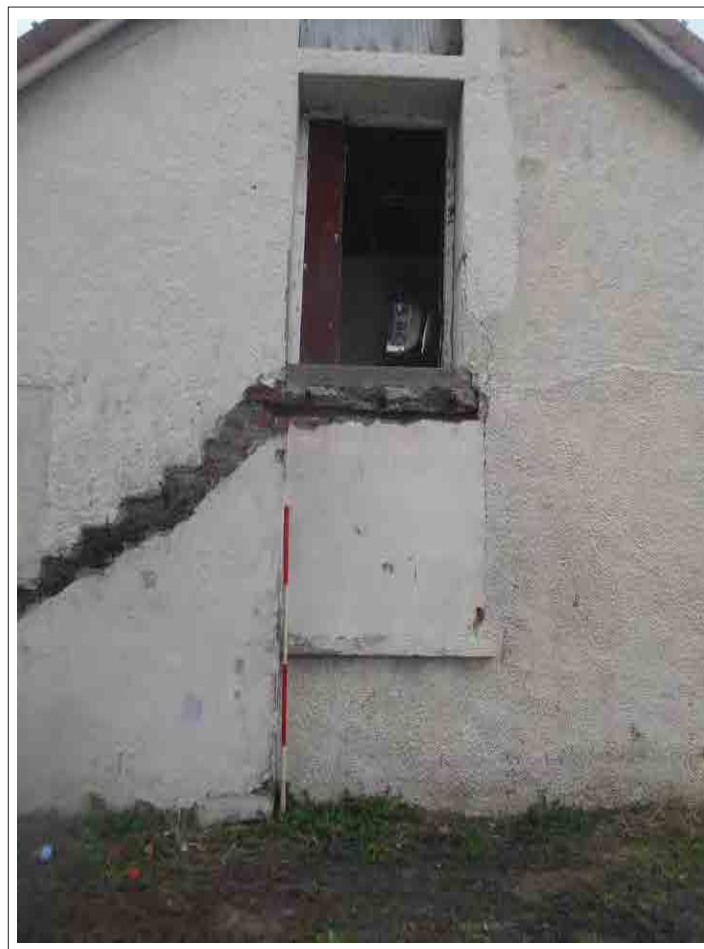
Plate 165. Detail of first floor door and exterior stair case, east facing wall.

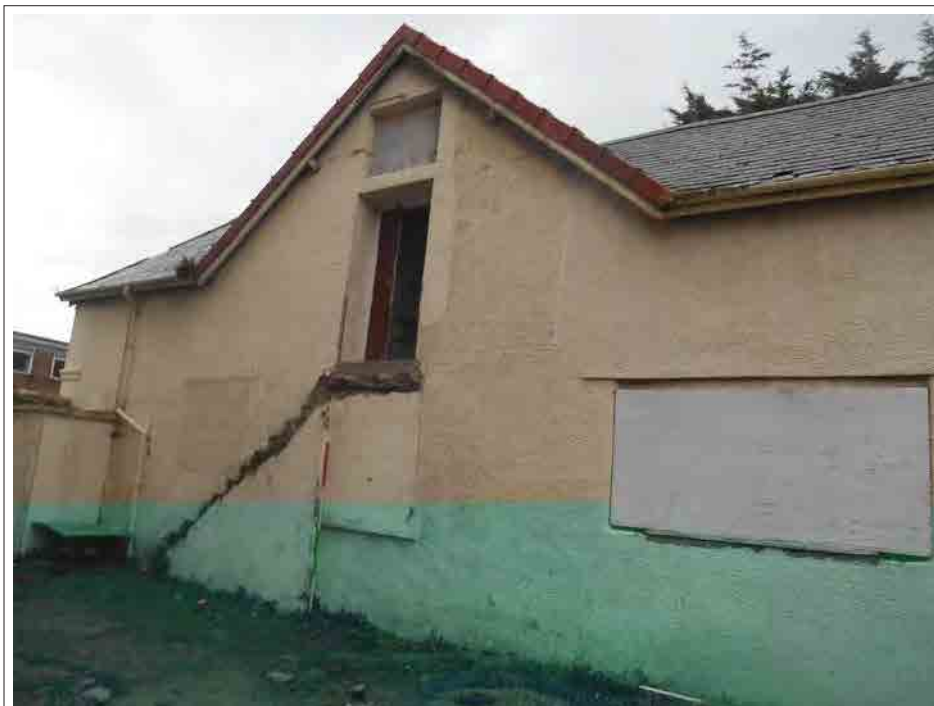
Plate 166. Detail of first floor door and exterior stair case, east facing wall.

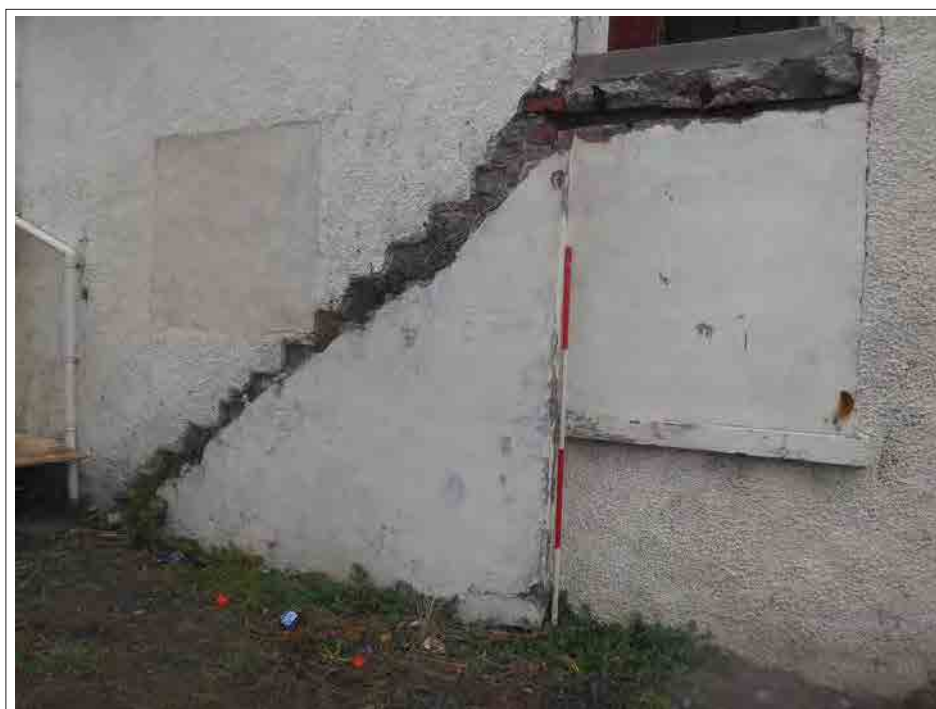
Plate 167. Detail of exterior stair case and doorway/window. Scale 2m

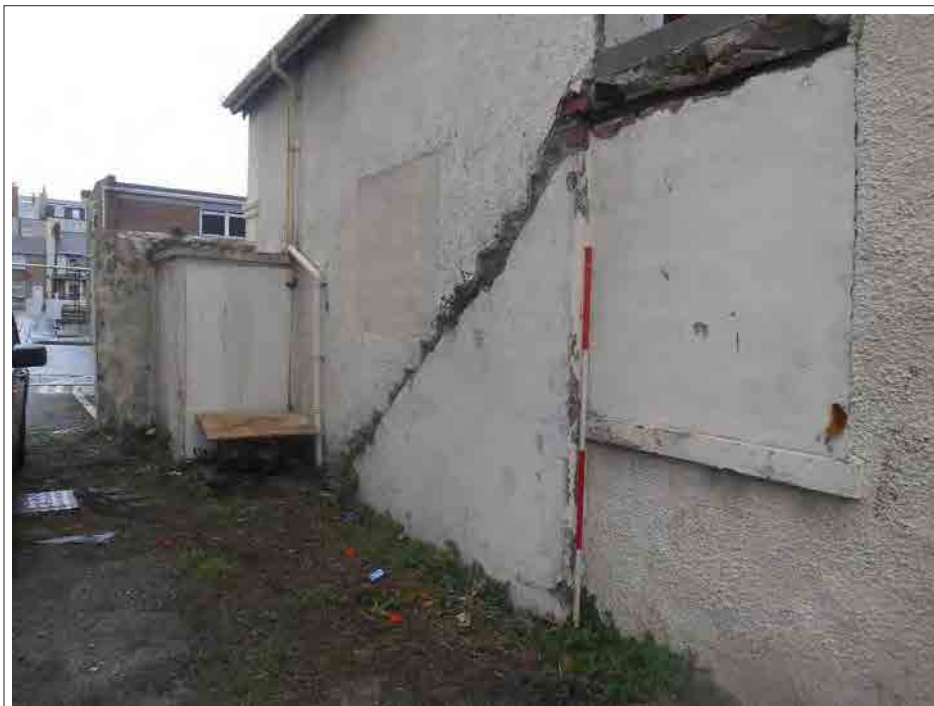
Plate 168. Outbuilding attached to garage behind facade wall.  
West facing wall.

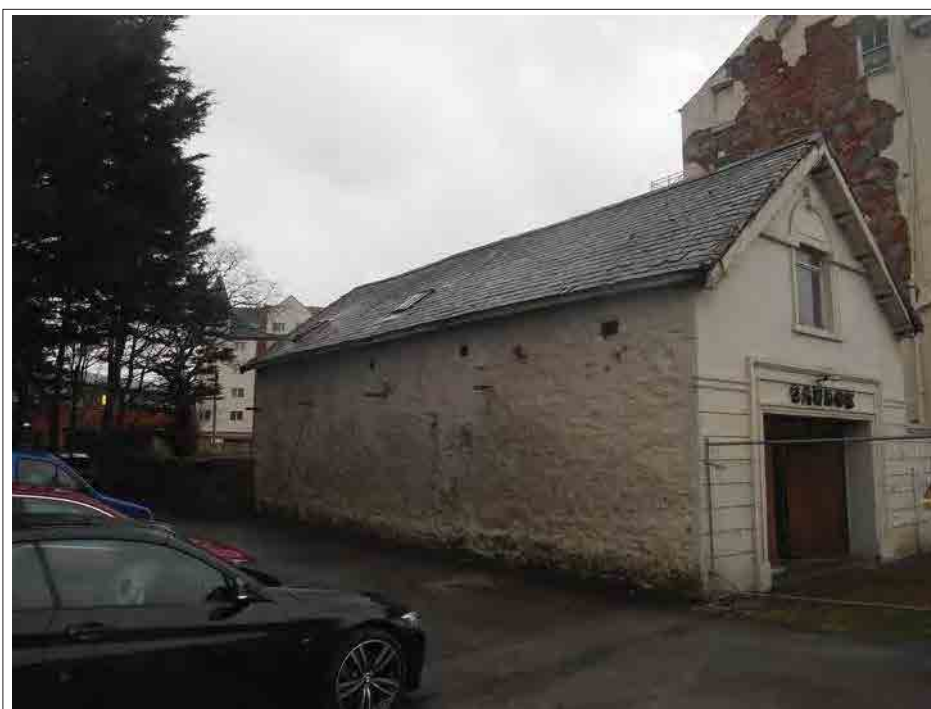
Plate 169. Detail of roof.

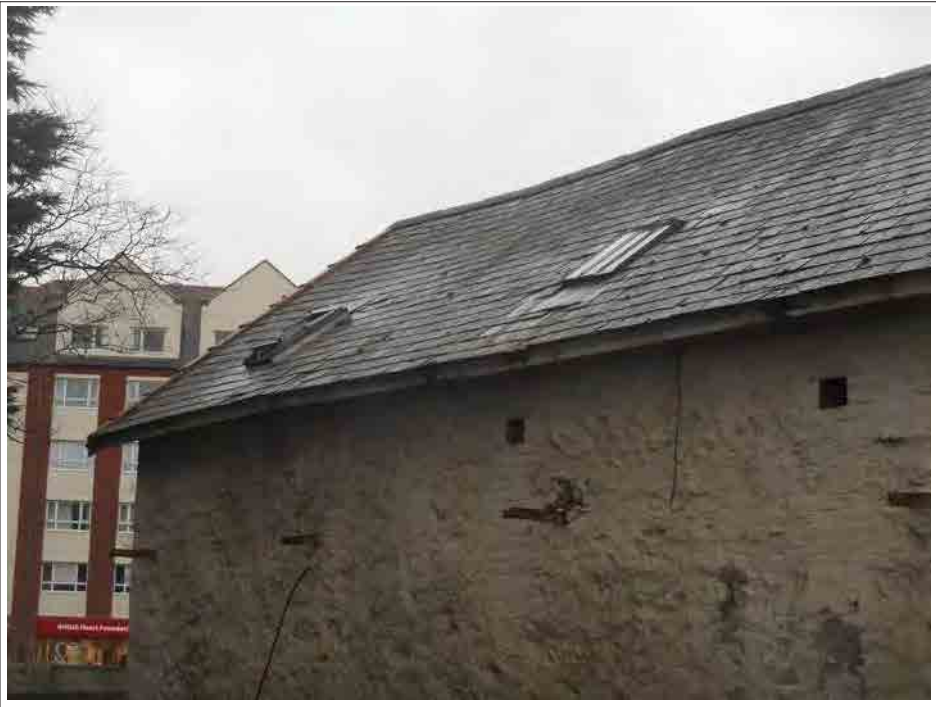
Plate 170. Detail of roof.

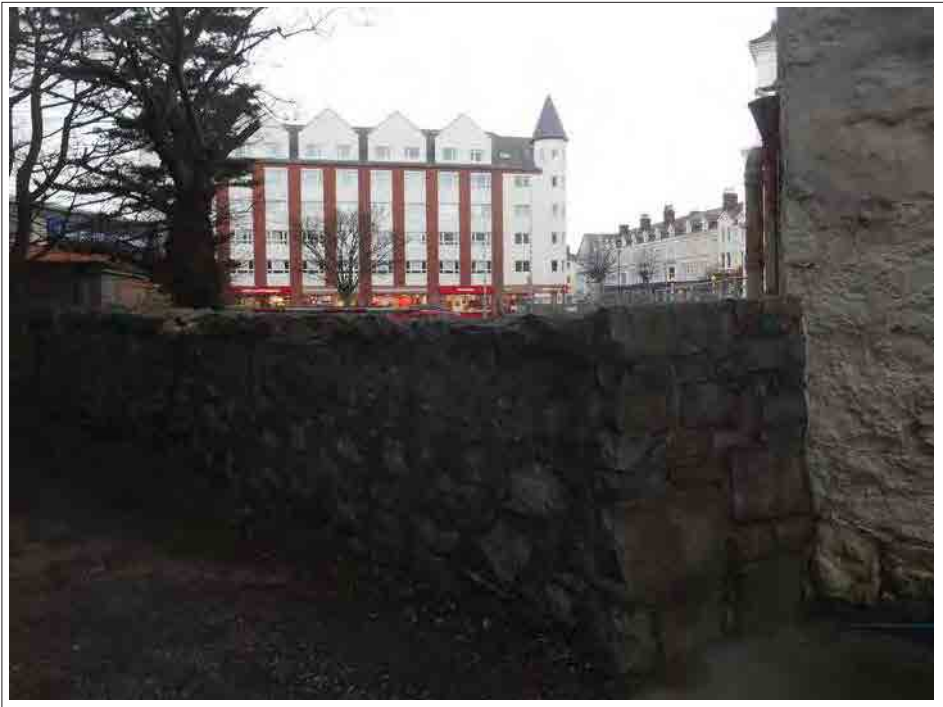
Plate 171. Detail of circuit wall.

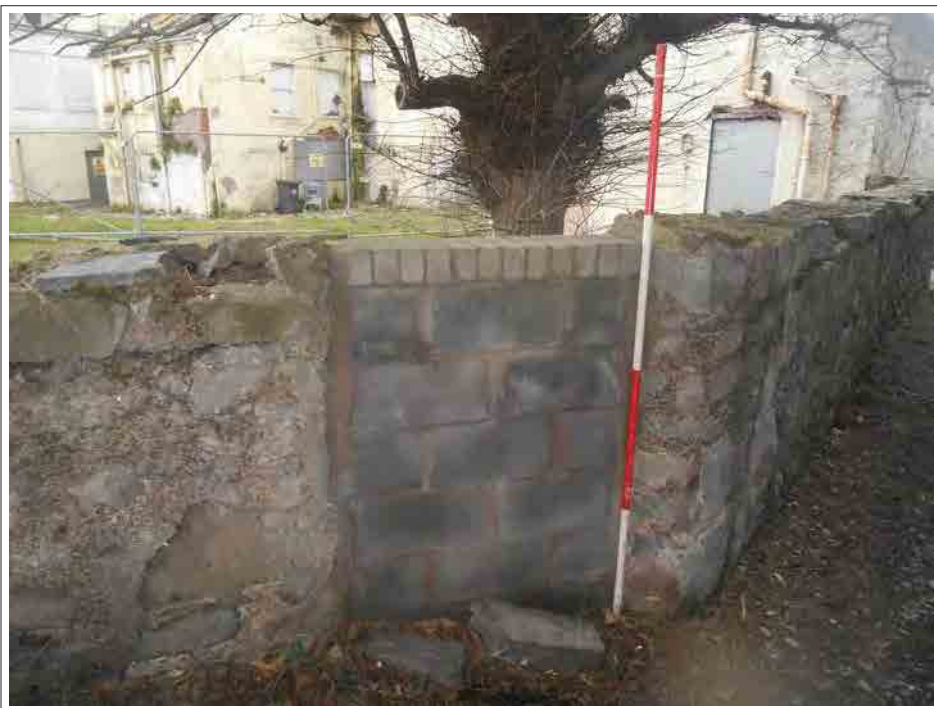
Plate 172. Modern alteration of circuit wall. Scale 2m

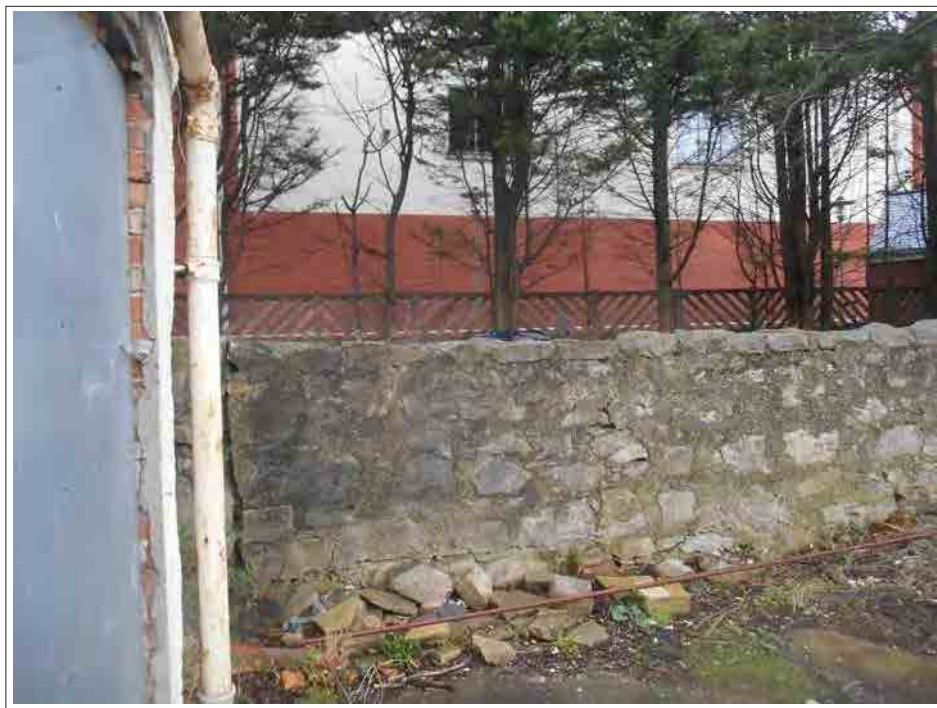
Plate 173. Circuit wall viewed from back entrance.

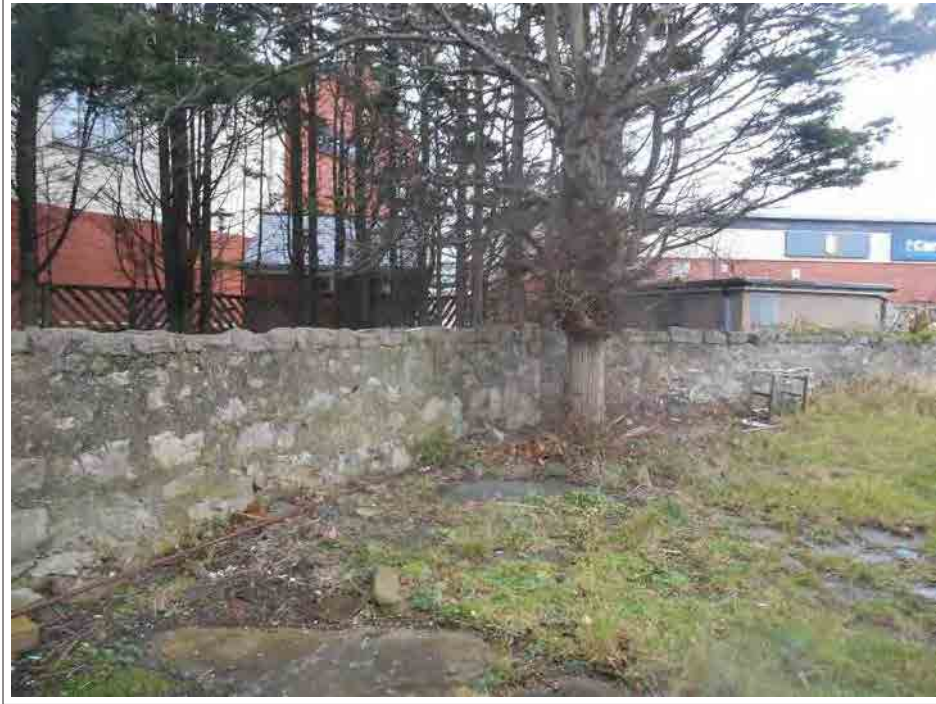
Plate 174. Detail of circuit wall viewed from back entrance.
